Successful Reversal of Deterioration in an Old Set of Coke Drums

Pierre DuPlessis

Mahmod Samman, Ph.D., P.E.

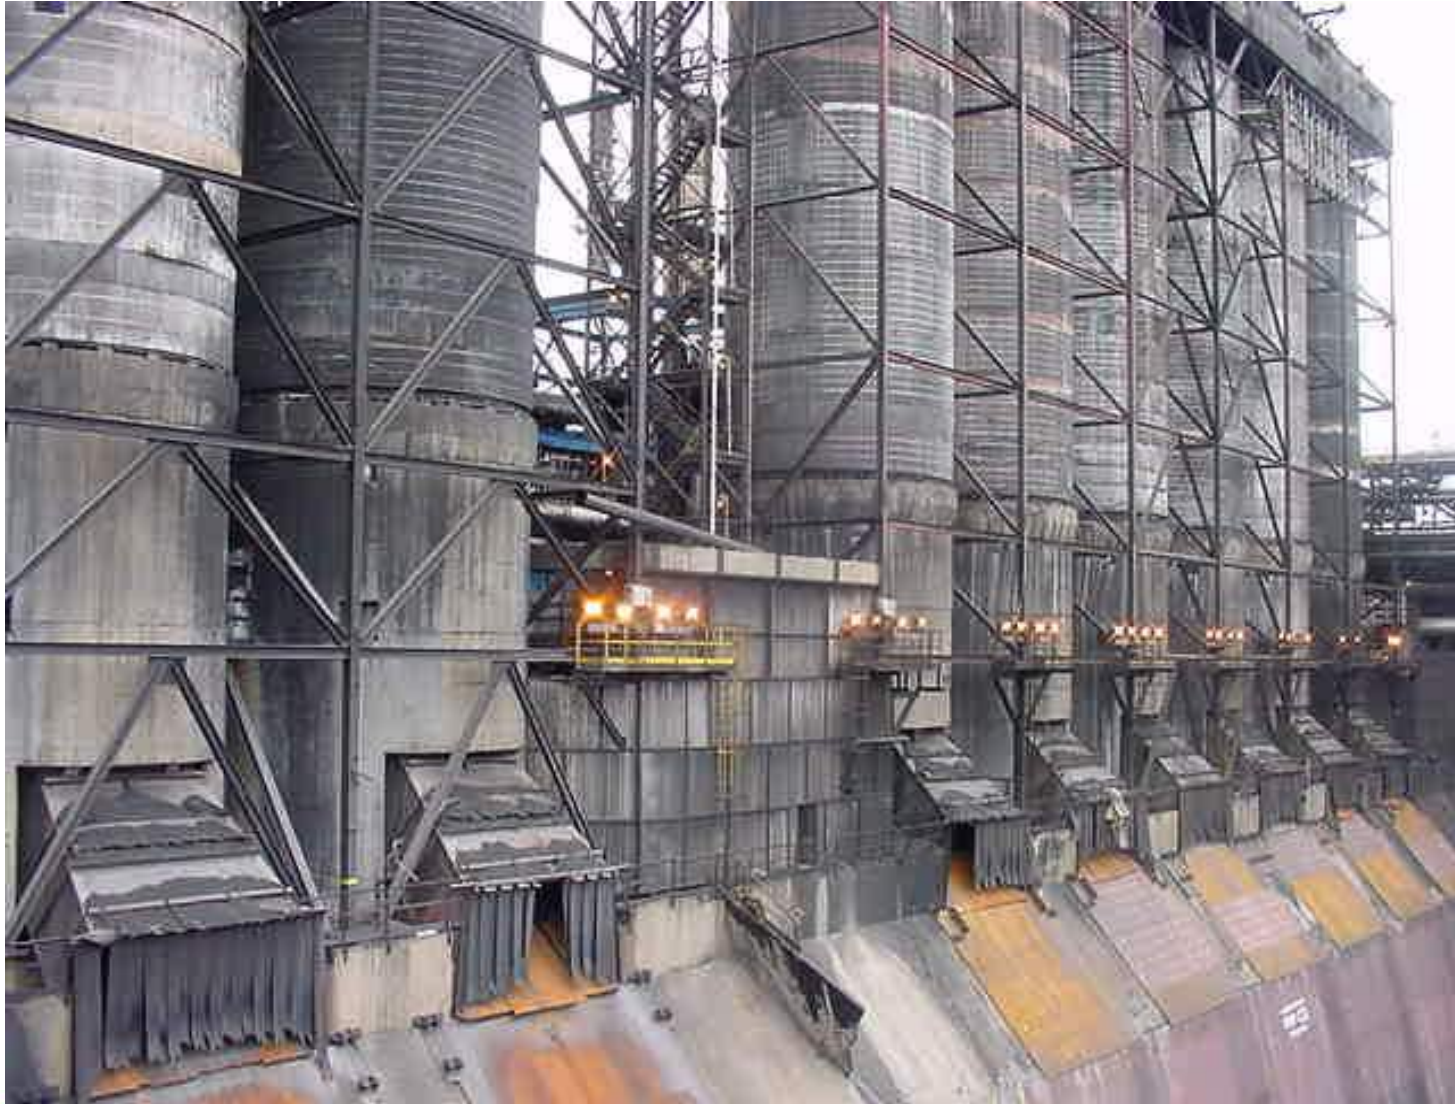
U1 Cokers

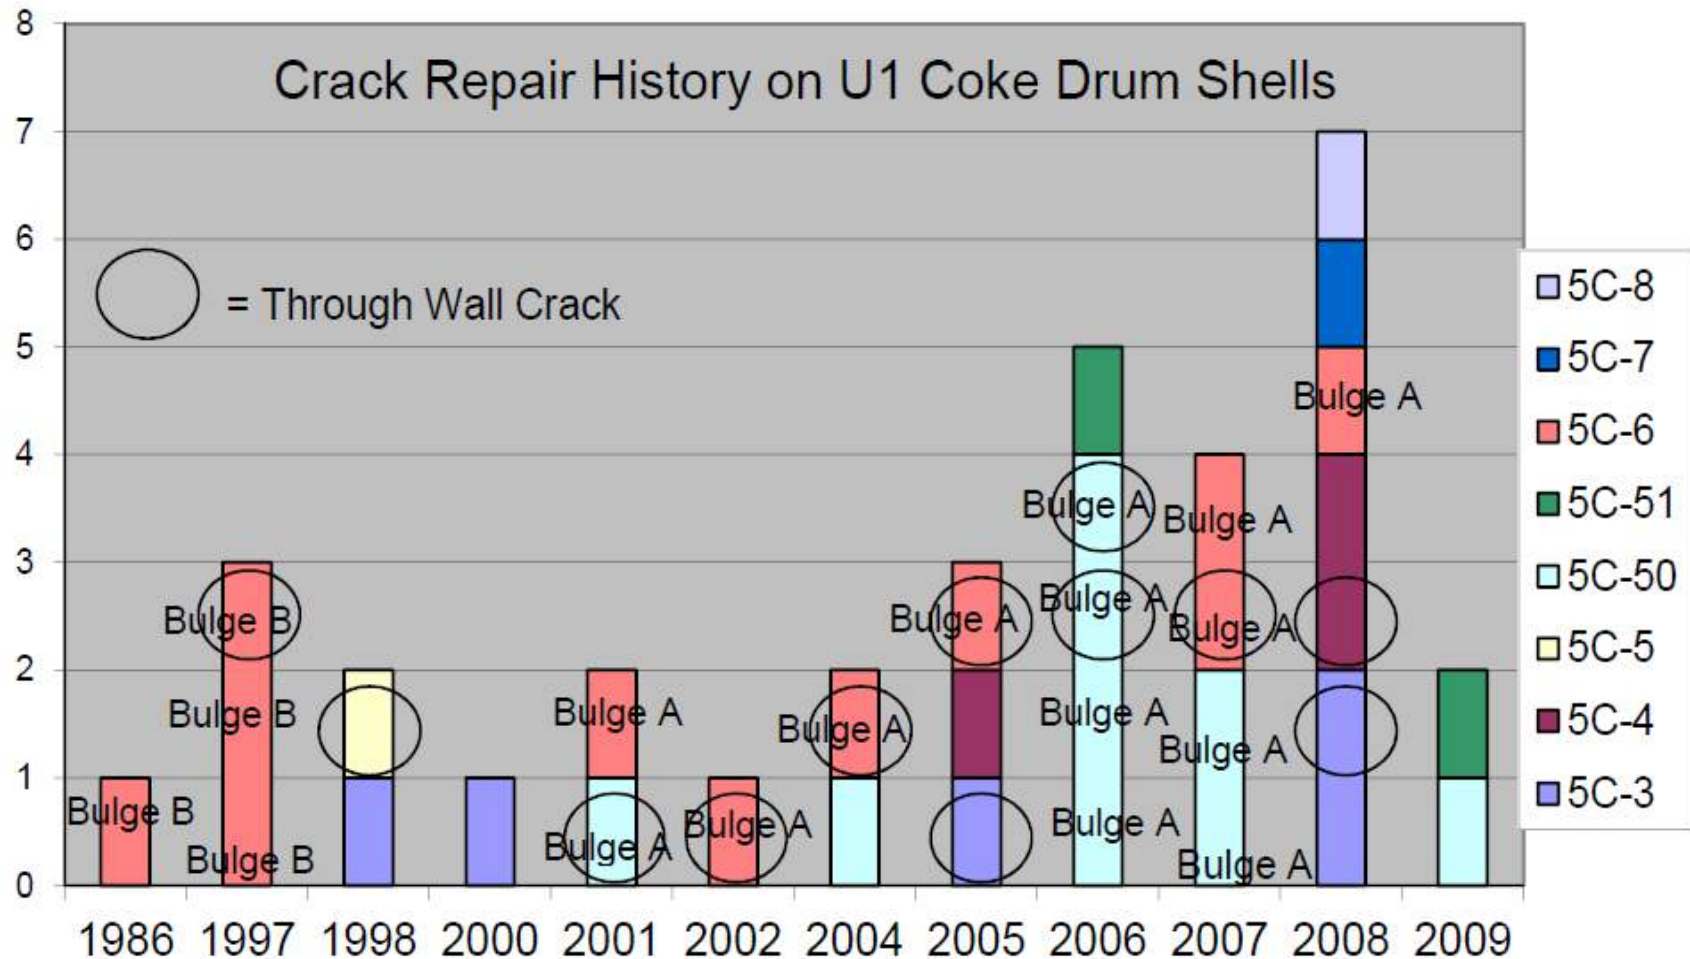
Crack Repair History in U1

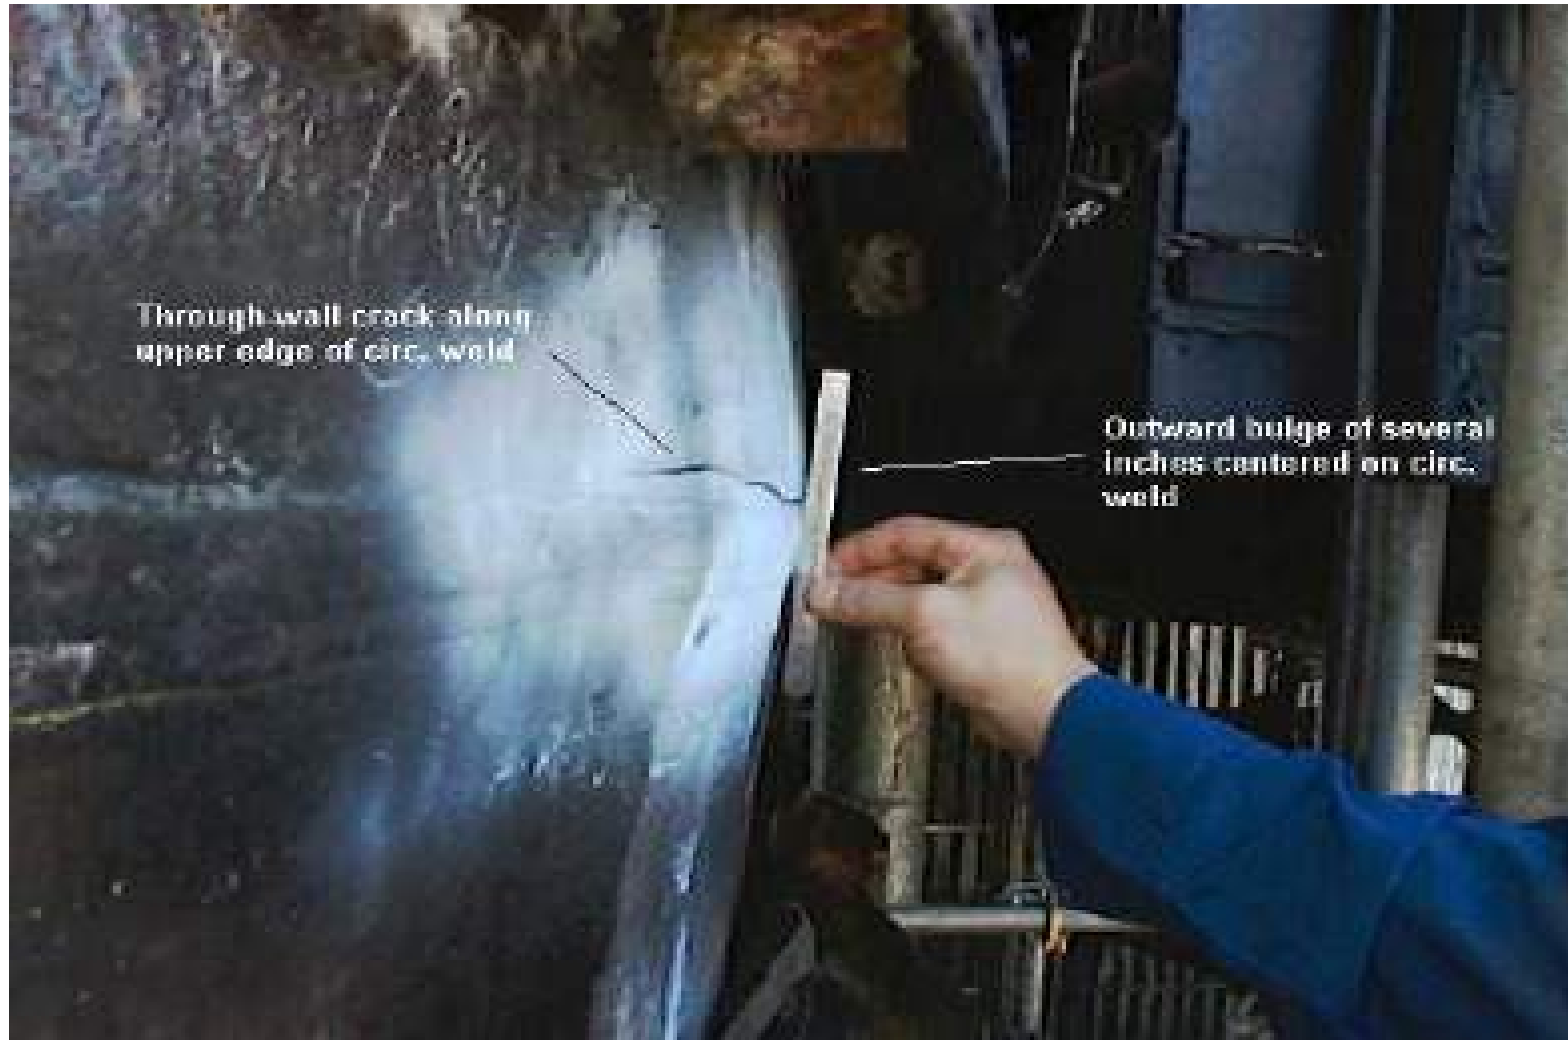
A Bulge and Through-Wall Crack

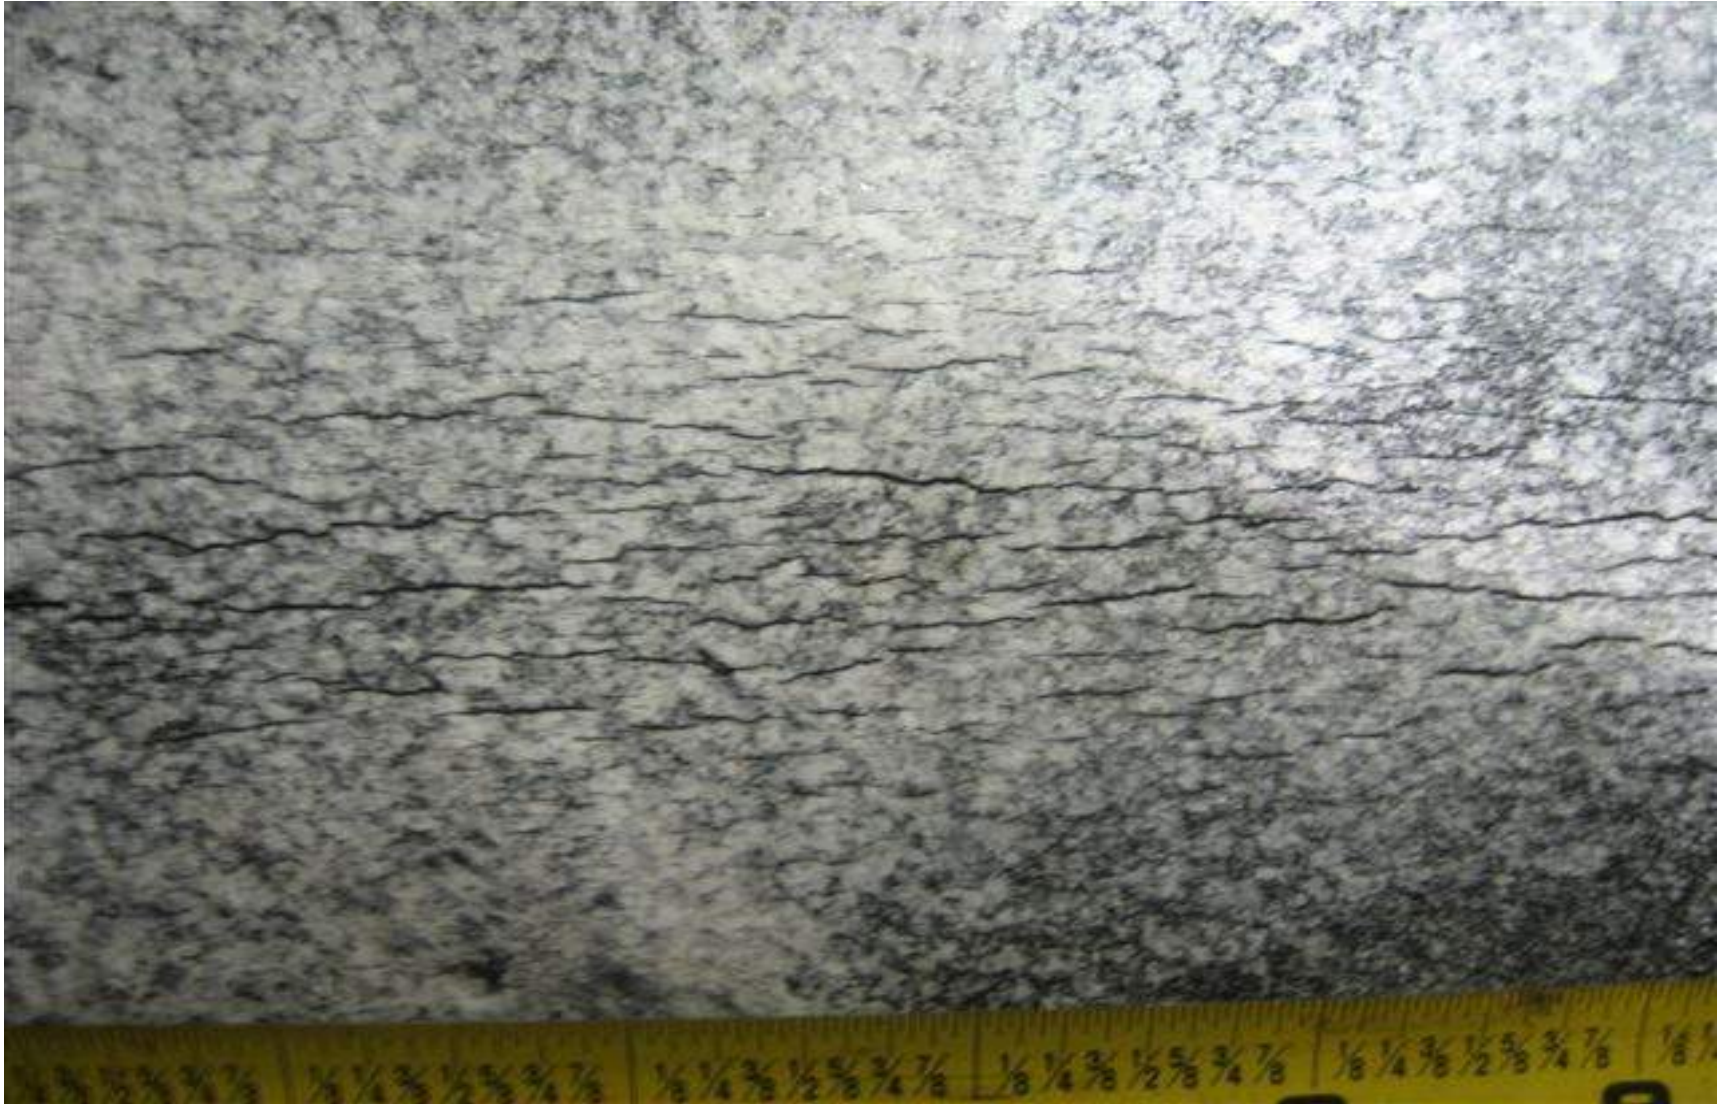
Typical Elephant Skin Cracks

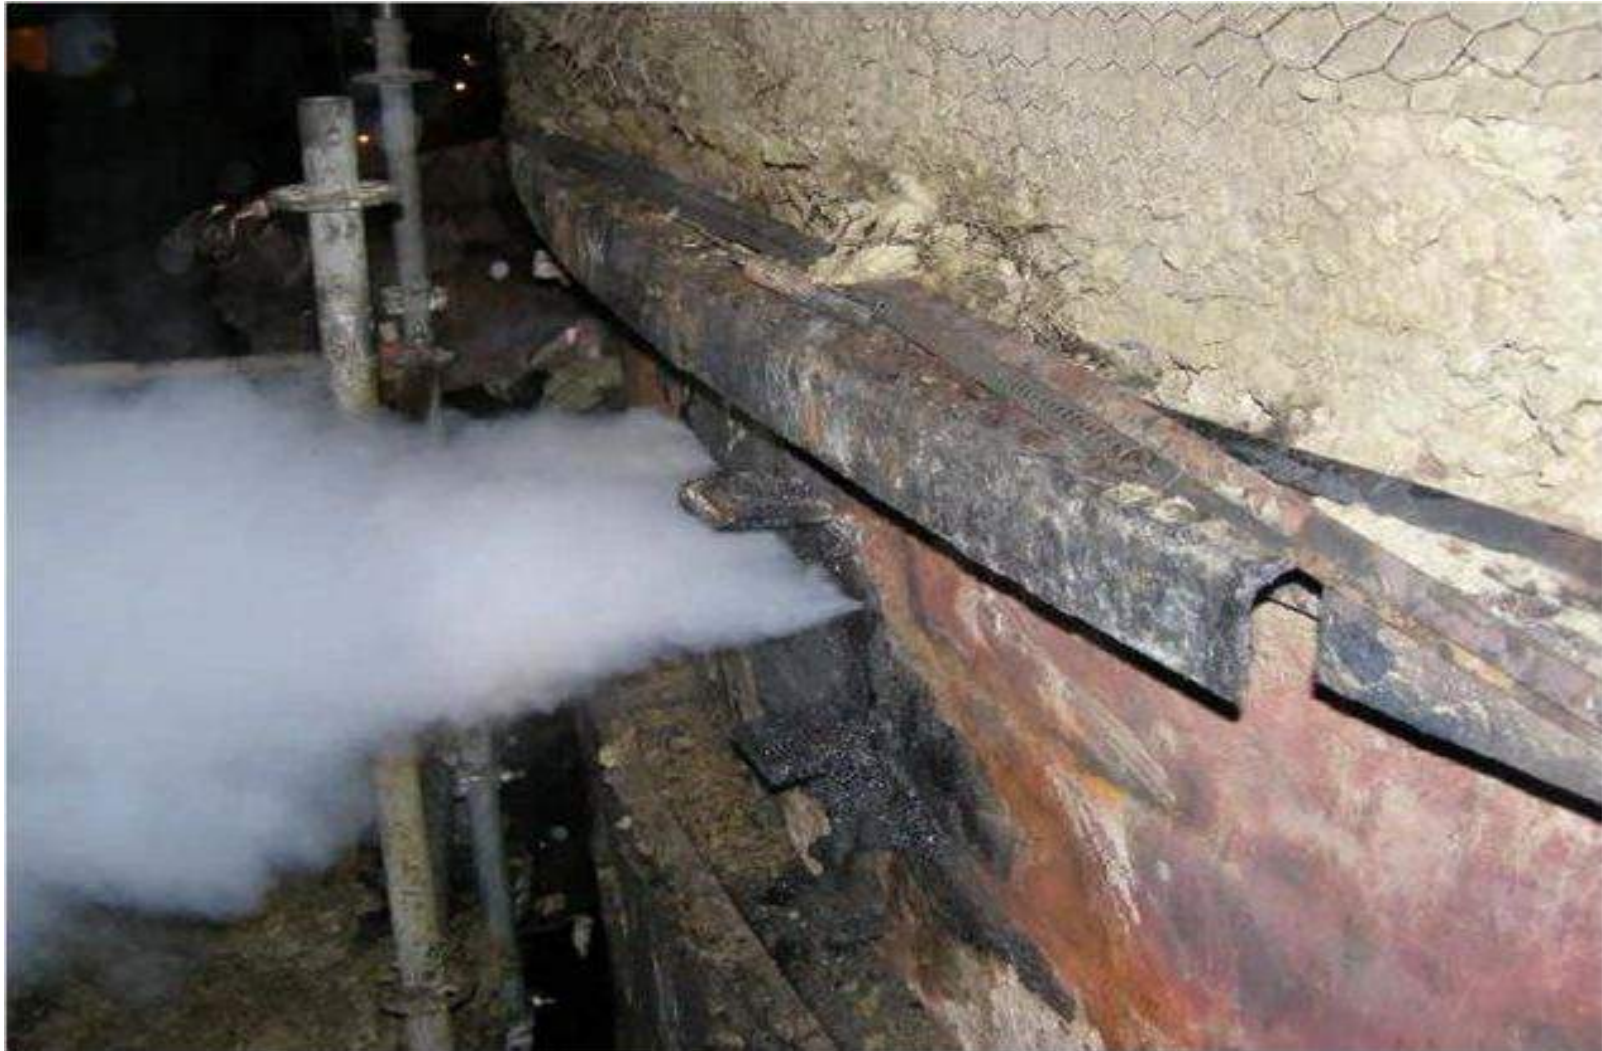
A Leak During Quench

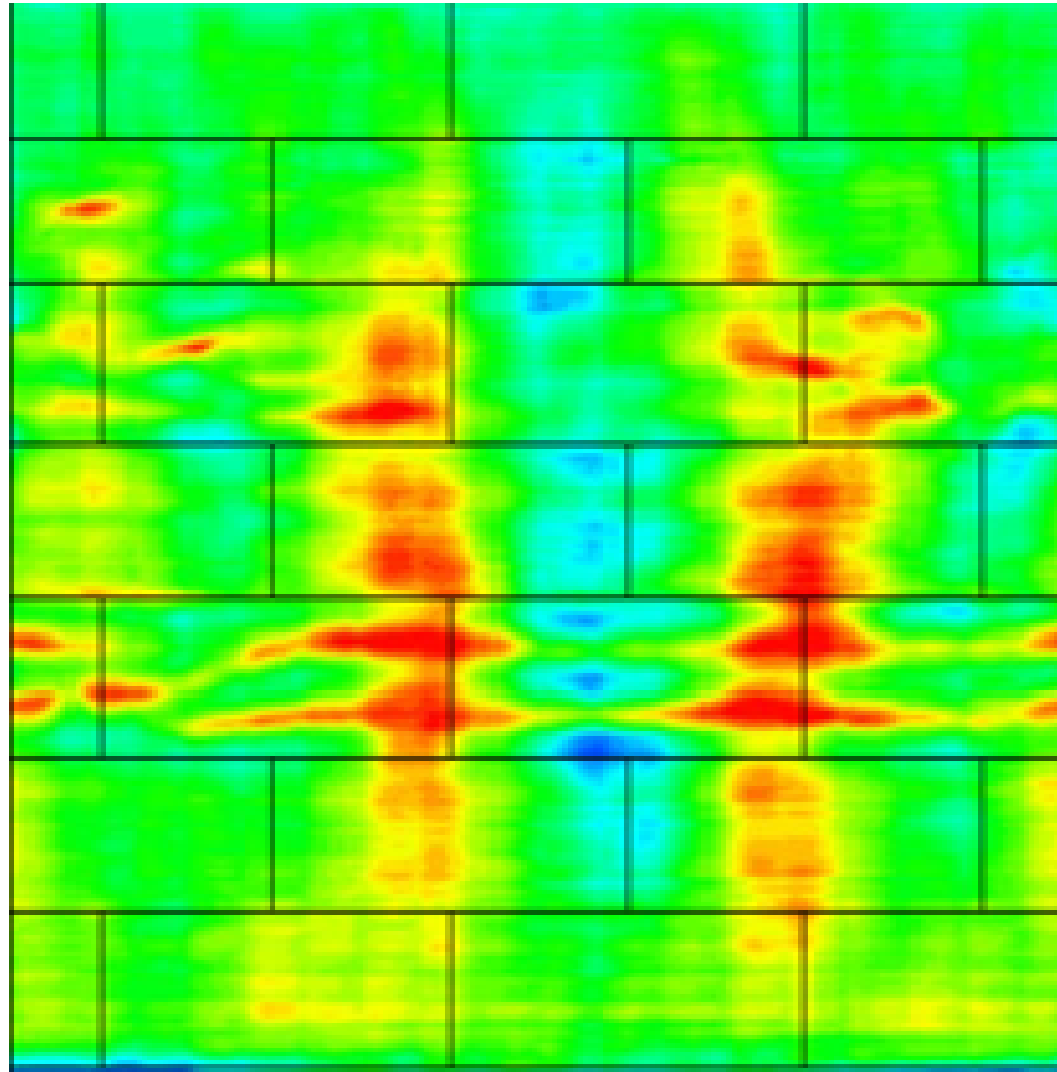
Laser Scanning

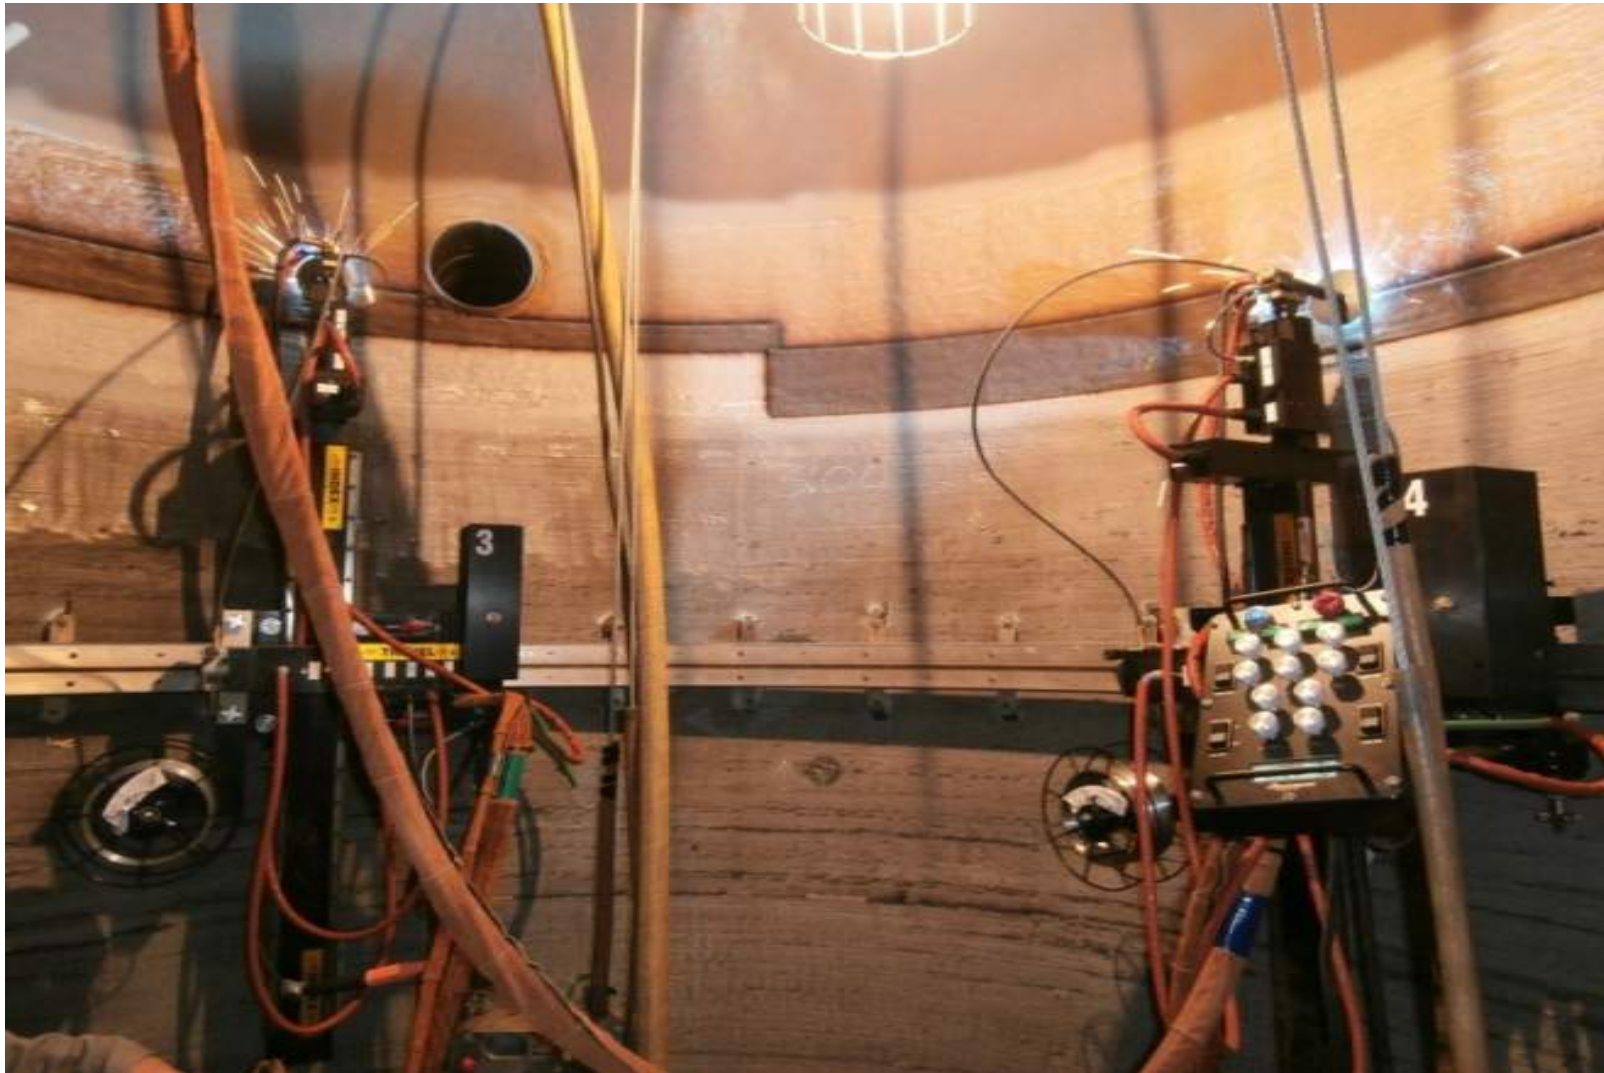
Automated Weld Overlay in Progress

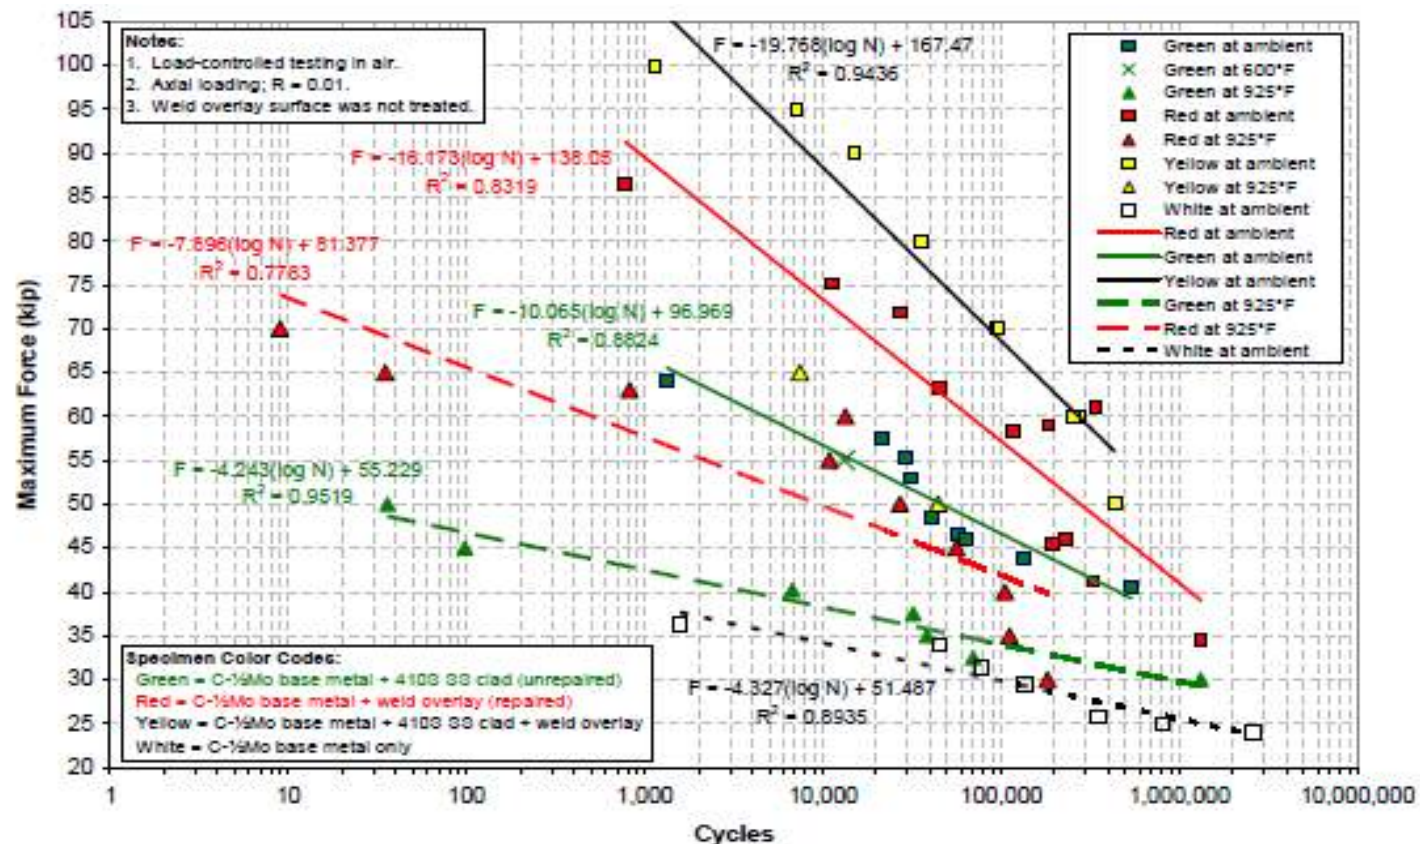
Fatigue Test Results

- At constant temperature, standard weld overlay (overlay on base metal) increased fatigue life of test coupons by an order of magnitude.
- Unconventional weld overlay on clad improved fatigue performance even more but, since tests were isothermal, effect of thermal cycling was not examined.

- In 2008, a test program was initiated to assess and optimize the performance of engineered weld overlays for long-term repairs of coke drums.
- Utilized a C-1/2Mo plate that was recovered from a retired drum that was in operation for 20 years and Inconel 625 weld overlay.
- Mechanical testing, metallurgical examinations, nondestructive evaluations, and load-controlled fatigue isothermal tests were conducted on:
 - base material + clad (unrepaired condition)
 - base material + weld overlay (repaired condition)
 - base material + clad + weld overlay (proposed unconventional overlay on clad)
 - as-welded overlay
 - retired base metal
- Some key findings:
 - Valuable unpublished properties were obtained for in-service base metal and as-welded Inconel 625 overlay.
 - Impact of weld overlay on fatigue life of test coupons quantified.

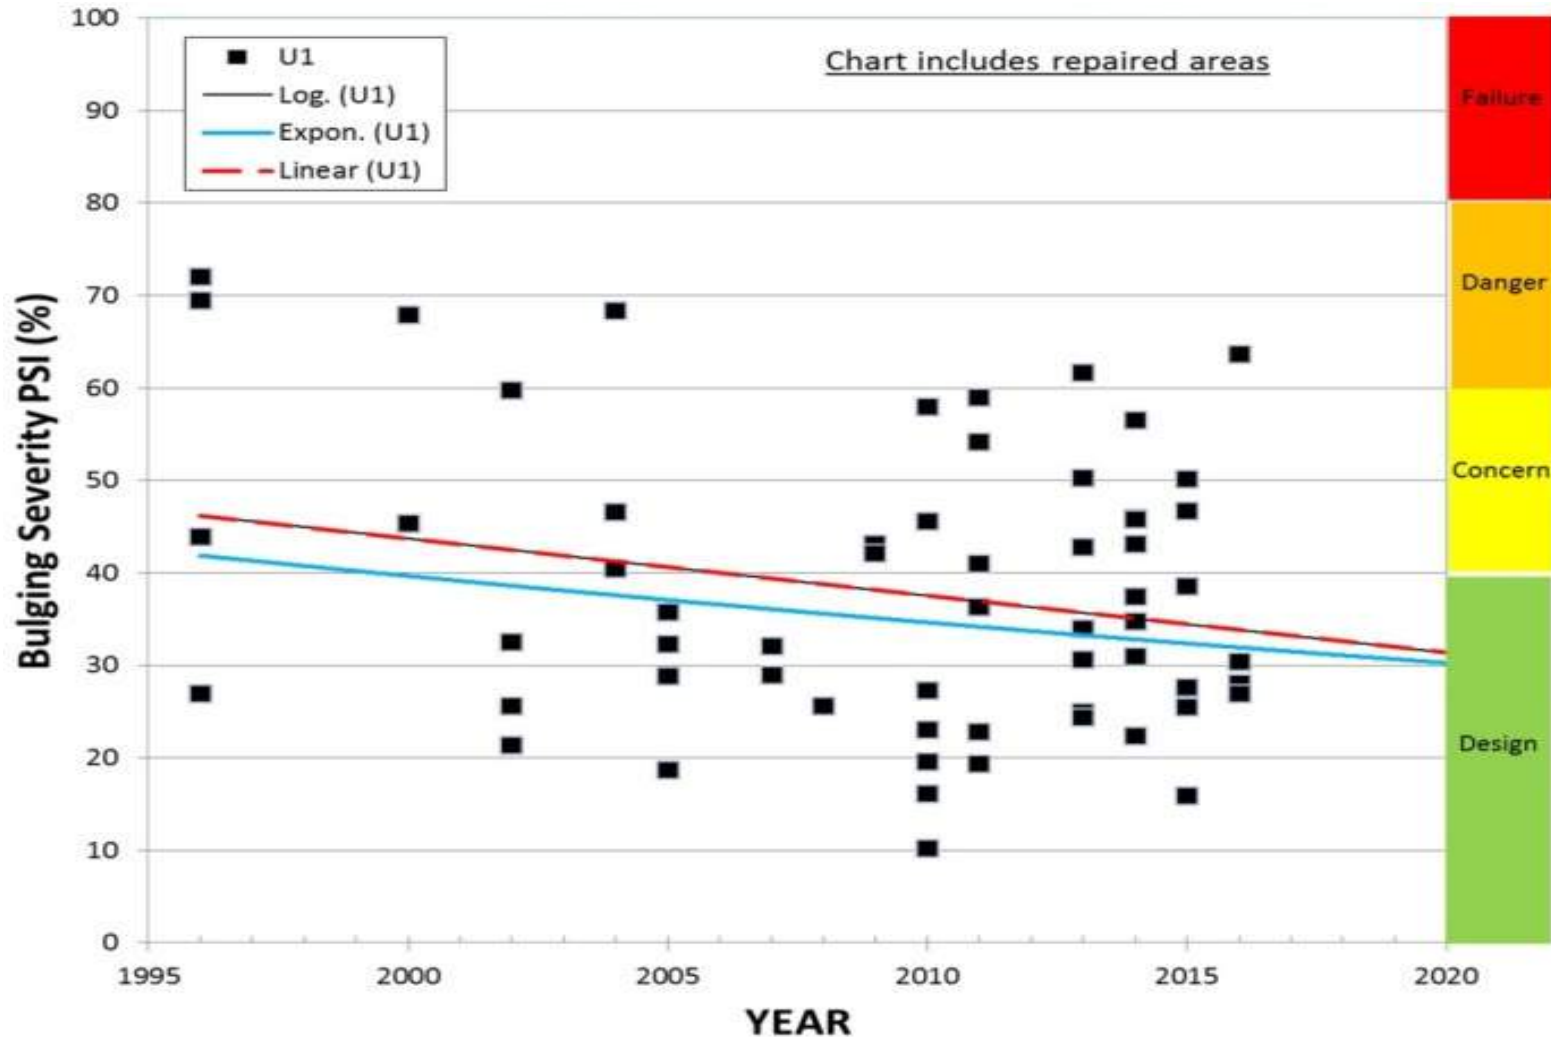
PSI Trend of U1 Drums

- Bulging severity in U1 drums has not only stabilized but decreased which is dramatic and unique in industry. Trend for U2 drums, which did not use the same strategy, showed a significant increase in bulging severity over time.
- No cracks in unpredicted areas were found in U1 drums. The few cracks found were mostly non-bulging induced at circumferential seam welds.
- None of the bulges that had been weld-overlaid experienced through-wall cracking.
- Extension of inspection intervals of U1 drums from three to four years is being considered. Combined savings are estimated at \$30 million per year for the four sets of drums.
- Project to replace U1 coke drums was cancelled in 2011.

Data have significant scatter because of the following:

- Not all drums in each set were laser-scanned every time. Initially, only suspected bad actors were scanned. Under the new strategy, all drums are scanned, if possible.
- Not all bulges in all drums were repaired using weld overlay.
- Not all repairs were made at the same time.
- The condition of drums significantly varied. While some drums experienced repeated bulging-induced through-wall cracks, others had none.
- The amount of noise in laser data is dependent on the technology and the inside condition of inspected drum.

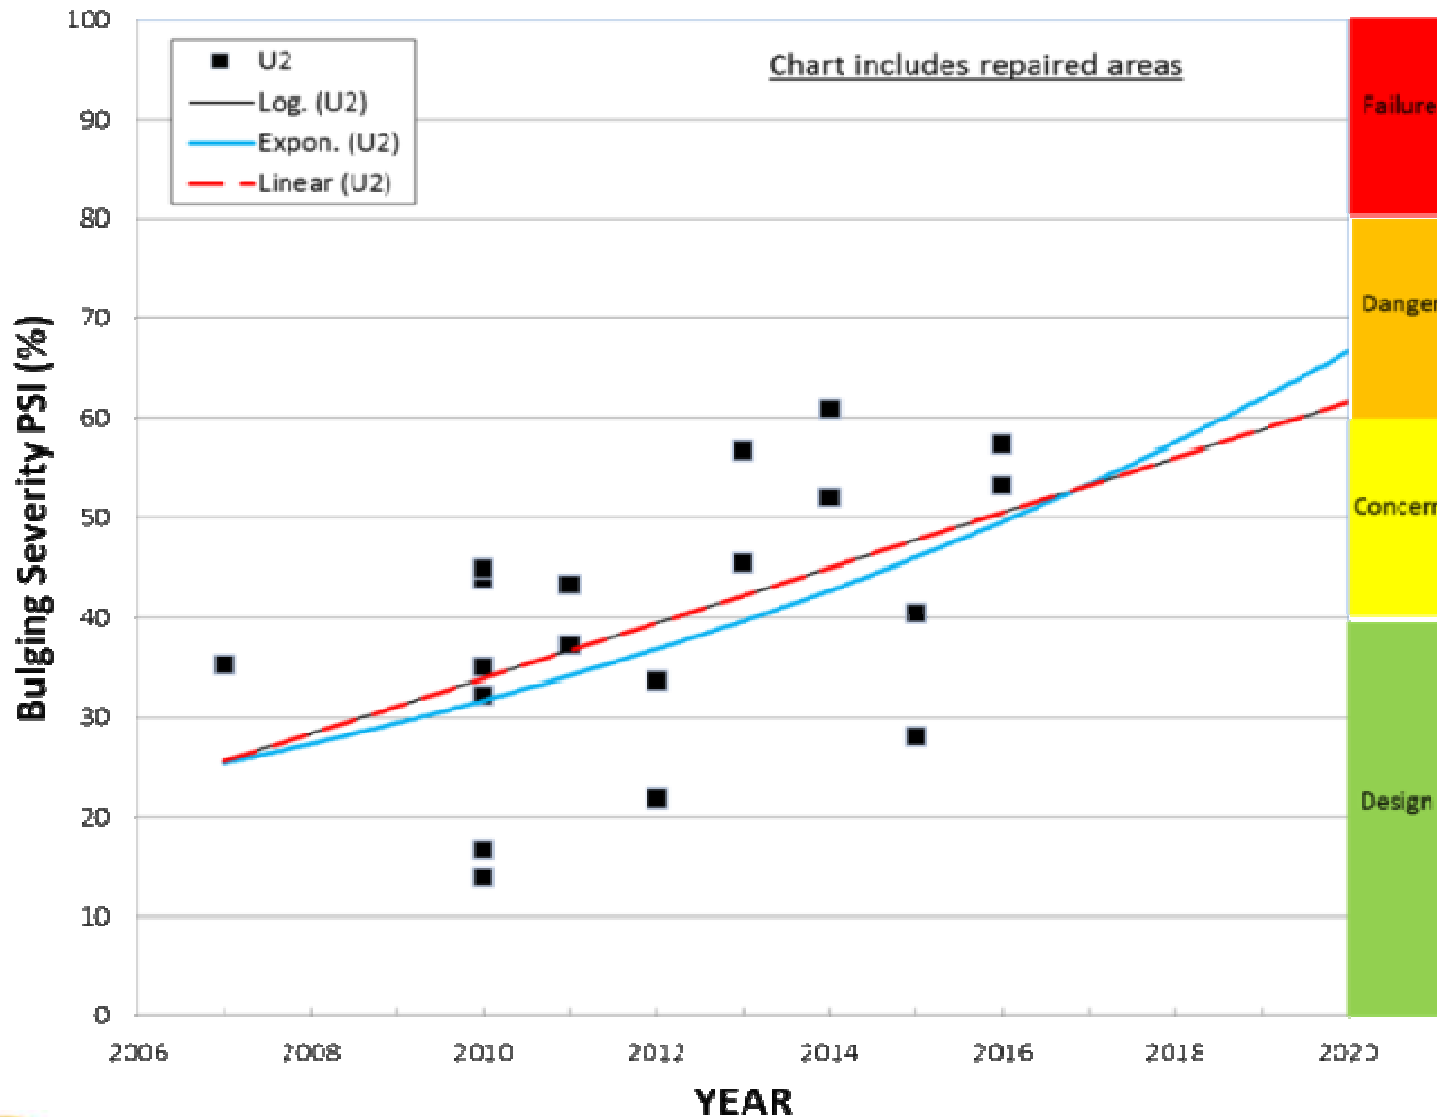
PSI Trend of U2 Drums

Comparison between the two drum sets can only be made in a directional manner because of design differences:

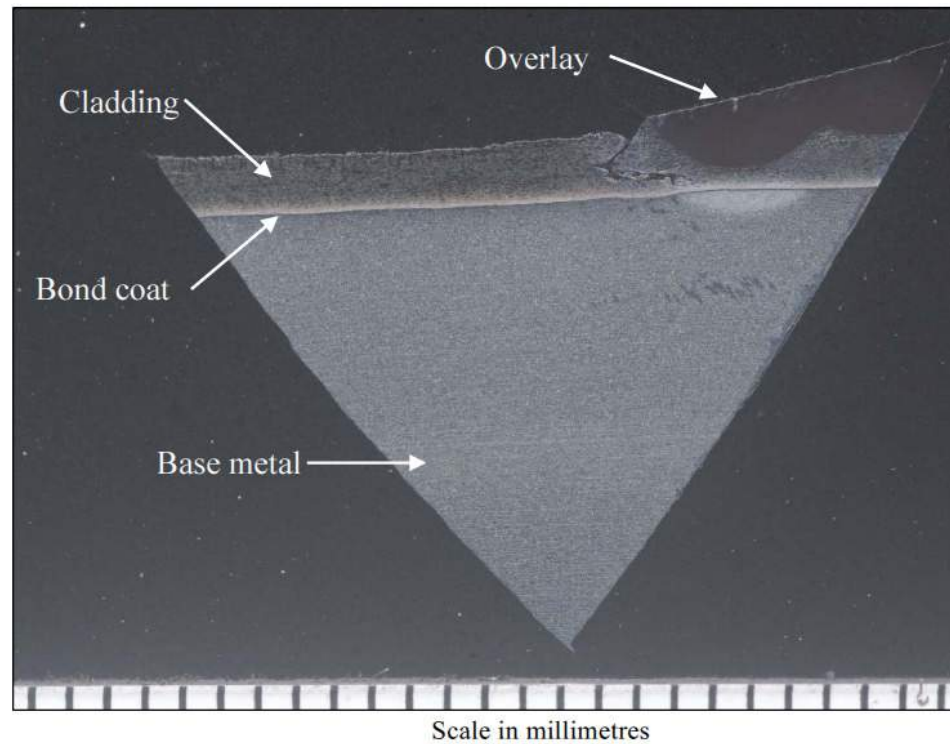
- Cracks at poorly-finished toes of weld perimeter.

Efforts to improve the procedures and inspection methods of perimeter transition details and weld surface finish are underway.
