**A CASE HISTORY OF  
REFRACTORY LINING IMPROVEMENTS FOR  
O<sub>2</sub>-ENRICHED FURNACE SERVICE  
(You Don't Know What You Don't Know)**

*Mrs. Susan Grigson, P.E., Ortloff Engineers, Ltd., Midland, Texas*  
*Mr. Shawn Olson, TOTAL Petrochemicals USA, Inc., Port Arthur, Texas*  
*Mr. Andy Piper, The THORPE Engineering & Construction Group, Houston, Texas*  
*Mr. Jeff Proctor, P.E., The THORPE Engineering & Construction Group, Houston, Texas*

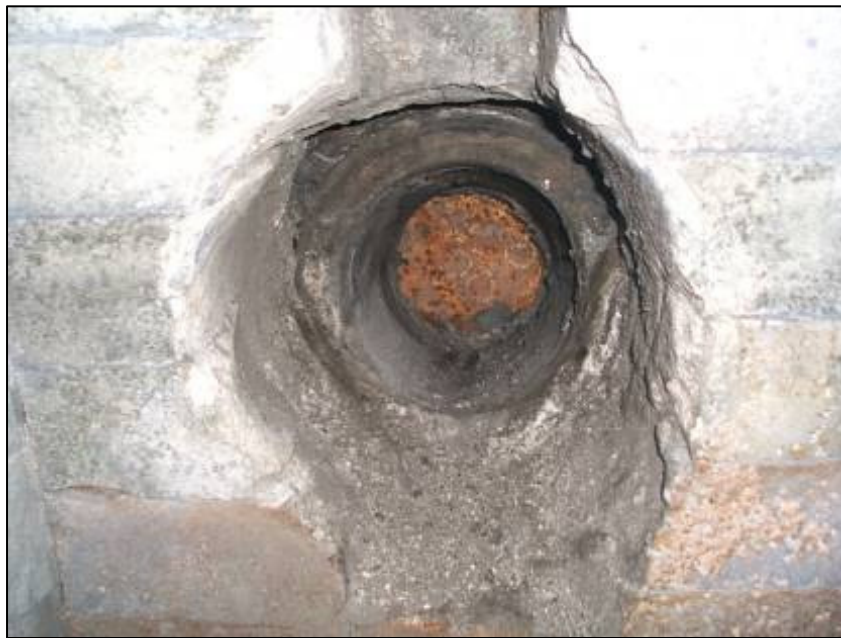
**Figure 6. Acid Gas Bypass Nozzle Failure**

To mitigate the repeated failures of these nozzles in both existing units, the Refiner's engineers designed a 1.25" [32 mm] thick ceramic ferrule insert for the nozzles. Multiple failures have continued due to internal metal loss of the inner pipe of these jacketed nozzles and the associated jacketed piping, resulting in severe damage to the adjacent and overhead refractory brick. In each of these failures, the ceramic ferrule cracked circumferentially (sheared) at the refractory-shell interface. (See Figure 6.)

In the cases of nozzle failures that did not result in complete refractory and shell failure, the breached process line (inner pipe of a jacketed nozzle or line) has typically caused spalled refractory brick that was discovered during turnaround entry into the vessel. Replacement of these nozzles “in-kind” has been performed in each case. Upgrading the nozzle metallurgy to 304 S.S. has not proven to extend nozzle life.

In the cases of nozzle failure precipitating complete refractory failure, complete shell burn-through has occurred in the overhead of the combustion chamber, extending to the furnace-boiler transition piece. In SRU-3, the resulting damaged shell area required a patch 4' W x 12' L [1.2 m W x 3.7 m L].

The oxygen enrichment retrofit of these units did not include adding purges for the acid gas bypass piping or nozzles. However, after repeated failures, SRU-3 was retrofitted with a nitrogen purge system in 2006 and no known nozzle failures have occurred since that time. An internal inspection will be necessary to verify the condition of the insert and surrounding refractory lining. The new units will include an improved ceramic ferrule design and an automatic nitrogen purge system for acid gas bypass piping. Improved refractory and ceramic inserts may be incorporated into the existing units as the opportunities arise.

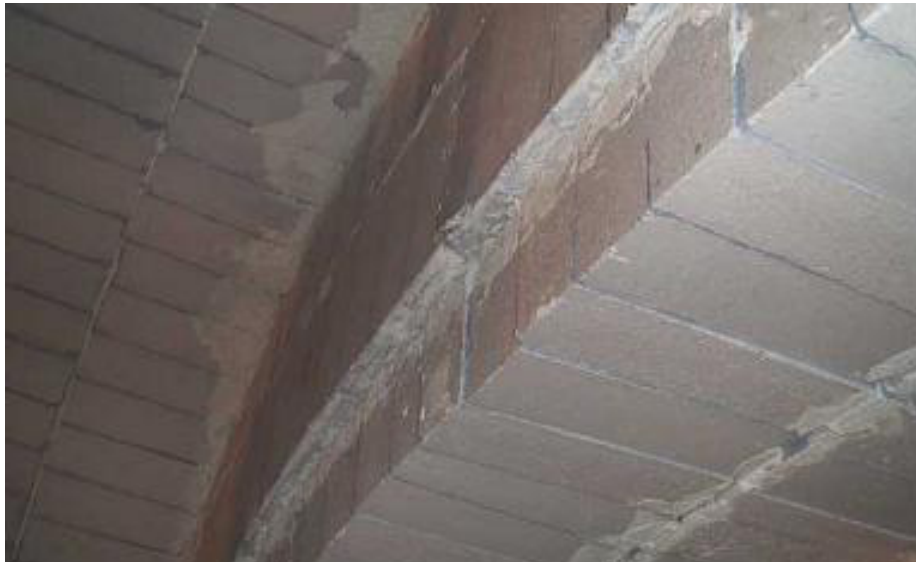
**Figure 7. Non-Anchored Flatwall Brick**

- First, the refractory brick on the flat endplate above the boiler inlet moves toward the burner, creating gaps behind the lining. This is due to the lack of a brick anchoring system typically provided for flat wall construction. Displaced endwall bricks are shown in Figure 7.

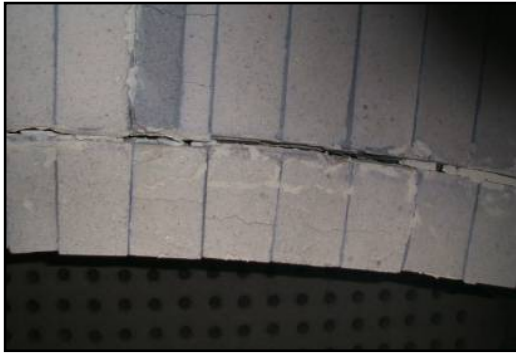
**Figure 8. Bullnose Brick Sag**

- Second, the hotface bullnose bricks below this flat endplate sag due to high-temperature deformation (see Figure 8). The bullnose brick are pushed toward the burner by the boiler inlet arch lining. The resulting gap opens in the hotface brick joints near the steel bullnose of the arch at the endplate, allowing hot gases to penetrate to the shell (see Figure 9).

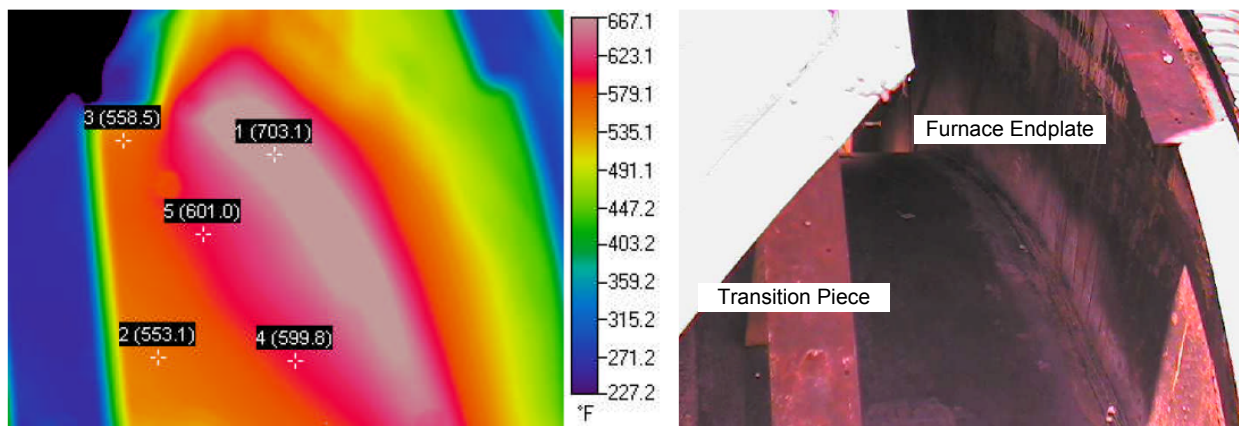
**Figure 10. Thermography Scan of Bullnose Area**  
(The temperature range of 227-703°F is equivalent to 108-373°C)

During regular operation, a hotspot is typically seen in the shell area of the bullnose, as shown in Figure 10 below. In the worst cases (occurring in each unit), the refractory lining of the bullnose has failed completely, resulting in a void behind the insulating brick and allowing burner effluent to reach the carbon steel shell. The shell metal was heavily carburized in these failures, most severely at the leading edge of the steel bullnose. This failure area is central in much of the following discussion. As discussed in Part I, the design of the new units considered several options, including a complete revision of the transition piece geometry and WHB configuration to remedy this problem.

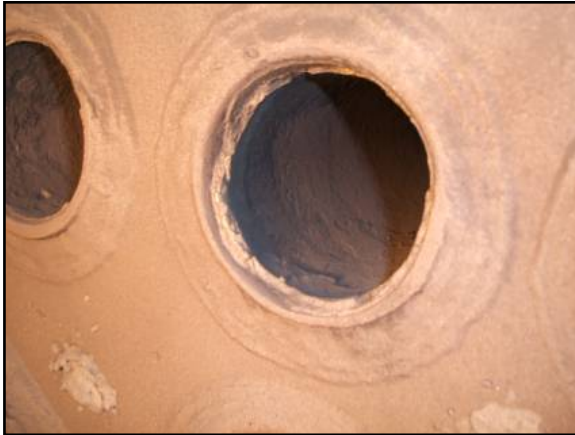
**Figure 11. WHB Tubesheet Joint  
After 25 Years Service**  
*(From an Ortloff licensed unit,  
case history SRU-1)*

The original design for both existing SRUs included straight shank ceramic ferrules (no head) with castable refractory on the tubesheet between and around the ferrule shanks to protect the WHB hot-end tubesheet from the hot furnace temperatures. The existing units have experienced regular cracking (shearing) of the tubesheet ferrules, which requires time-intensive outage repair. Figure 11 shows the existing SRU-1 hot-end tubesheet with moderate metal loss after 25 years of service.

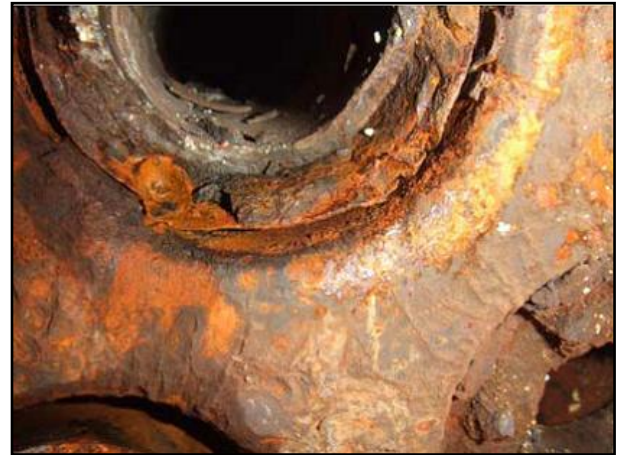
**Figure 12. WHB Tubesheet Joint  
After One Year of Service**  
*(From a non-Ortloff licensed unit,  
not one of the case history SRUs)*

Though the Refiner's domestic SRUs have not experienced WHB hot-end tube-to-tubesheet joint failure, an overseas unit (non-Ortloff licensed) has seen this type of failure (Figure 12). After one year of service, a catastrophic failure did occur in the tubesheet joint.

This failure is similar to those of 1970s vintage SRUs and is attributed to WHB design practices that result in overheating at the hot-end tube-to-tubesheet joint<sup>2</sup>. This recent experience provides an important data point, demonstrating the importance of the design details for the hot-end tube-to-tubesheet joint and weld, and the potential impact on the life of the waste heat boiler.

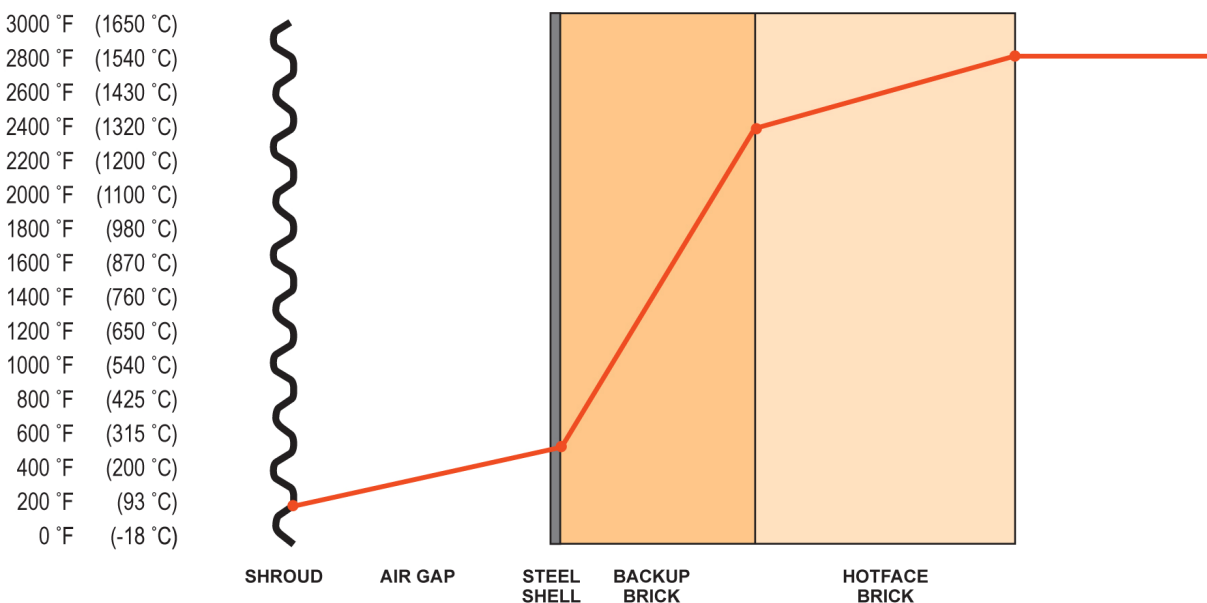
**Figure 13. Typical Thermal Profile**

At this point it is necessary to understand heat transfer and the resulting design constraints on the lining system. The typical thermal profile representing heat transfer through a lining is illustrated in Figure 13 below. Note that the bulk of the temperature drop takes place in the insulating refractory backup layer and that the drop through the more dense and thermally conductive hotface layer is minimal (typically only a few hundred degrees).

Let's talk about the possible utilization of metallic anchoring systems to secure a hotface lining. If the furnace is running at 2800°F [1540°C] and the temperature drop through the dense hotface brick is only 400°F [220°C], the back surface of the dense brick will be running at 2400°F [1320°C]. This essentially precludes the use of any metallic anchoring system due to service temperature limitations, as even the best alloys are only good for about 2000°F [1100°C]. **A self-supporting brick system is therefore the best solution.** However, we must have assurance that such a brick system can withstand the extreme compressive stresses that will exist at operating temperatures.
