## Coke Drum Workshop

### AUT TOFD Inspection of Coke Drums

- David Bajula    Houston, Texas
- Director – Advanced NDT Services

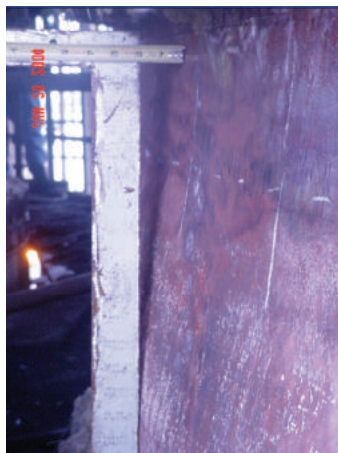
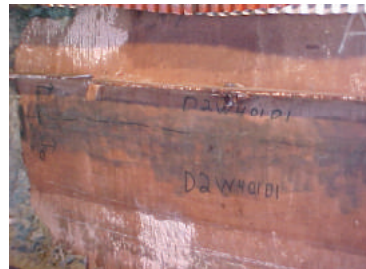
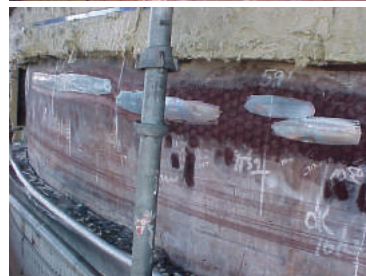
Typical Coke Drum, bulges and all, does not restrict our unique TOFD inspection.
