DETERIORATED SLUICeway AT A DELAYED COKING UNIT AND AN INNOVATIVE T/A REPAIR SOLUTION

Repairing the Repair

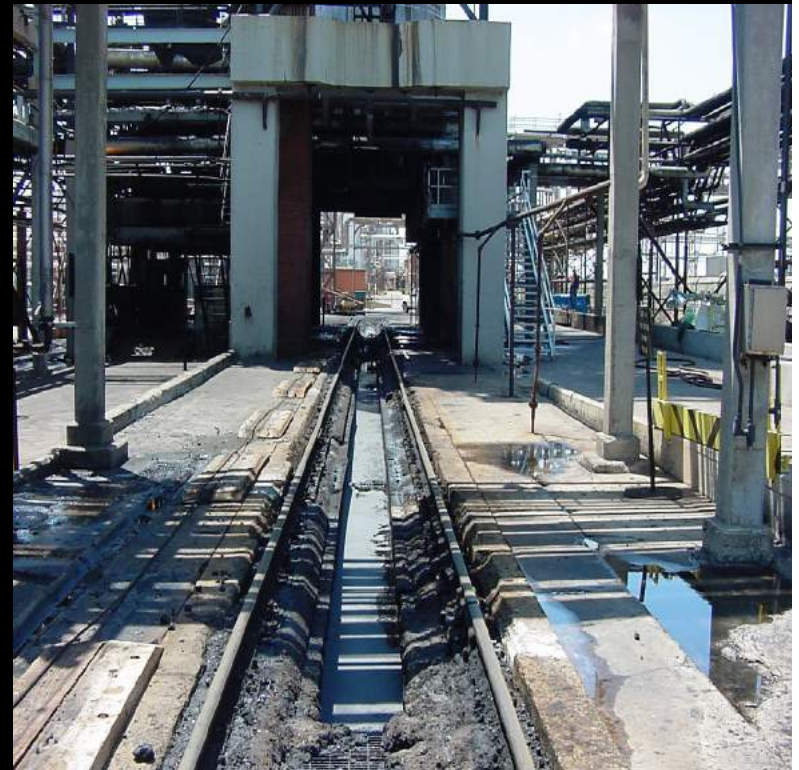
- ◆ Delayed Coker Unit is reported to be 1940's vintage
- ◆ Sluiceway directs hot process fluids assisted by high-pressure water jets
- ◆ Hydrocarbon based products exceeding boiling point of water

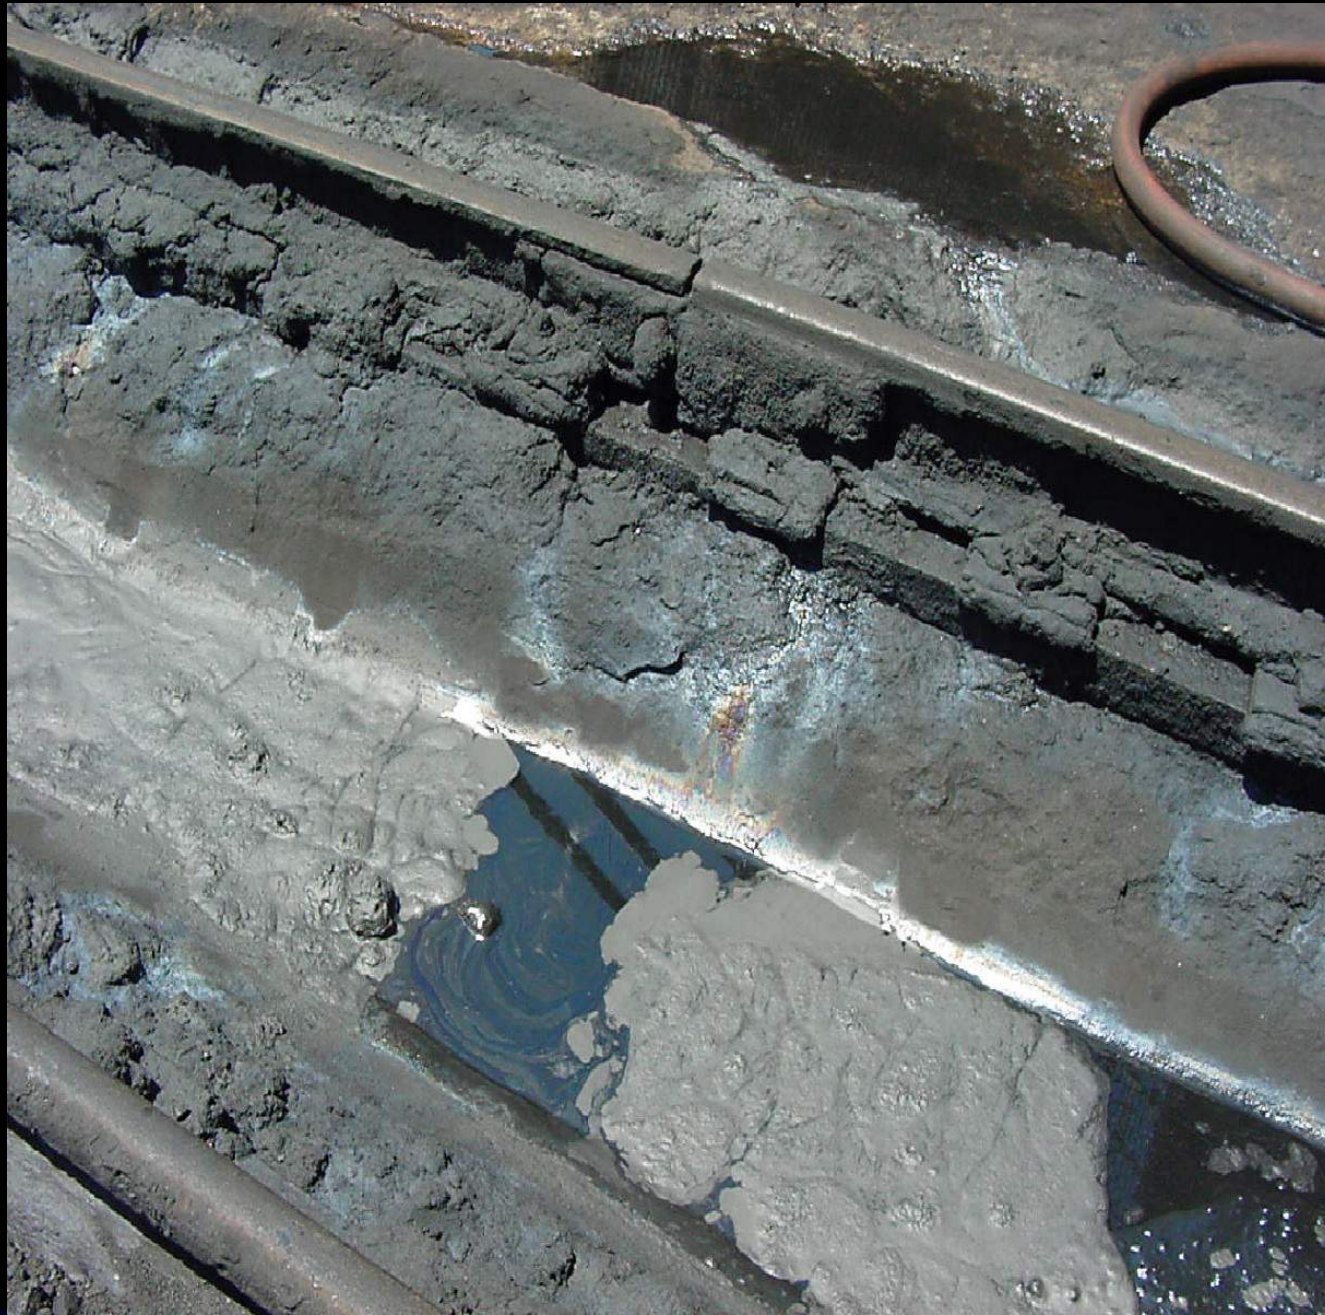
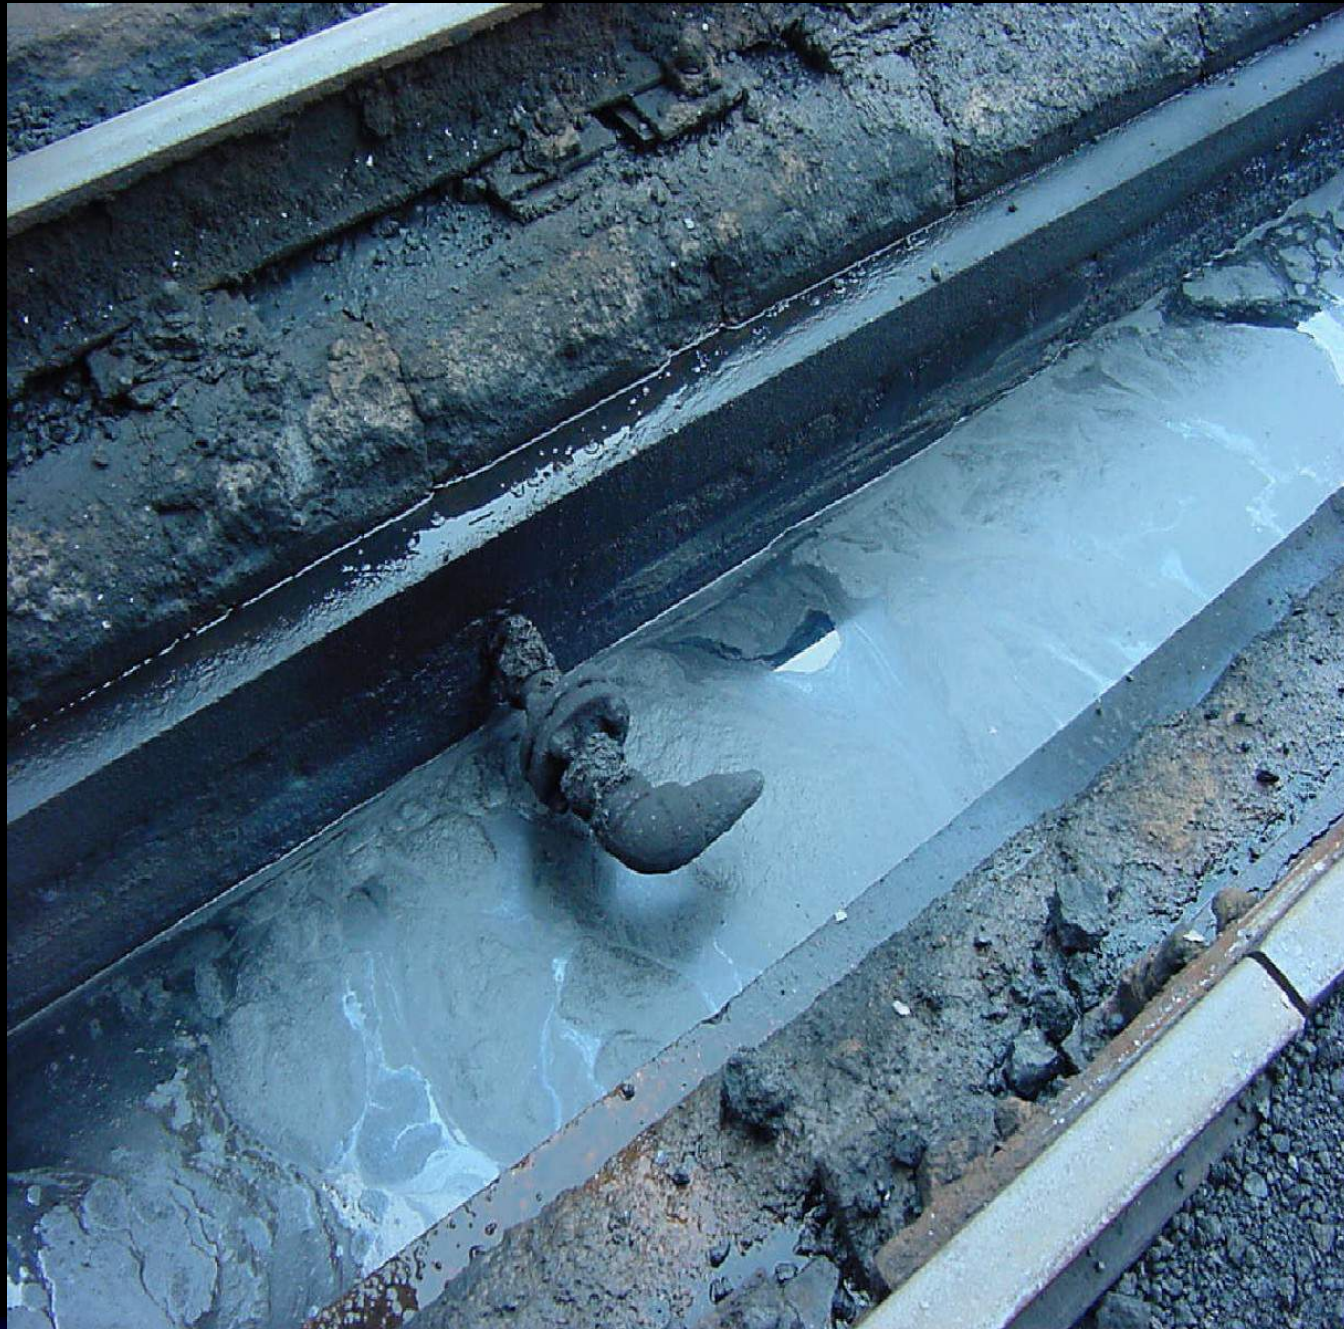
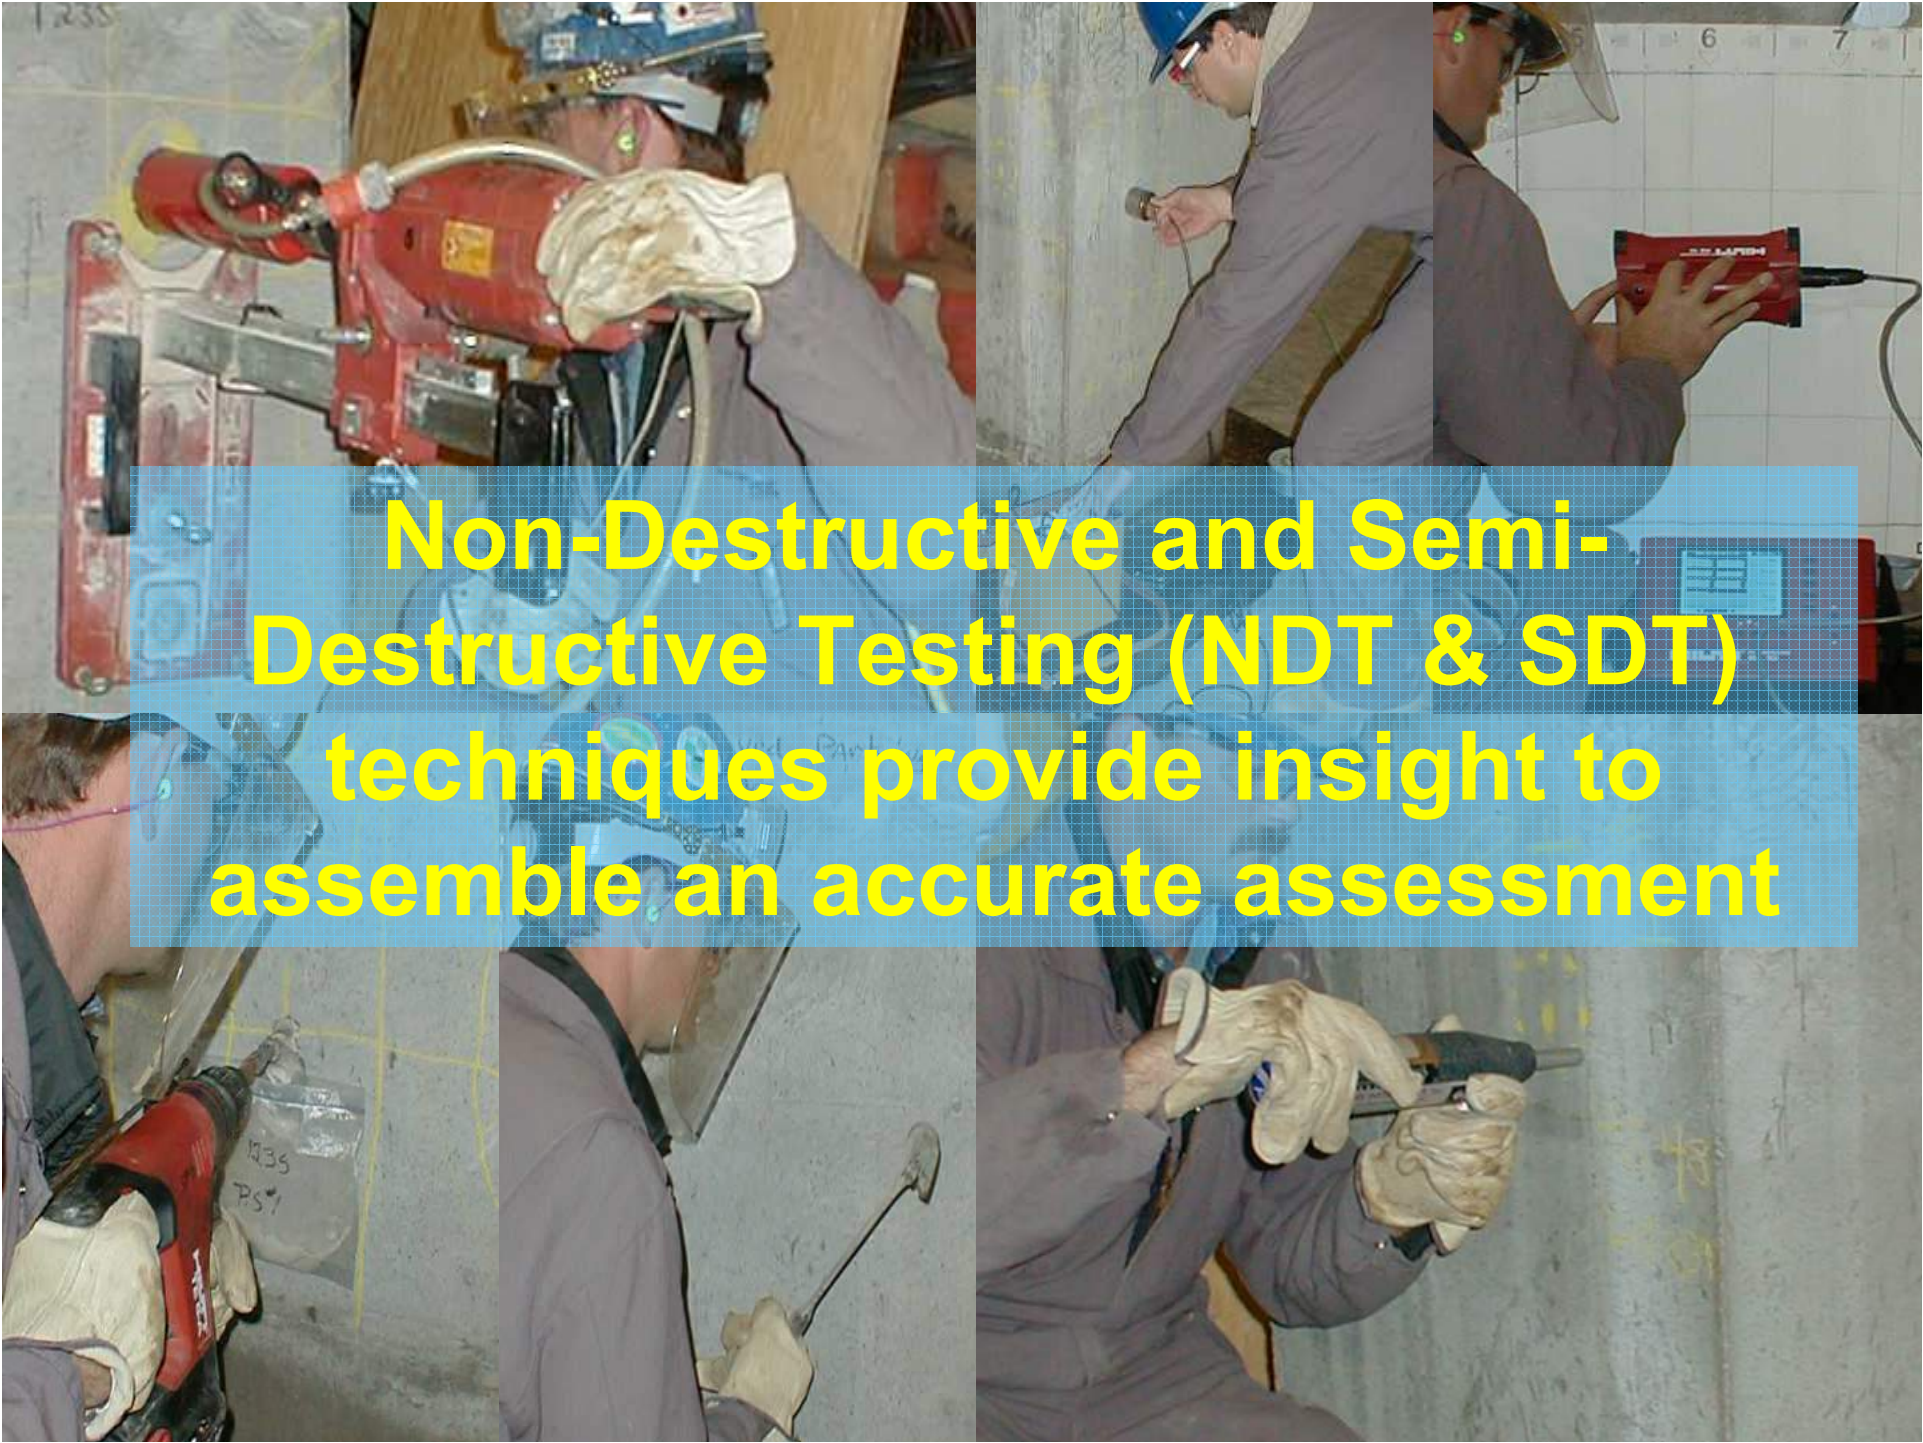
- ◆ Documentation of observed deterioration in the form of cracks, delaminations, spalls, etc.
- ◆ Physical measurements for comparison of as-design details

Non-Destructive and Semi-Destructive Testing (NDT & SDT) techniques provide insight to assemble an accurate assessment

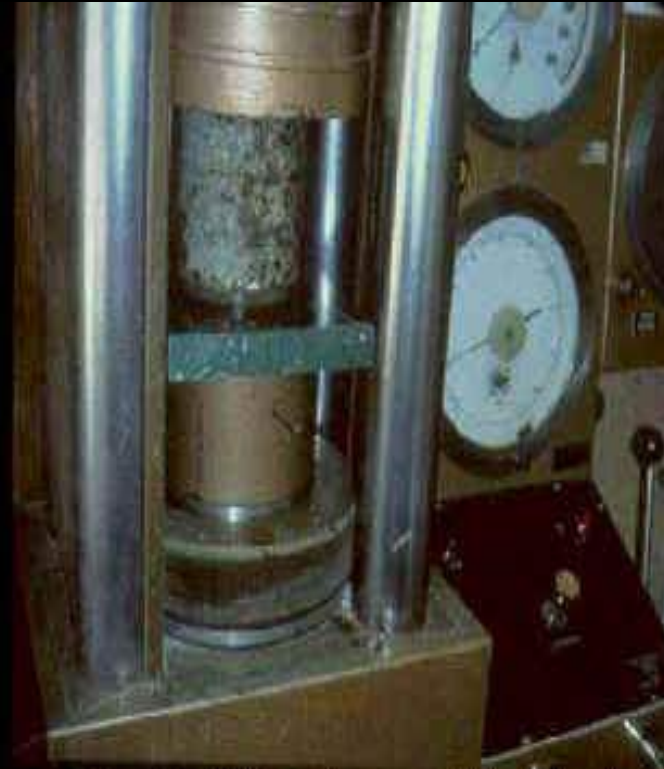
Compressive Strength Testing

- ◆ Drilled core compression test report
- ◆ Certified third party laboratory
- ◆ 6,410 to 8,720 psi
- ◆ Based on ACI guidelines, average compressive strength exceeds 9,000 psi

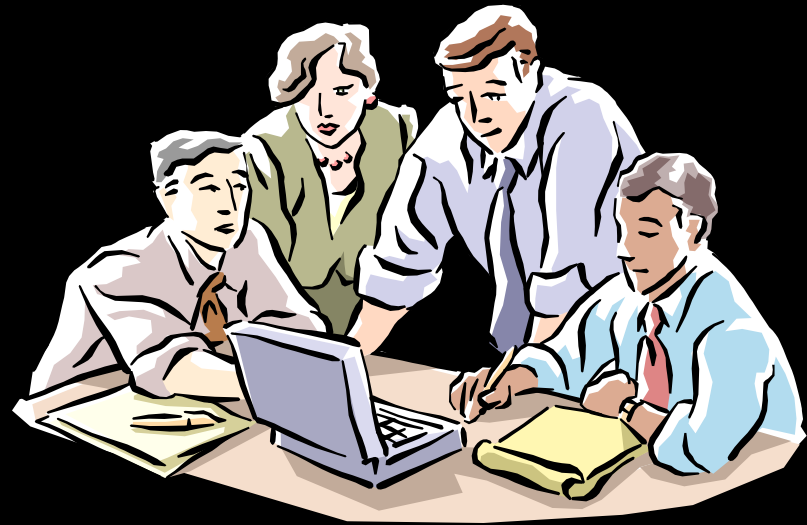
- ◆ To Implement a Fast-Track Repair Requires Extensive Preplanning and Incorporation of Proven Construction Technology

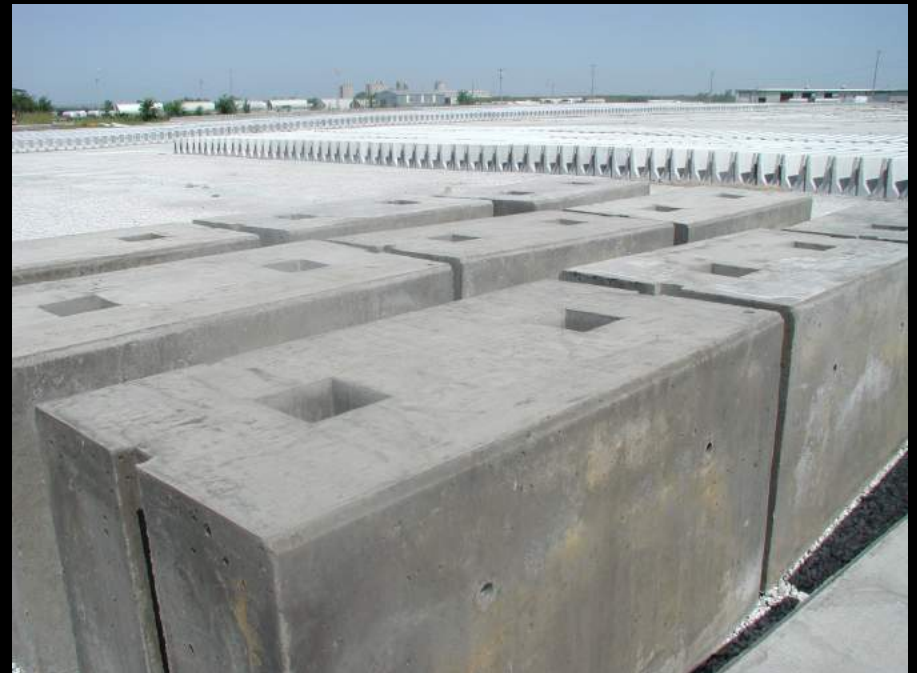
Precast Concrete Block Segment Fabrication

- ◆ Standard Precast Concrete Design with High Performance Concrete Materials

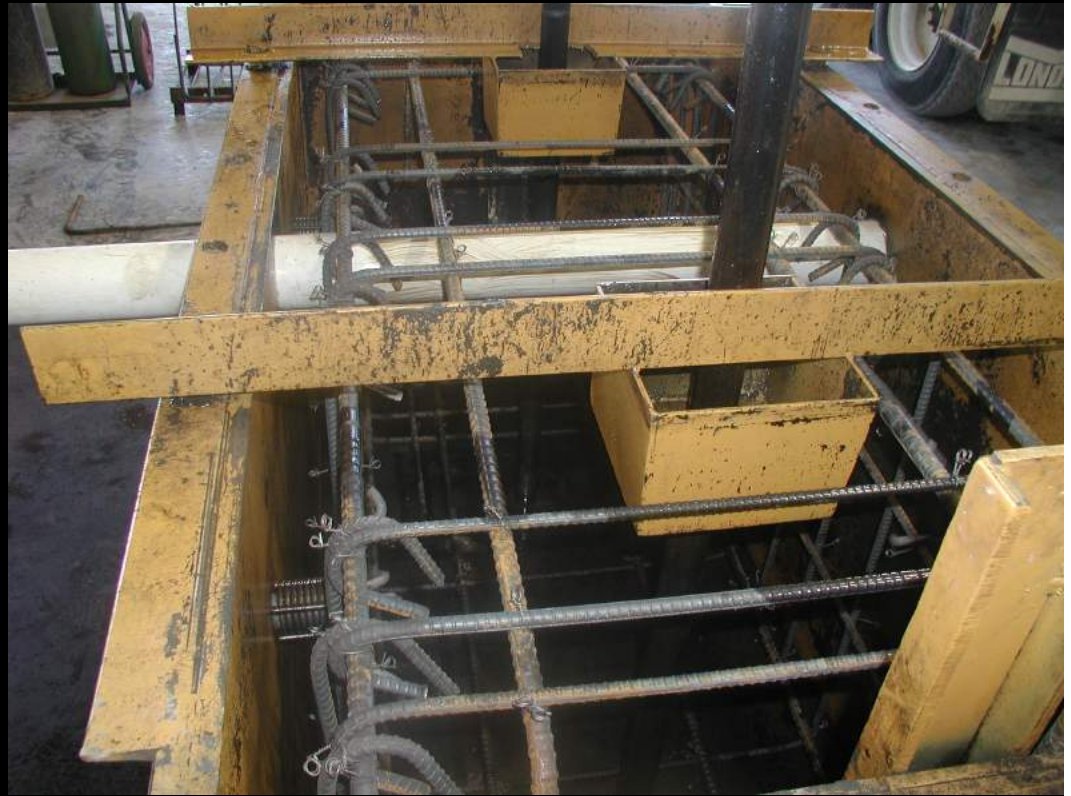
Precast Concrete Block Segment Fabrication

- ◆ Use of Metal Formwork and Inserts Assure Proper Alignment of Construction Details During Concrete Placement

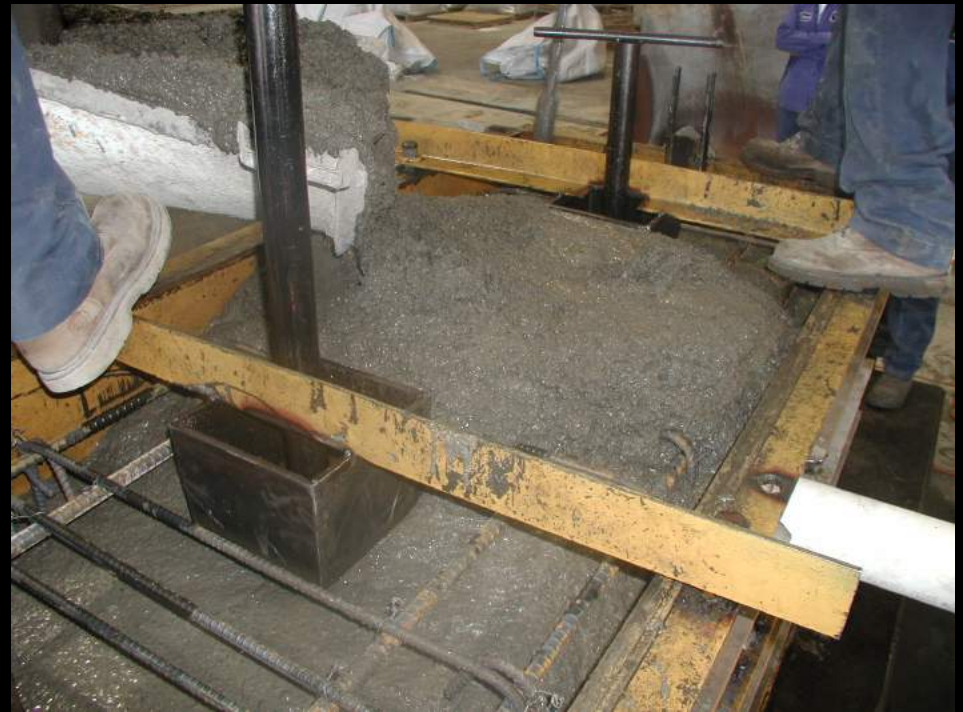
Precast Concrete Block Segment Fabrication

- ◆ Using a Calcium Aluminate Based Cement Concrete with Stainless Steel Fibers, the Blocks were Placed & Consolidated

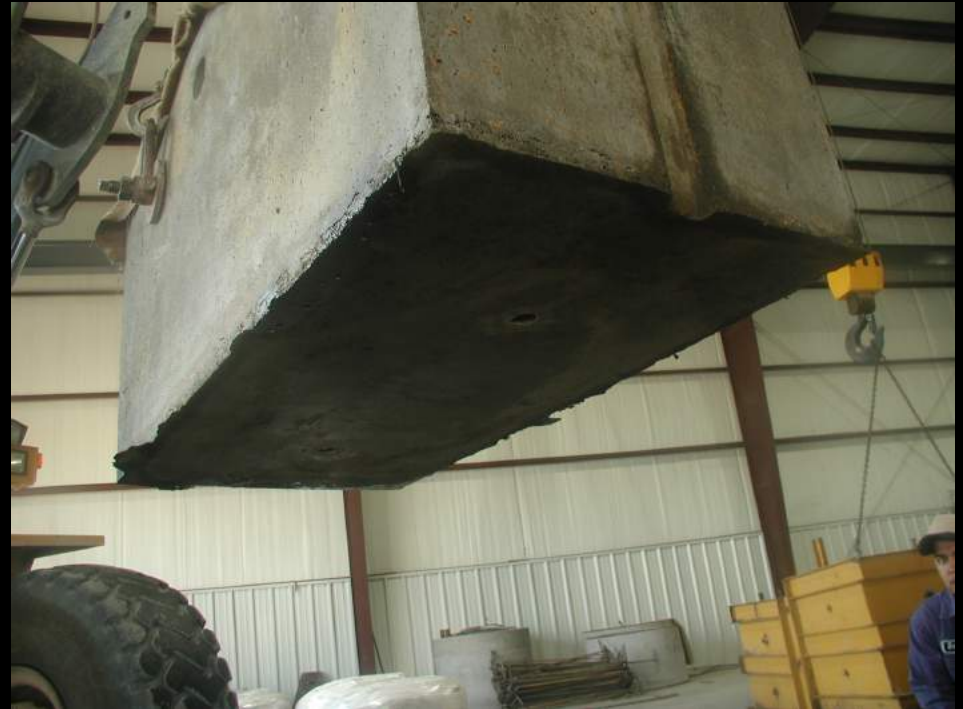
Precast Concrete Block Segment Fabrication

- ◆ Metal Formwork was Stripped Within 1 Day and the Blocks were Stored in a Cool Location W/O Moist Curing Provisions

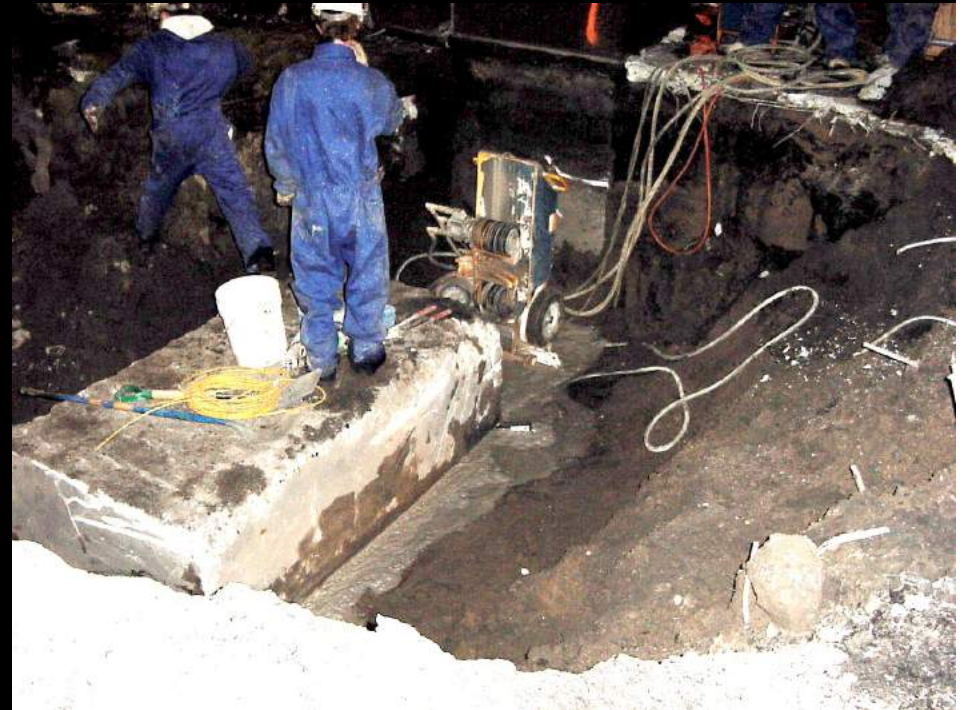
Demolition of Existing Sluiceway

- ◆ Use of Hydraulic Diamond Wire Cutting Equipment to Remove Massive Subsurface Foundations

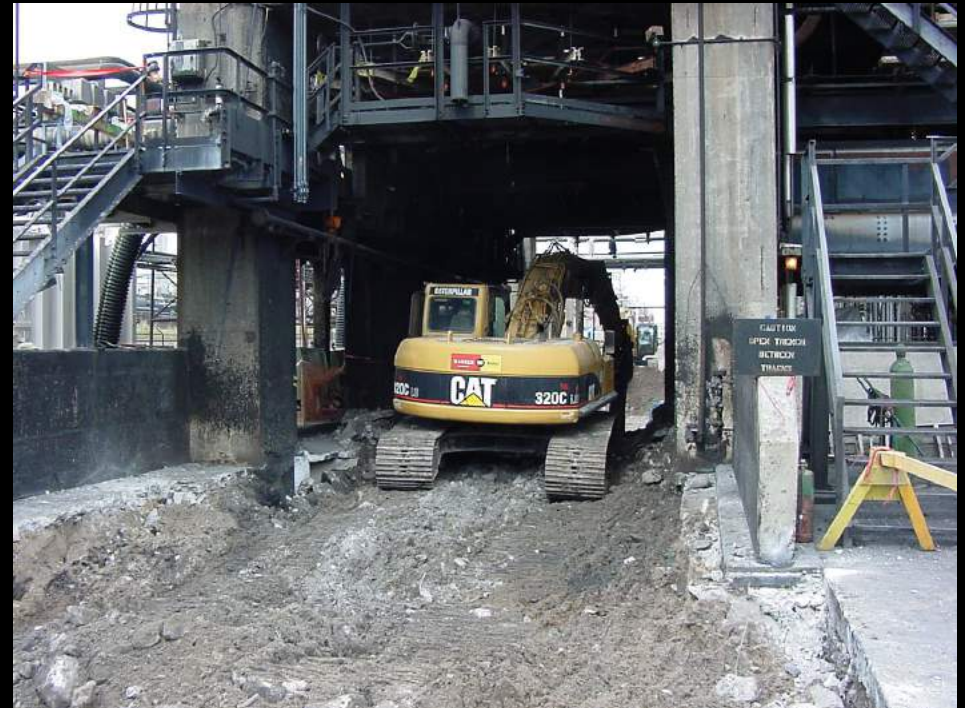
Demolition of Existing Sluiceway

- ◆ Low Overhead Clearance Hoe Ram Excavators Were Used to Remove Majority of Sluiceway Concrete

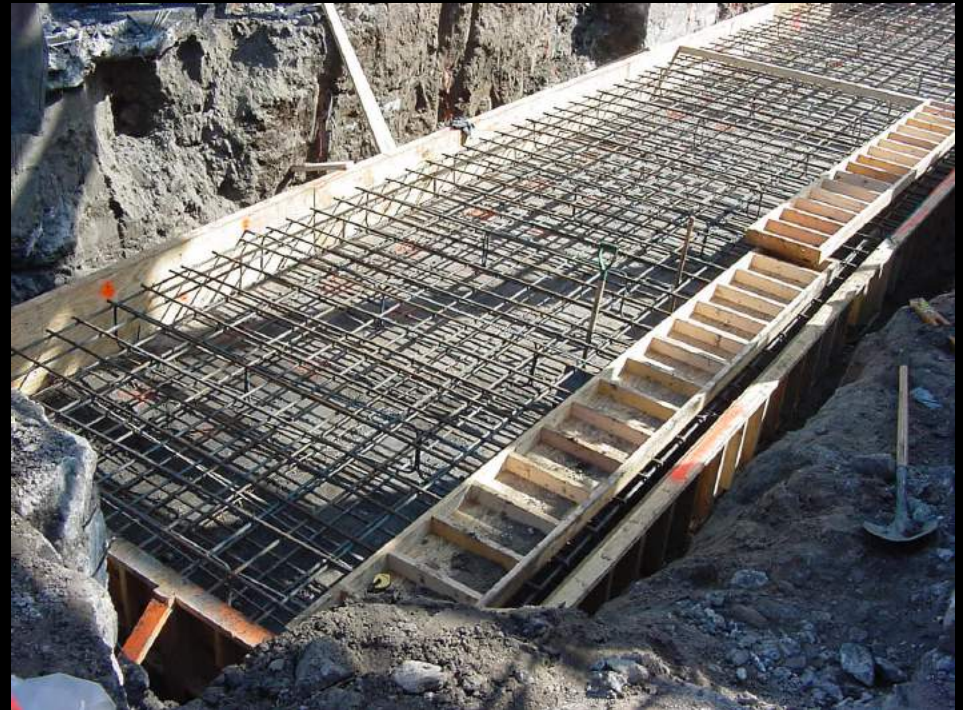
Install New Base Slab for Sluiceway

- ◆ Installation of a New Double Mat Reinforced 22-inch Thick Base Slab Overtop a Previously Placed Mud-Mat

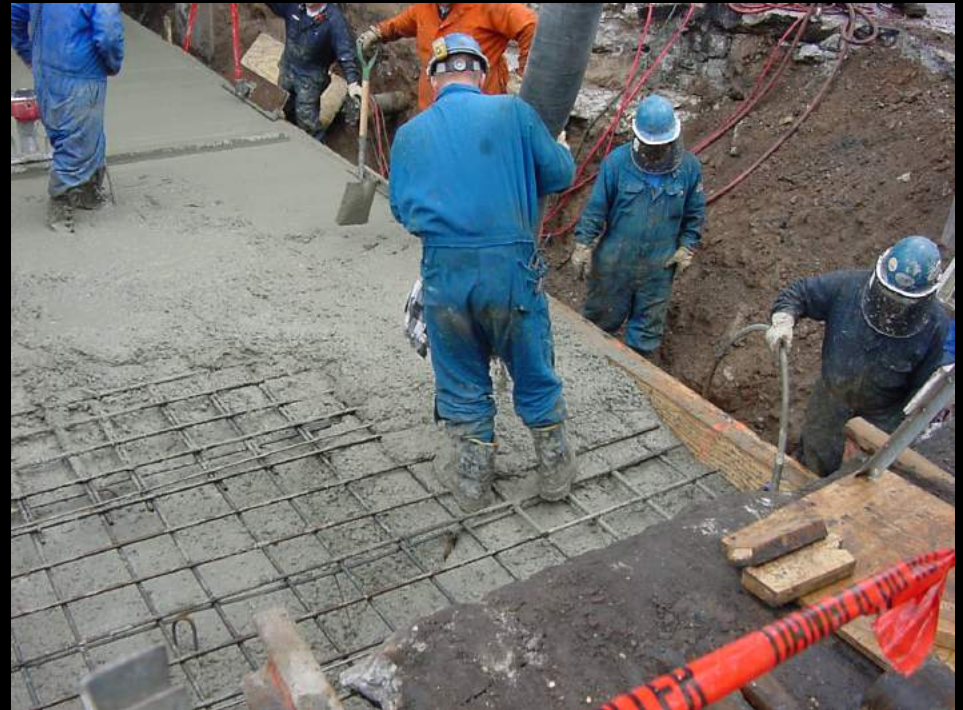
Install New Base Slab for Sluiceway

- ◆ Concrete Placement Using a High-Early Strength Concrete Mix Conveyed via a Concrete Pump Truck

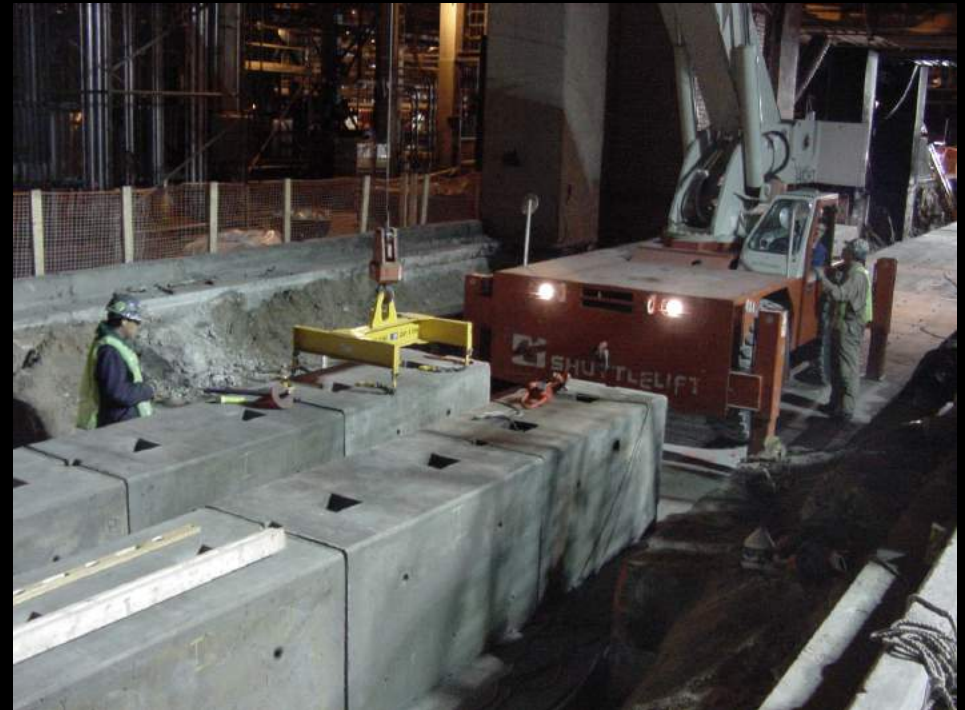
Placement of New Precast Concrete Segments

- ◆ Precast 10,500# Concrete Block Segments Placed Sequentially Using a Compact Carry-Deck Crane

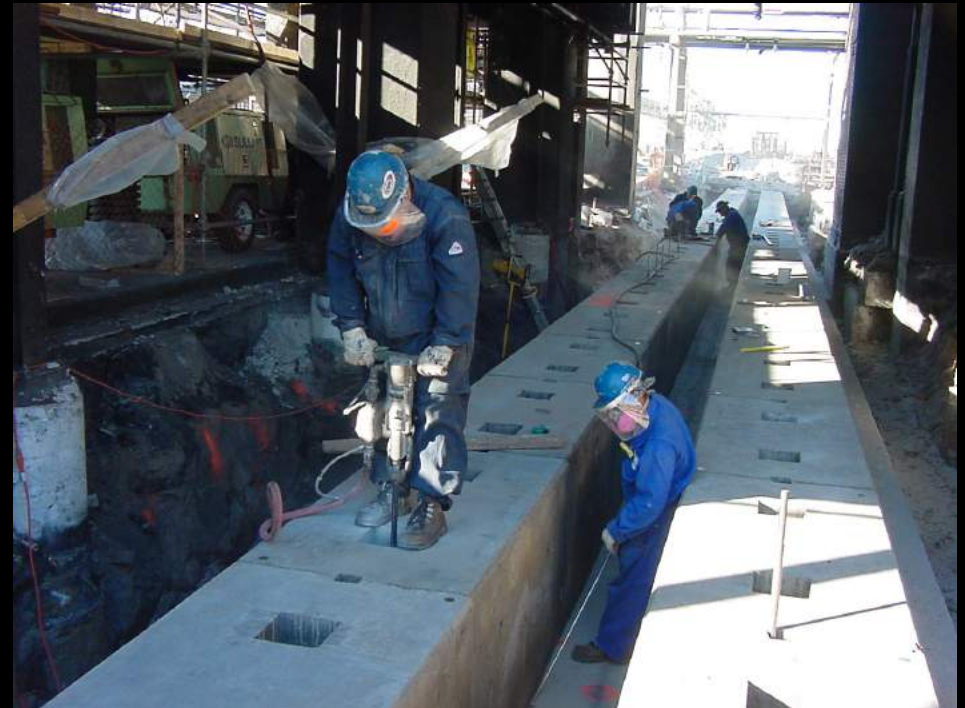
Placement of New Precast Concrete Segments

- ◆ Drilling and Installation of PT Grouted Anchors Thru Sleeved Precast Blocks into CIP Structural Base Slab

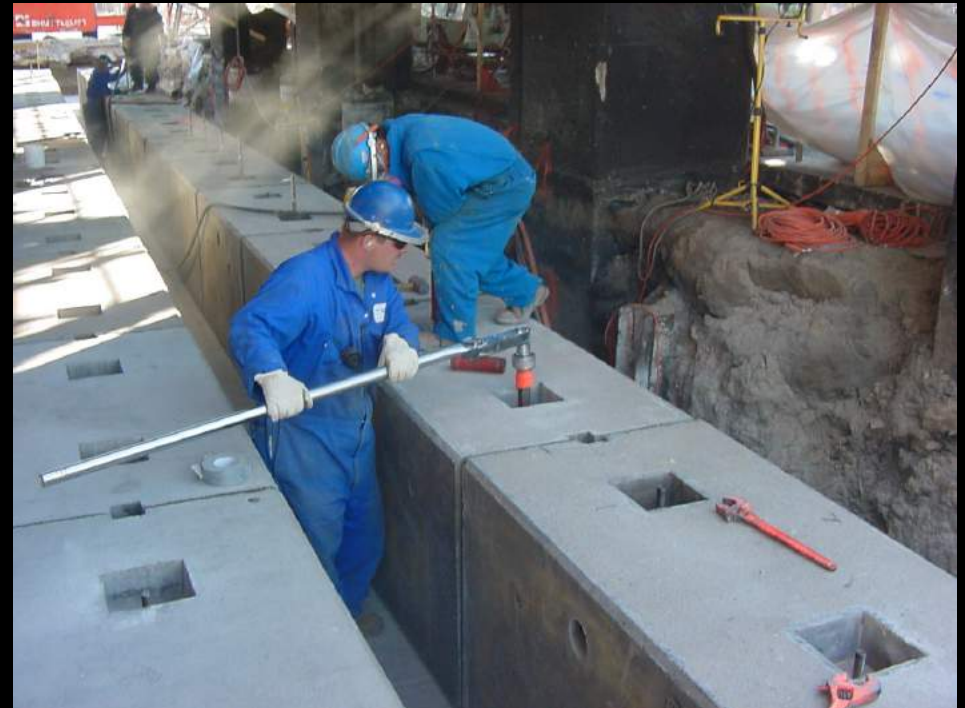
Placement of New Precast Concrete Segments

- ◆ **Torquing and Stressing PT Anchor Rods to Spec. To Assure Composite Behavior Between Block & Base Slab**

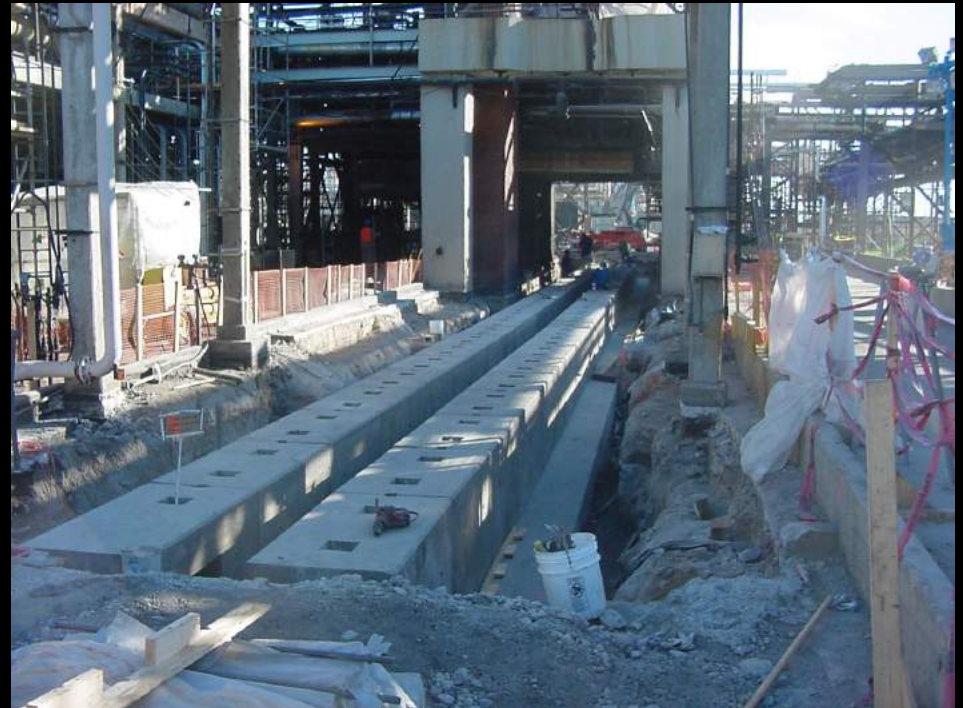
Placement of New Precast Concrete Segments

- ◆ Precast Concrete Segments Installed and Prior to Joint Grouting, Waterproofing and Backfilling
