IMPROVEMENTS IN LIFE EXTENSION AND DESIGN PRACTICES OF COKE DRUMS

Bobby Wright P.E.

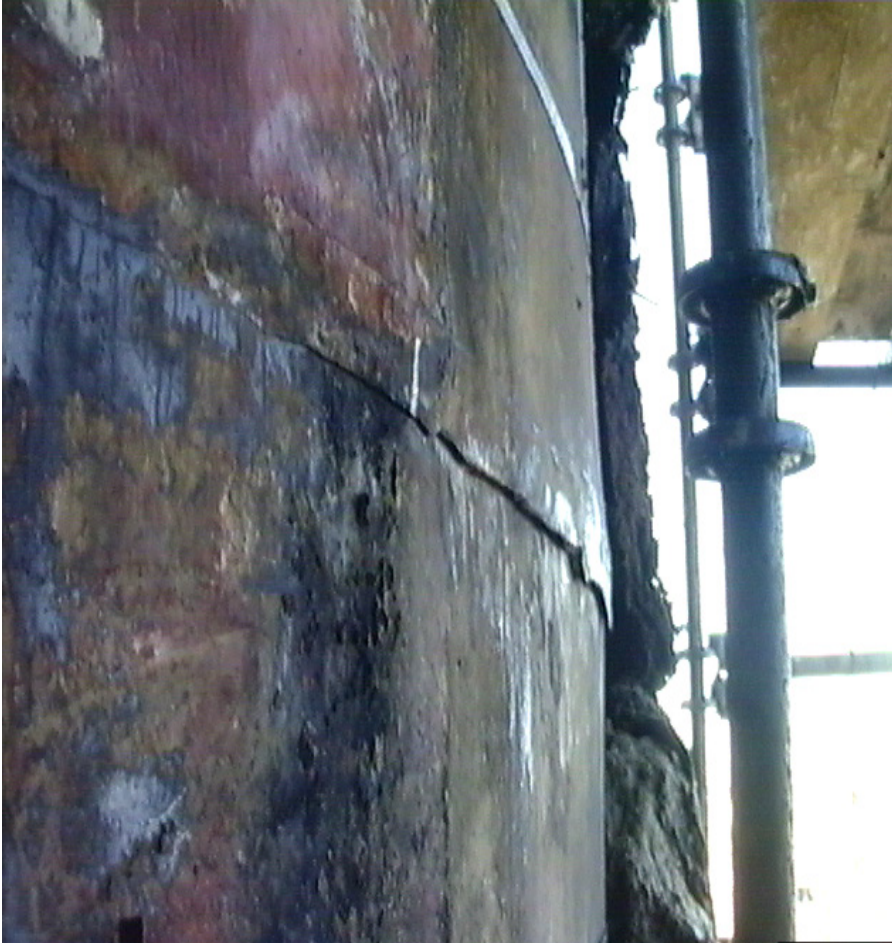
Coke Drum Failed During Quench After Repair

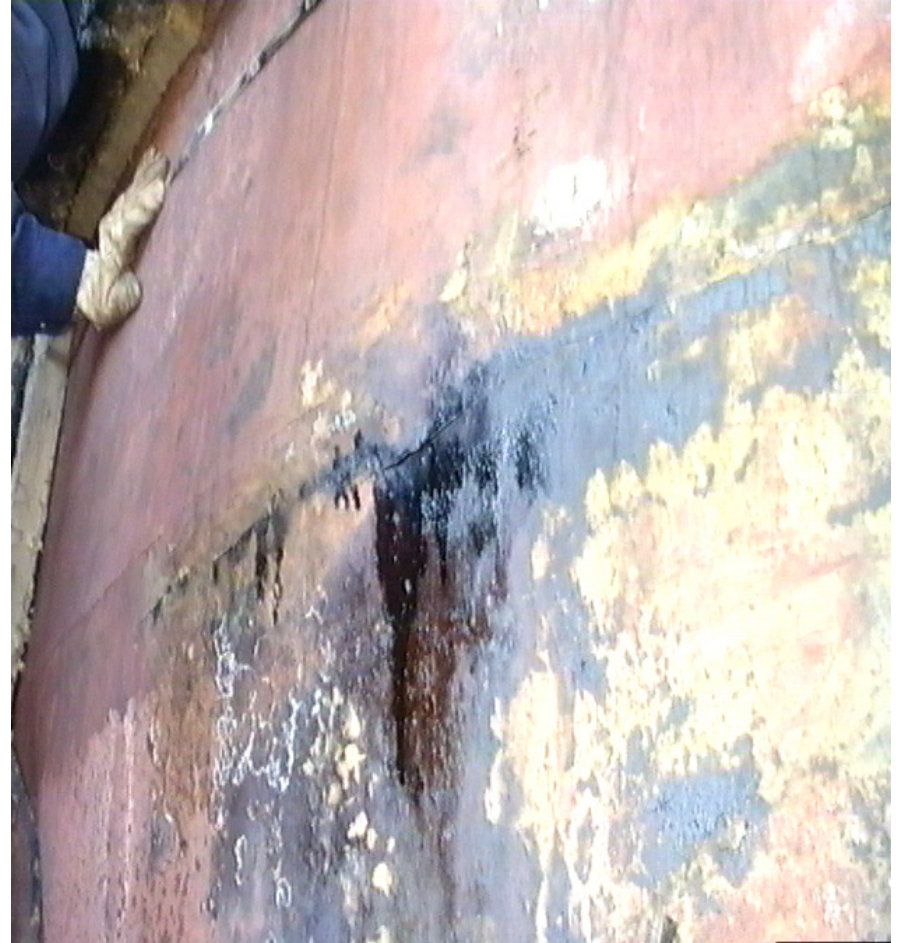
Coke Drum Failed During Fill

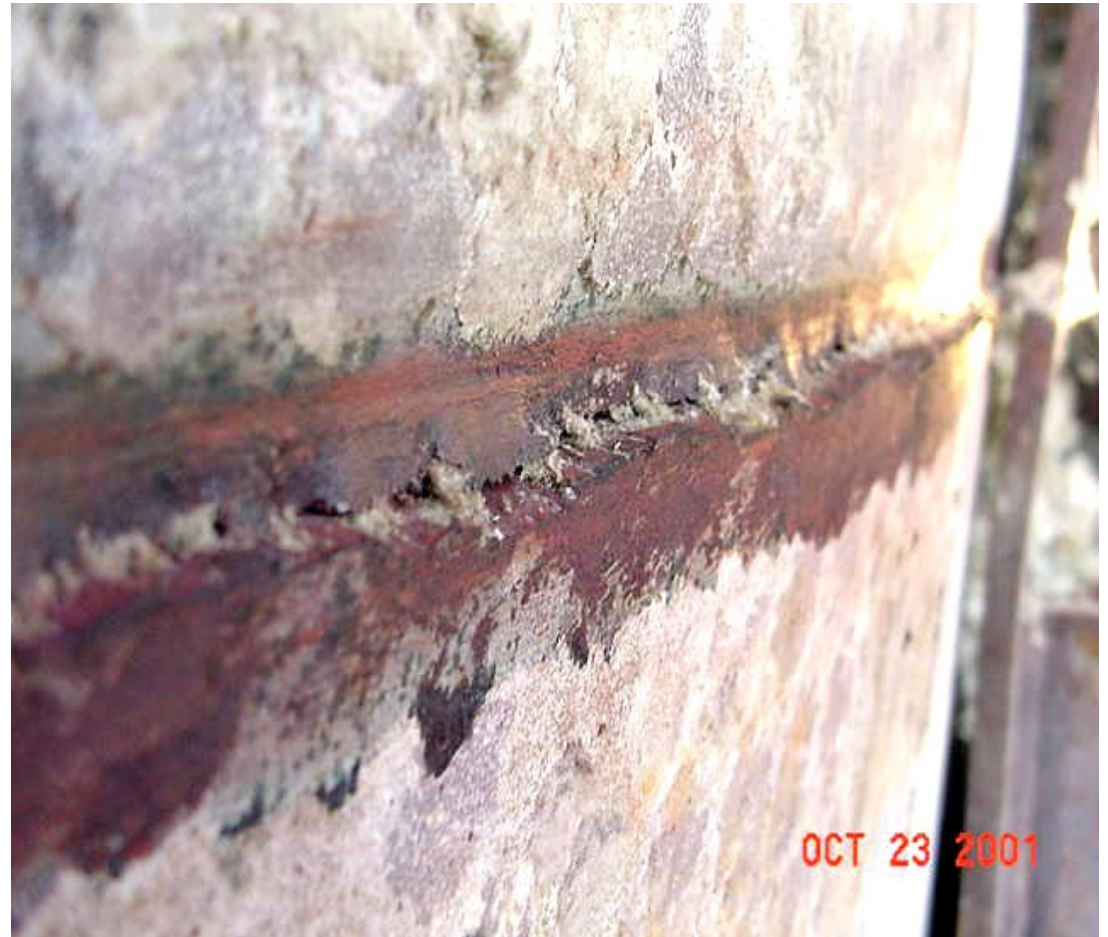
Cracked Skirt to Shell weld 4 Drums– 1369 Cycles or about 5 Years (SES Predicted 1228 Cycles)

- Design (by others) predicted 152 years
- SES Transient analysis performed prior to T/A
- Maximum stress intensity range during transient = 143,430 psi
- Using ASME code Section VIII Division 2 fatigue design Table 5-110.1, UTS < 80 ksi, a fatigue life of 1228 cycles was obtained.

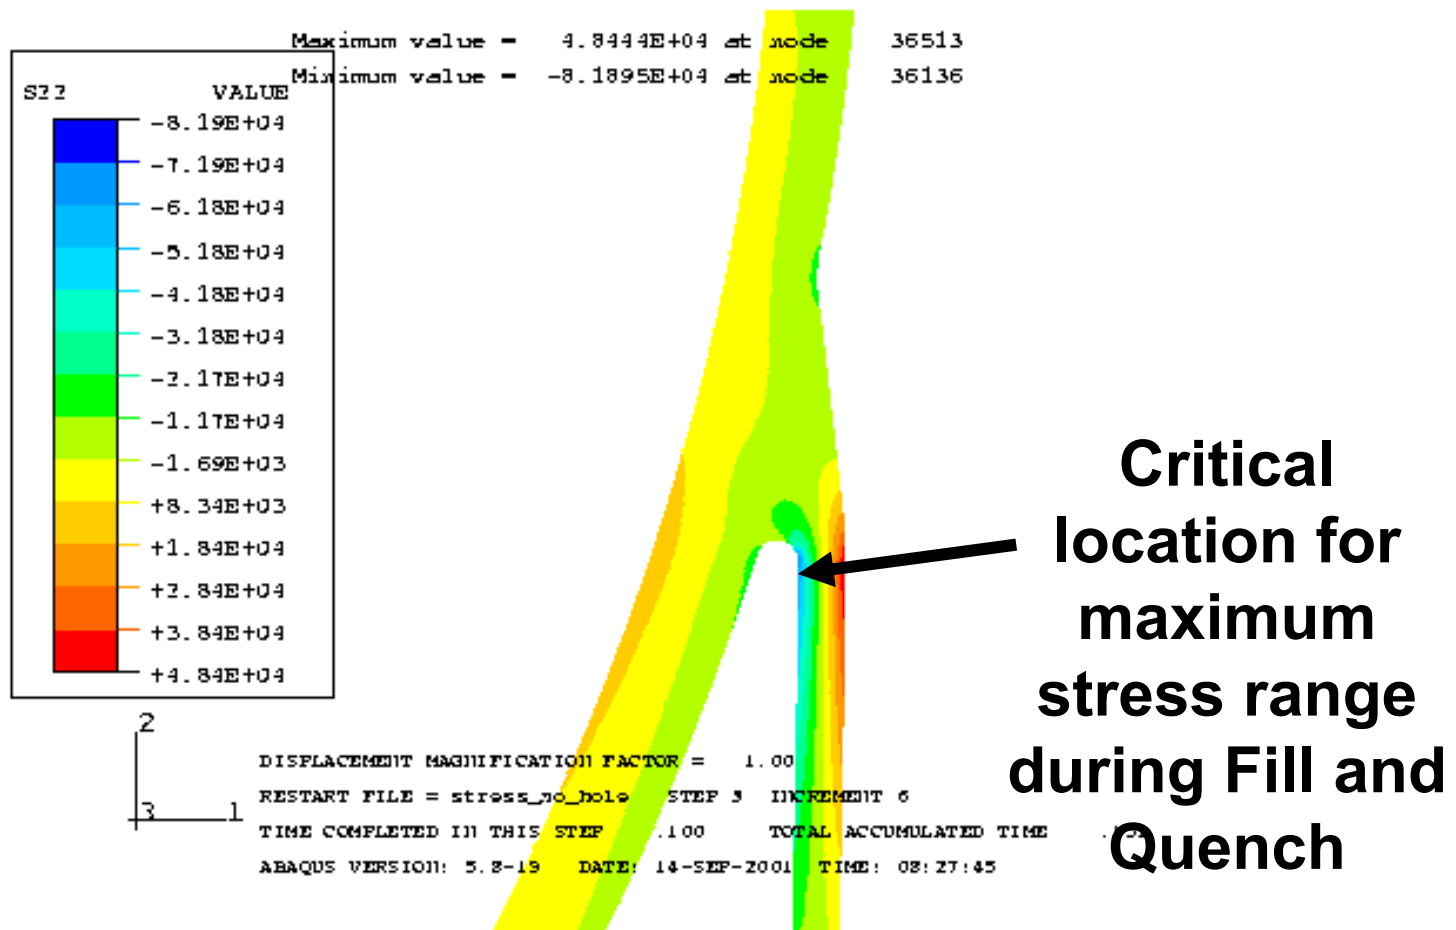
DISPLACED SHAPE 1 HOUR INTO QUENCH

(MAXIMUM STRESS DURING QUENCH OCCURS HERE)

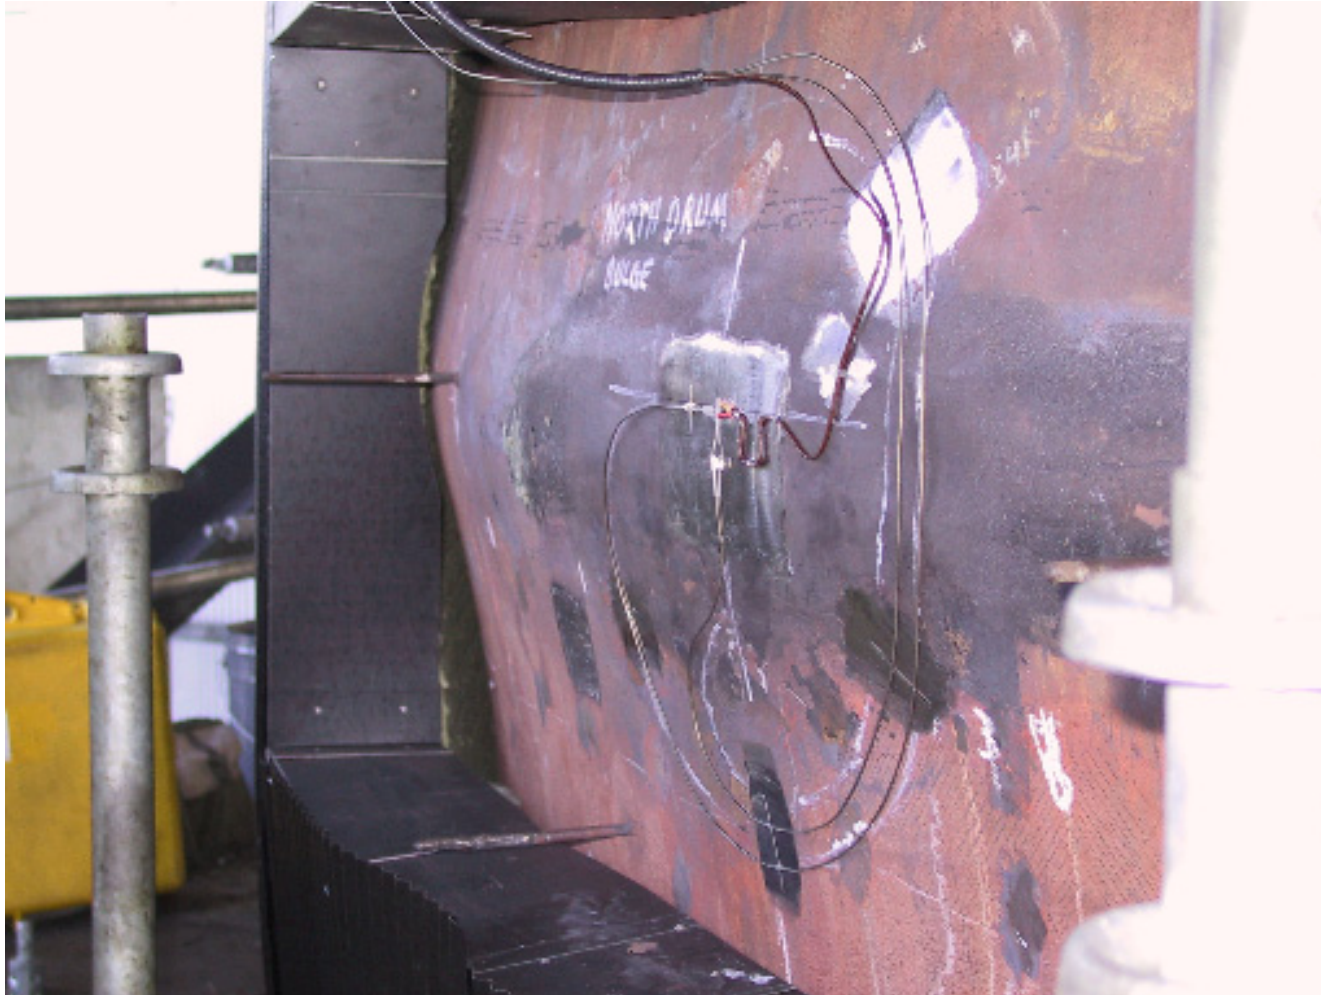
High Temperature Strain Gage Locations at Bulge

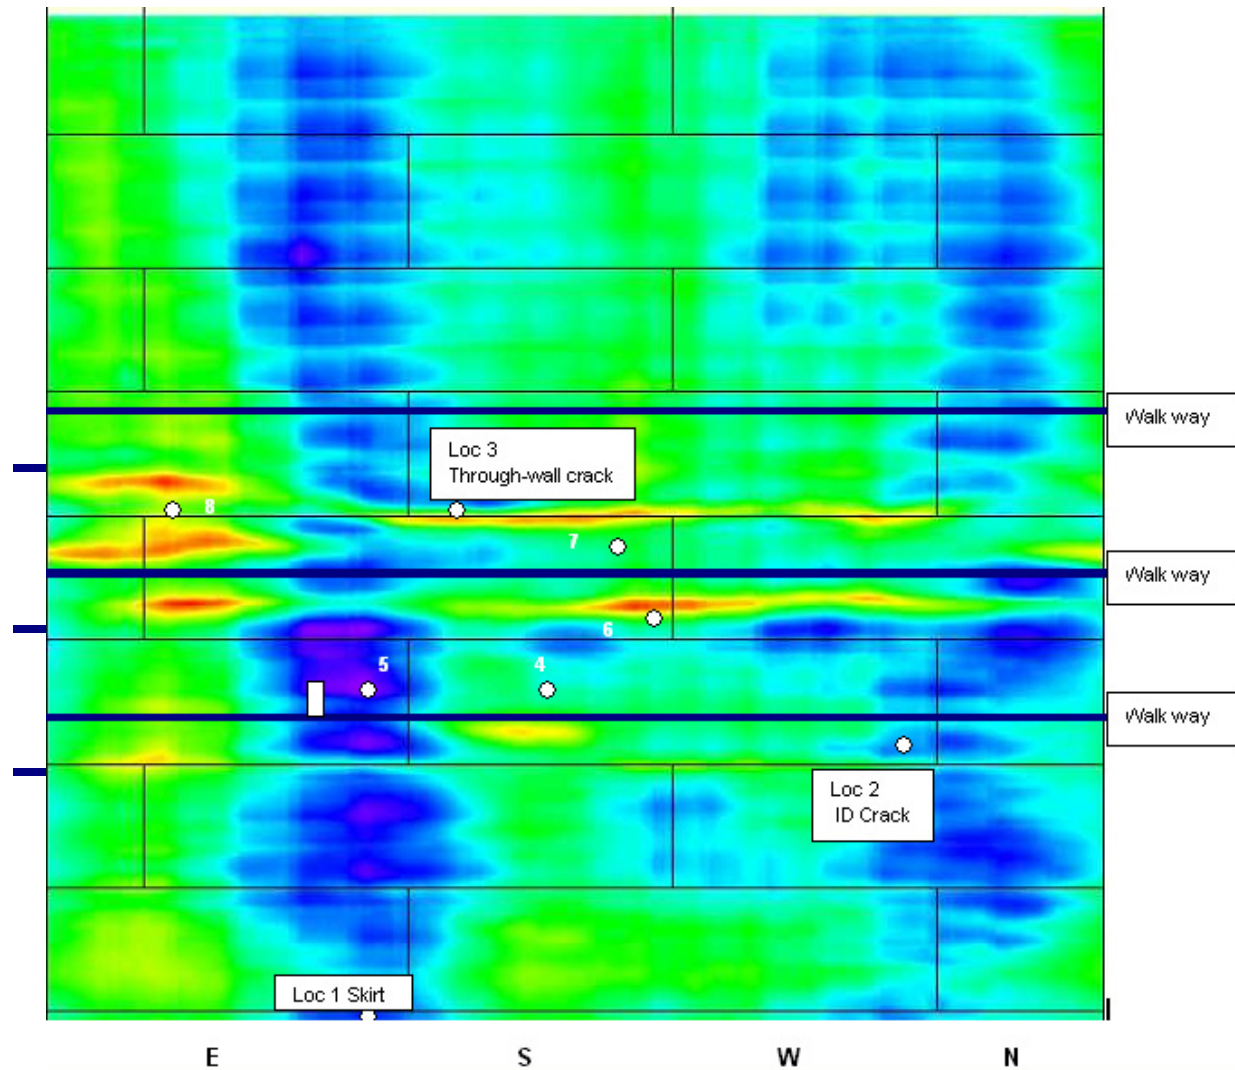
Laser scan with HTSG locations on drum

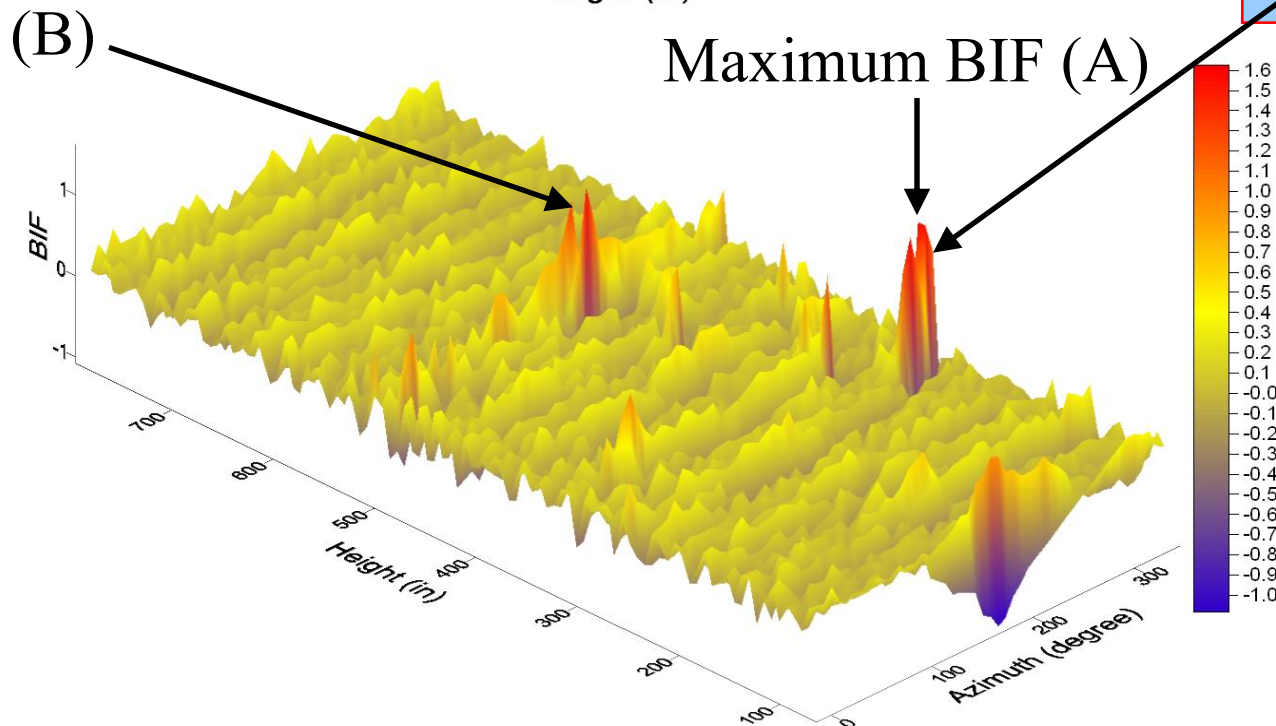
**THROUGH WALL
CRACK August
2005 !**
