Innovative Coke Drum Repairs

Coking.Com Conference

Welding Services Inc.

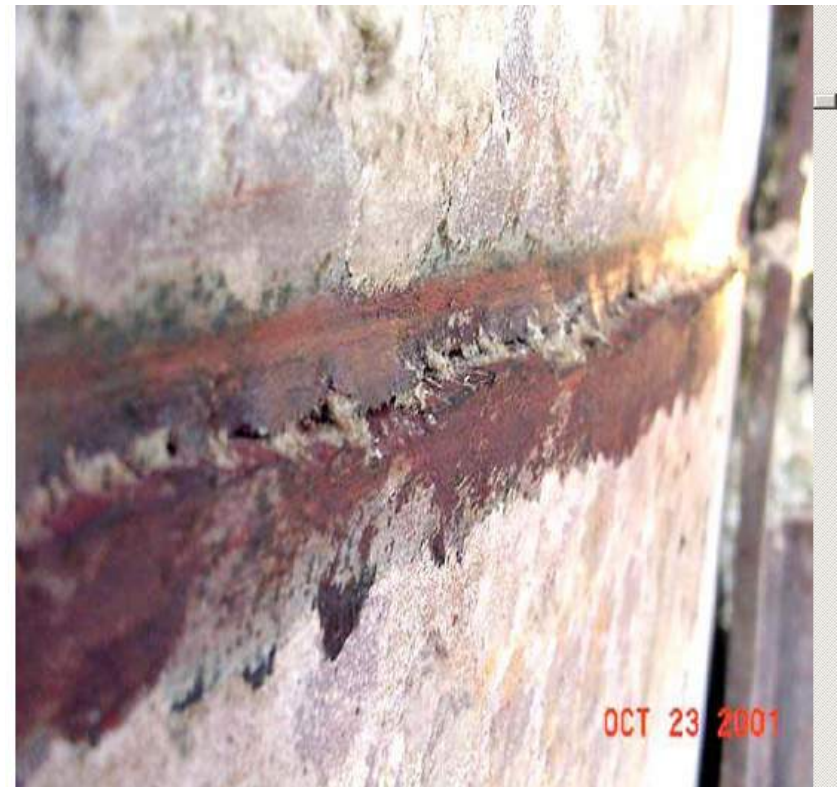
Typical Coke Drum Failures

- Cracking
 - Circumferential seam
 - Skirt to Shell welds
 - Shell cracks
- Bulging
 - Circumferential Seams
 - Shell Course
- ID Corrosion
 - Delamination/wear of cladding

**Many skirts are cracking within
5 years of operation**

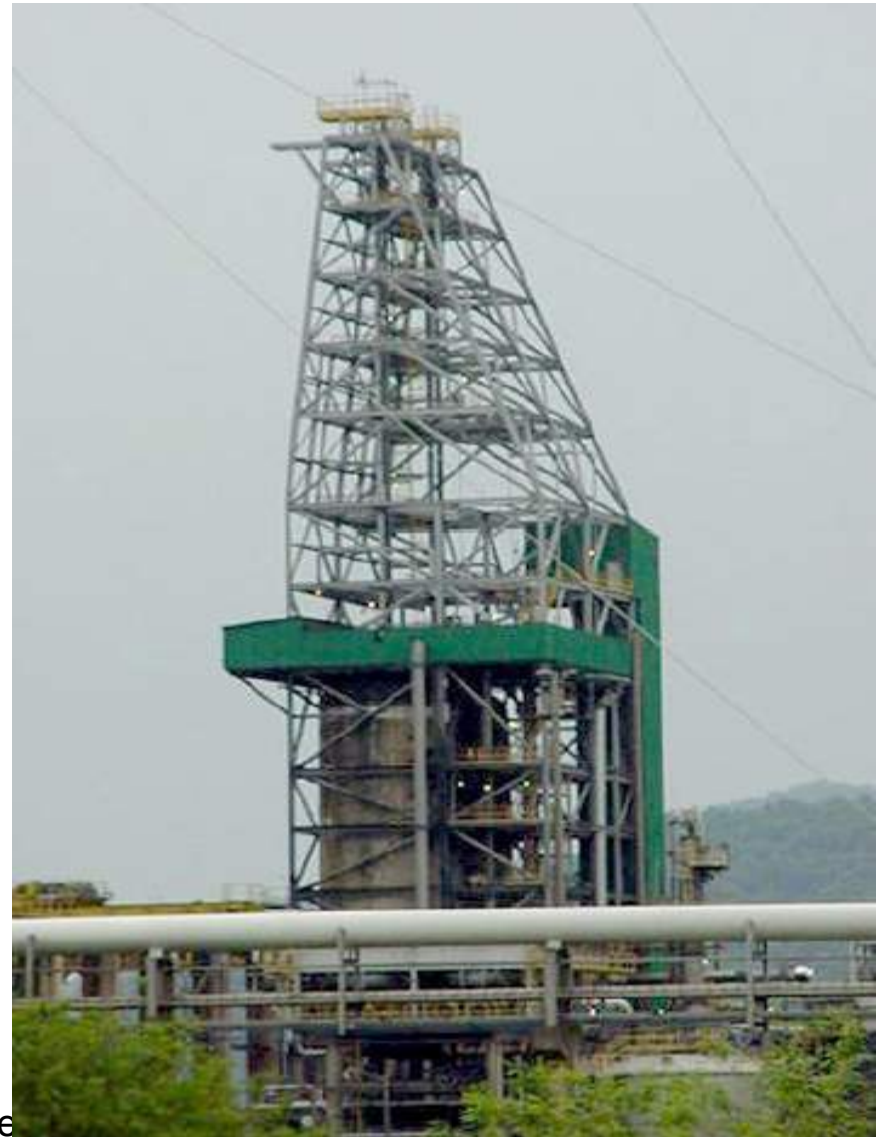
- T/A to Retro fit (4) four Coke Drums to accept new Delta Valves
- Coke Drum Material: SA387, Grade C, 1 ¼ Cr ½ Mo, 1" thick
- Perform repairs to existing 410 explosion bonded cladding by applying over 1200Ft² of Inconel 82 Overlay in cone section above bottom nozzle
- Schedule: 10 days for all four drums total completion

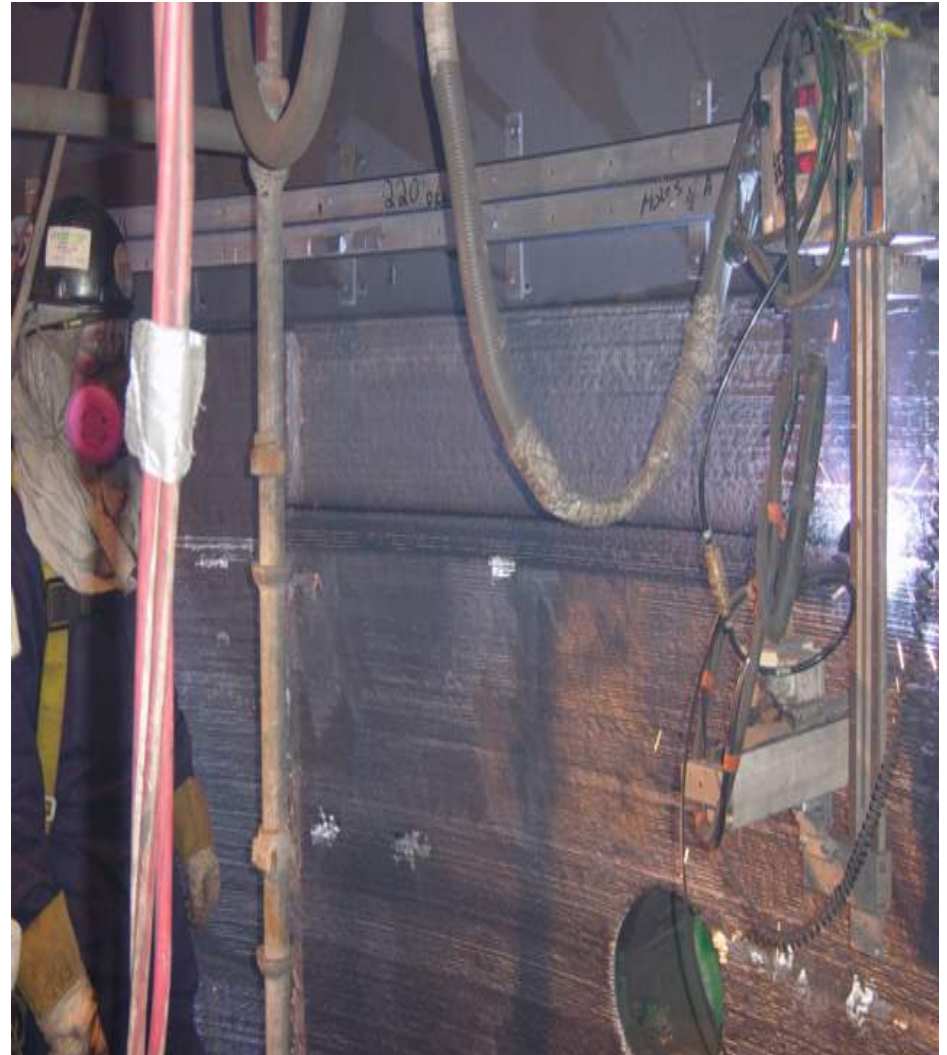
- Provided T/A Planner to evaluate other contractors schedule and coordinate activities and scopes
- Developed detailed ventilation plan so other contractor personnel can continue to work while WSI performed our scope
- Provided crew of 8 In-direct personnel for entire project and 8 weld operators per coke drum working two shifts
- All work performed under WSI “R” stamp and QA program

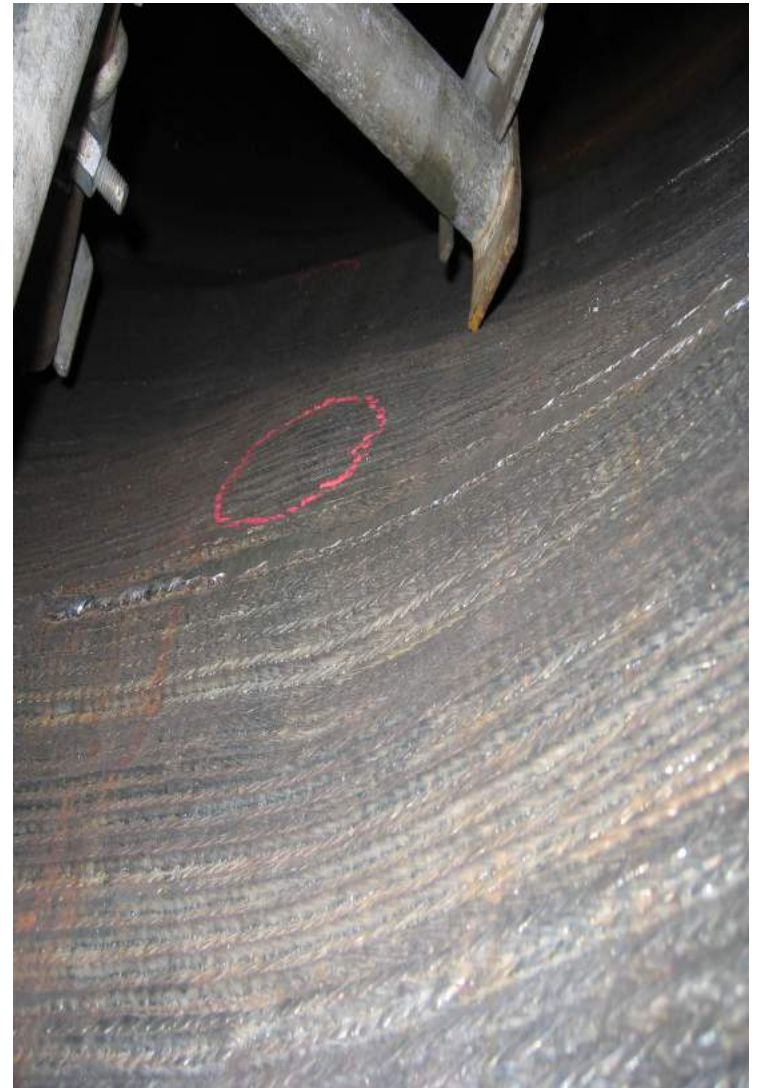
- Utilized 4 **Unifuse** PLC controlled Automated Weld Systems per drum
- Met customer's 10 day schedule
- Took on additional scope during the T/A
- Safety: Zero lost time accidents
- Customer stated: "WSI was the best company out 22 on this T/A...First Class Crew"

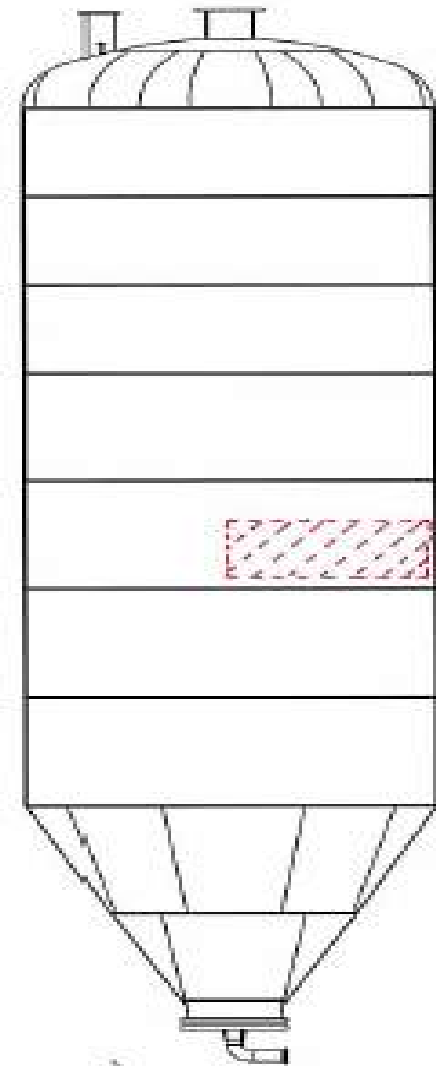
Bulging Coke Drum

- 8 Coke Drums
- Material: SA 263 Grade C
- Wall Thickness: .875
- Diameter: Ranging from 26 to 32 Ft.
- Size: Ranging from 66 to 94 Ft.
- One of the Cokers was experiencing bulging due to fire in drum

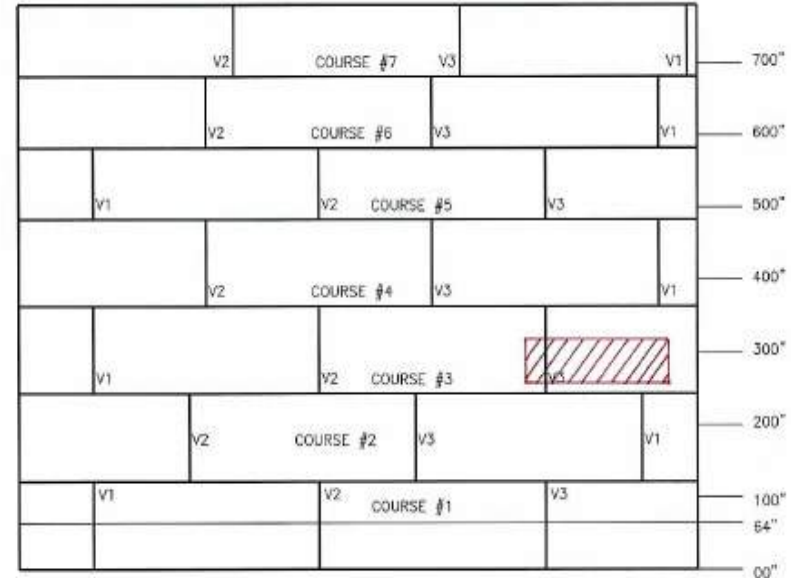
Bulge Overlay

NORTH - 0 DEGREES
 EAST - 90 DEGREES
 SOUTH - 180 DEGREES
 WEST - 270 DEGREES

WELD OVERLAY AREA
 * HEIGHT AREA (265
 * LENGTH AREA (0° -

- Bulged area overlaid: 21' x 6'
- Applied Alloy 625, .375" thick (2 layers), overlay utilizing temperbead utilizing (2) PLC controlled Unifuse Weld Systems
- Temperbead eliminated the need for PWHT
- Post Soak of 450° for 2 hours to eliminate any potential for hydrogen

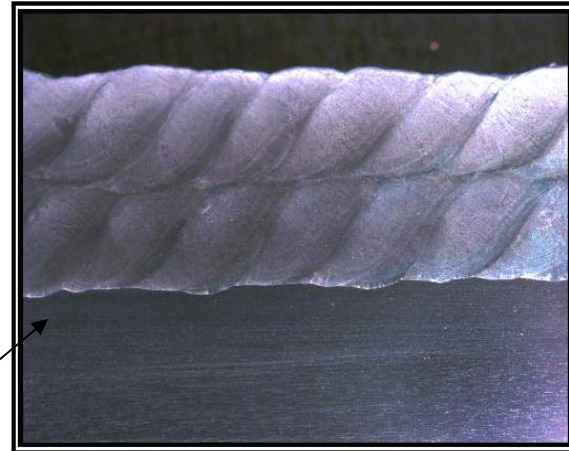
HAZ created by 1st weld layer

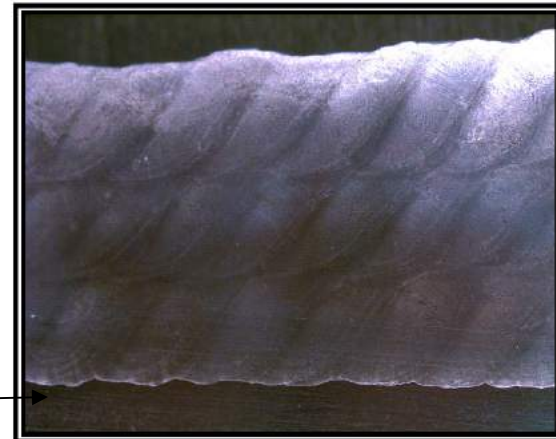
HAZ is tempered by deposition of successive layers

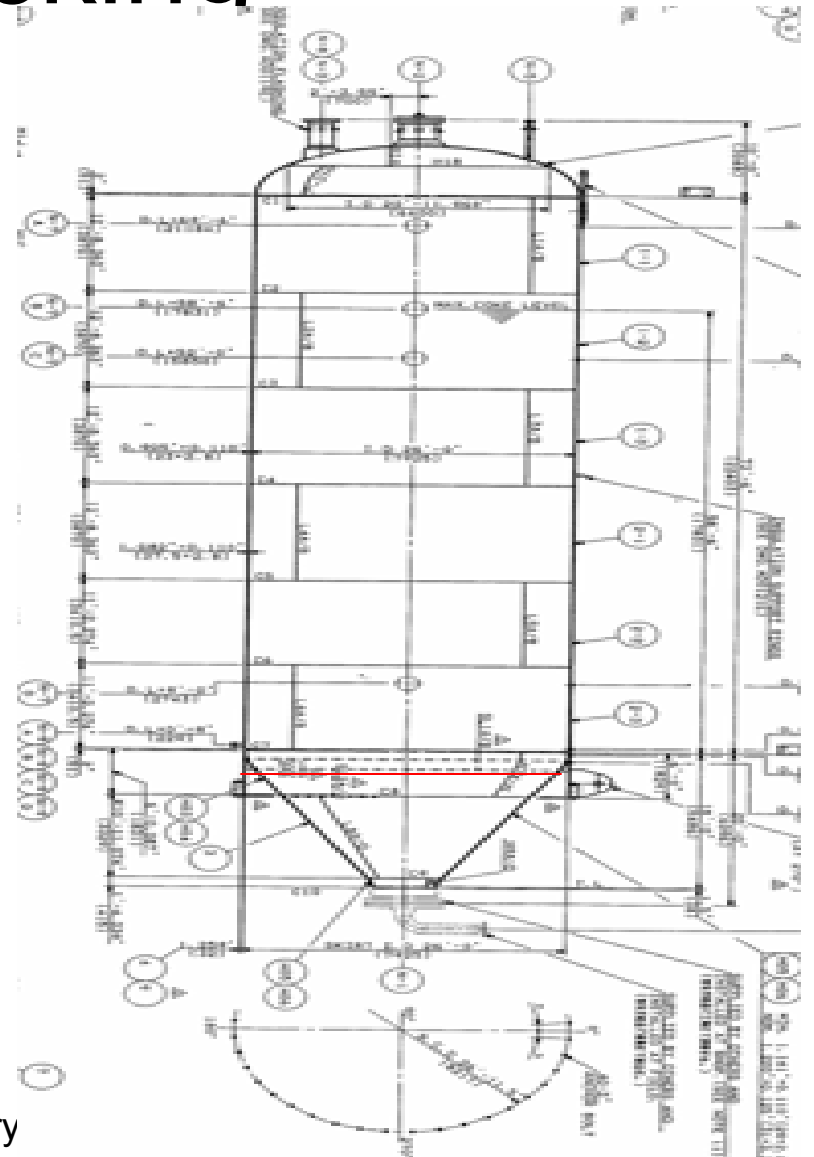
Skirt Cracking

- 2 - Coke Drums
- Tower details:
 - SA-387-Grade 11 material
 - 103 foot tall
 - 26 foot ID
 - Original wall thickness 1.25"
- Turnaround inspection:
 - 2003 T/A repaired weld seams in Coker # 2
 - May 2006 found indications approximately 0.190" deep, 1" long, encompassing entire circumference of weld seam in both drums

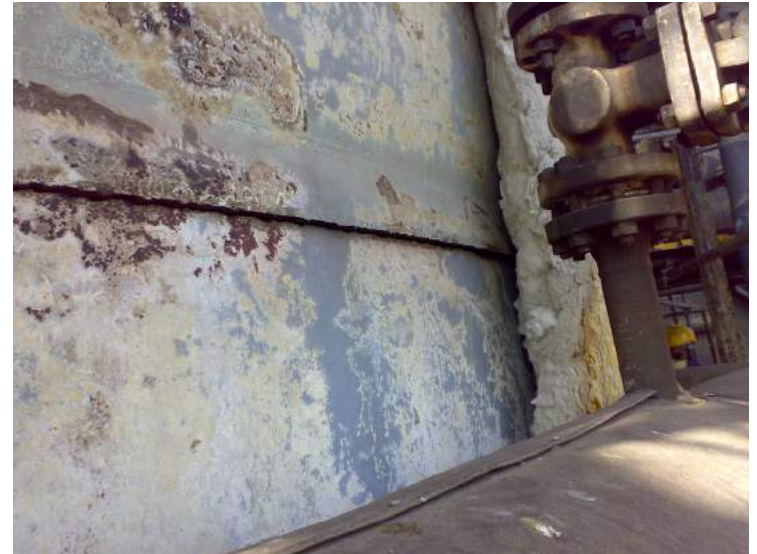
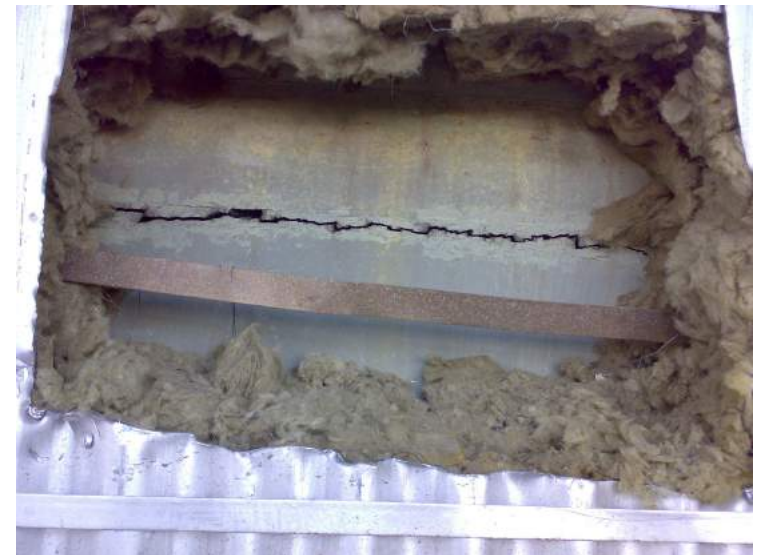
- 8 - Coke Drums (4 Trains)
- Tower details:
 - Material – SA 387 Grade 11
 - Height: 87 feet
 - Diameter: 21.7 feet
 - Original W.T.: 1.37"
- Customer was experiencing extensive cracking at skirt to shell circ seams 360 degrees all 8 drums

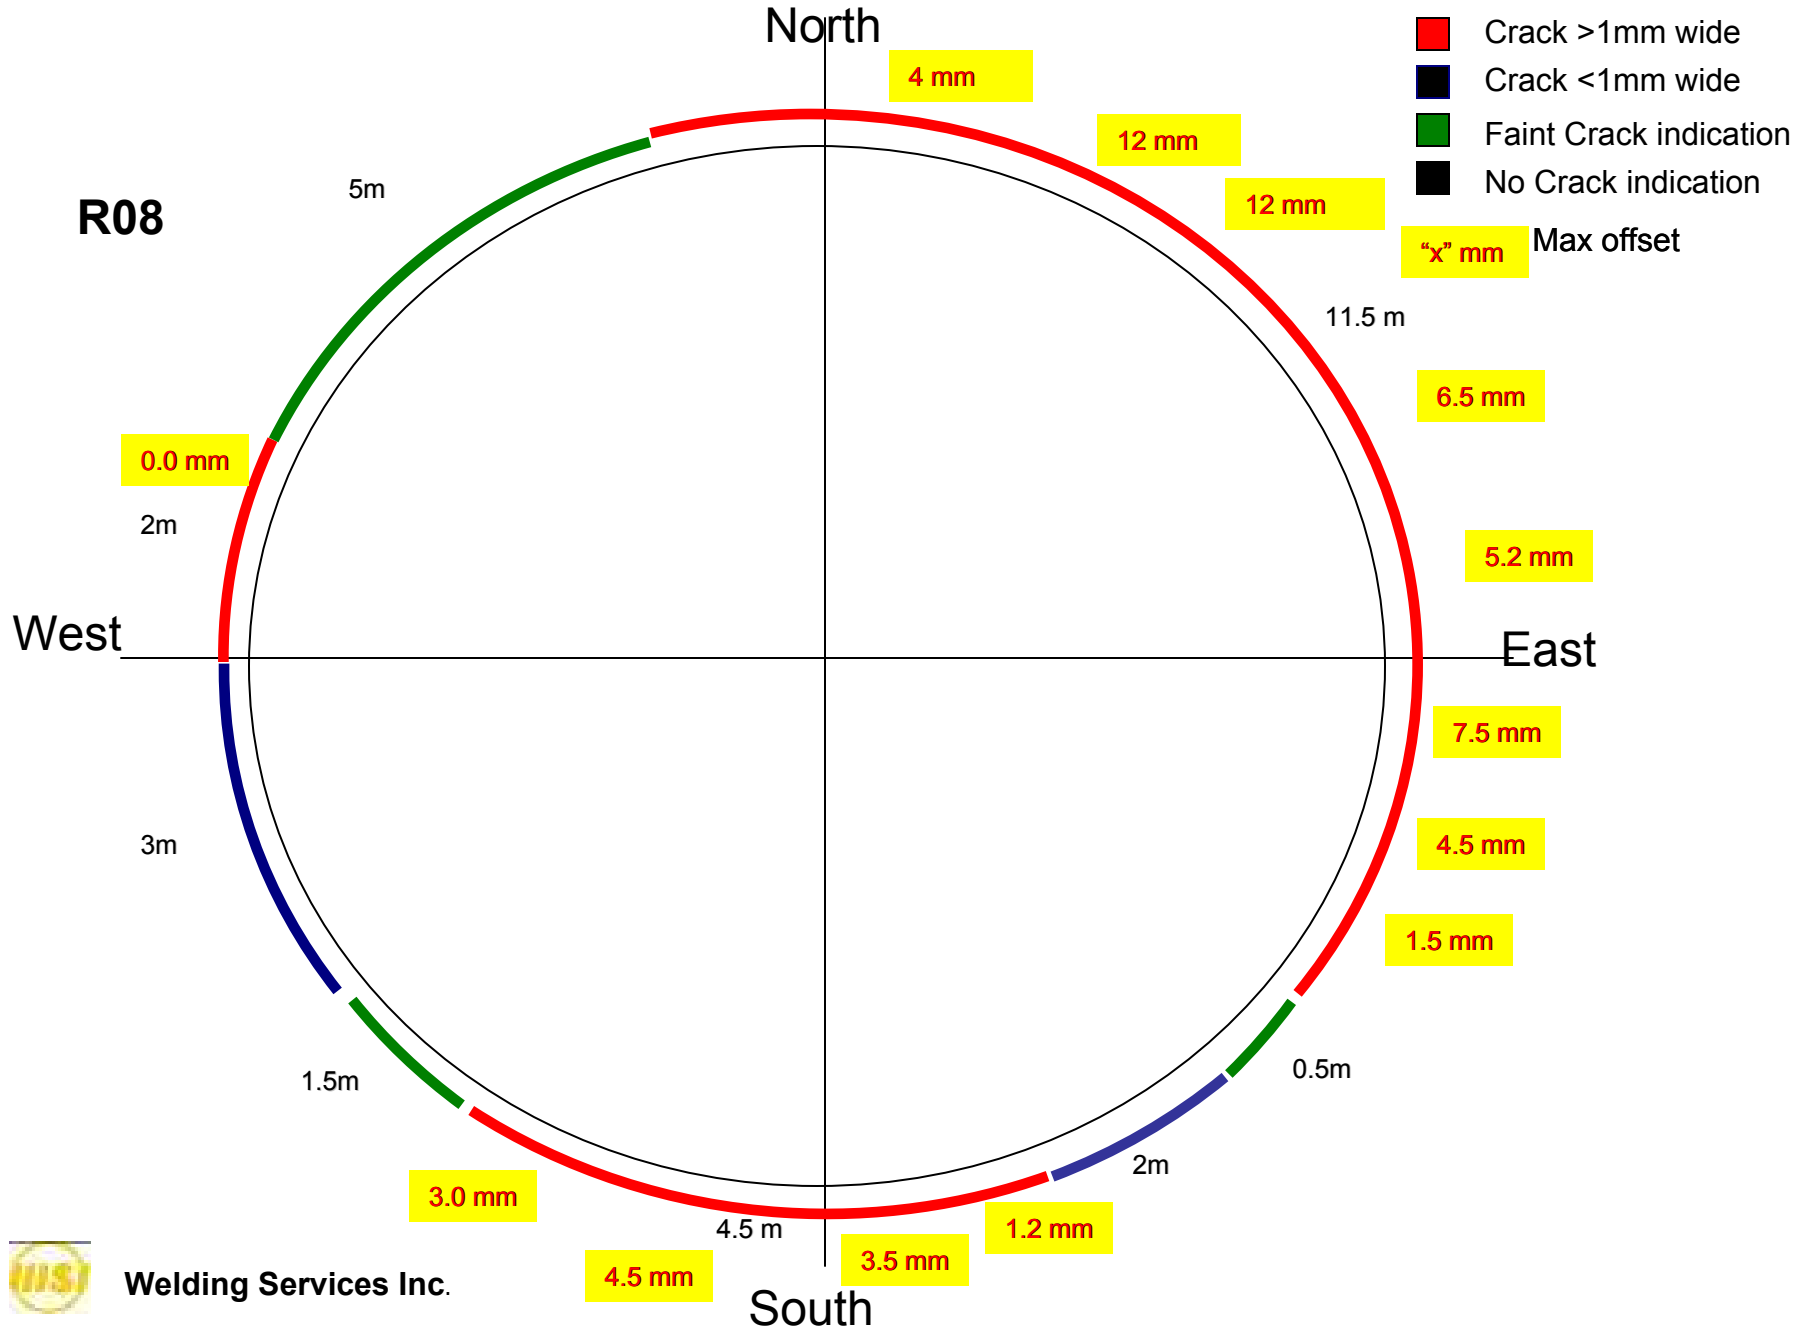
Crack Assessment

- Cracks did not penetrate into the base material (shell wall), and customer wanted to perform the repairs to cracks with little to no separation while on-line
- Safety and Risk Evaluation
 - Reviewed Refinery's Past Safety Performance
 - H2S Monitoring
 - Customers existing permanent plant monitors
 - Addition of temporary monitors strategically located
 - Structural Stability Evaluation
 - including wind load

- Review Crack Mapping, Structural Stability, and Work Environment
- Crack Excavation
- Pre-Heat: 250 Degrees Utilizing Resistance Heaters
- Root – GTAW Semi-Auto
- Fill – GMAW Semi-Auto
- NDE -Dye Penetrant
- Post Soak (de-gas) – 450 degrees

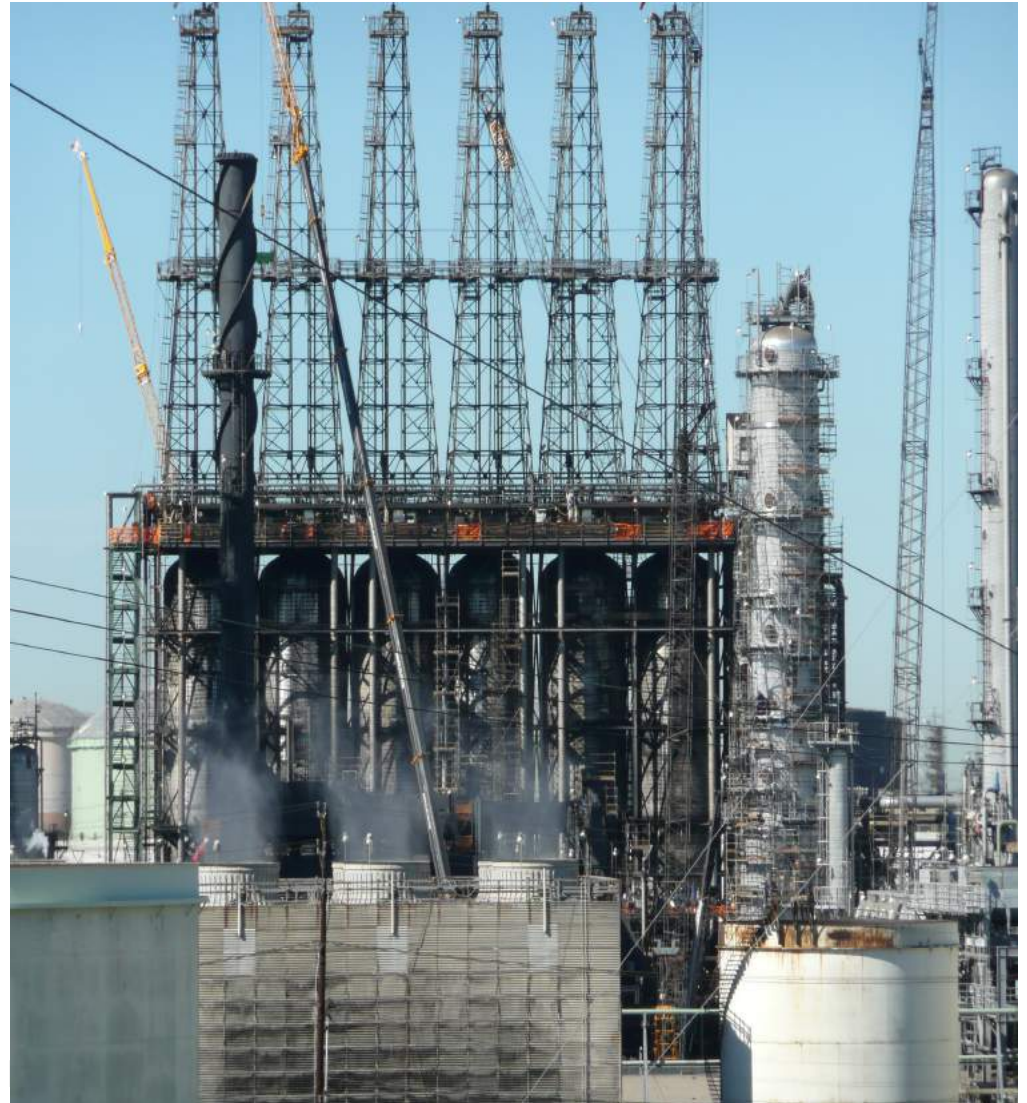
- T/A to connect new piping from capital project to existing unit
 - Installed Distillation Column and Fractionator Tower
 - Knockouts for processing heavy crudes
- Welds ranging in size from 1.5” to 36”
- Schedule: 50 days
- Goal: Zero manhour lost time.

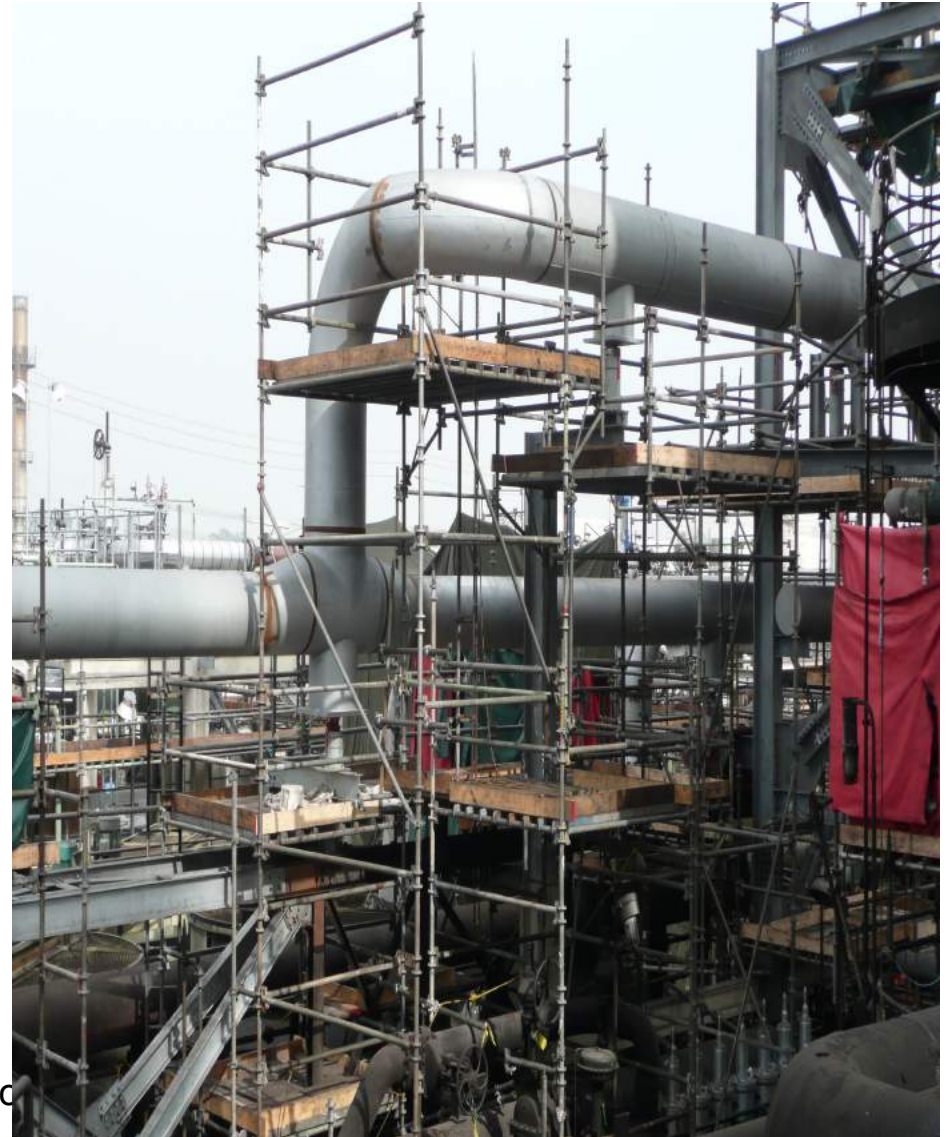
- Provided T/A Planner to evaluate all welding work scopes
- Developed detailed plan to weld all 5 Cr and SS piping 8"-30" 274 weld count
- Provided crew of 18 weld operators and 9 pipefitter support personnel per shift
- All work performed under WSI "R" stamp and QA program

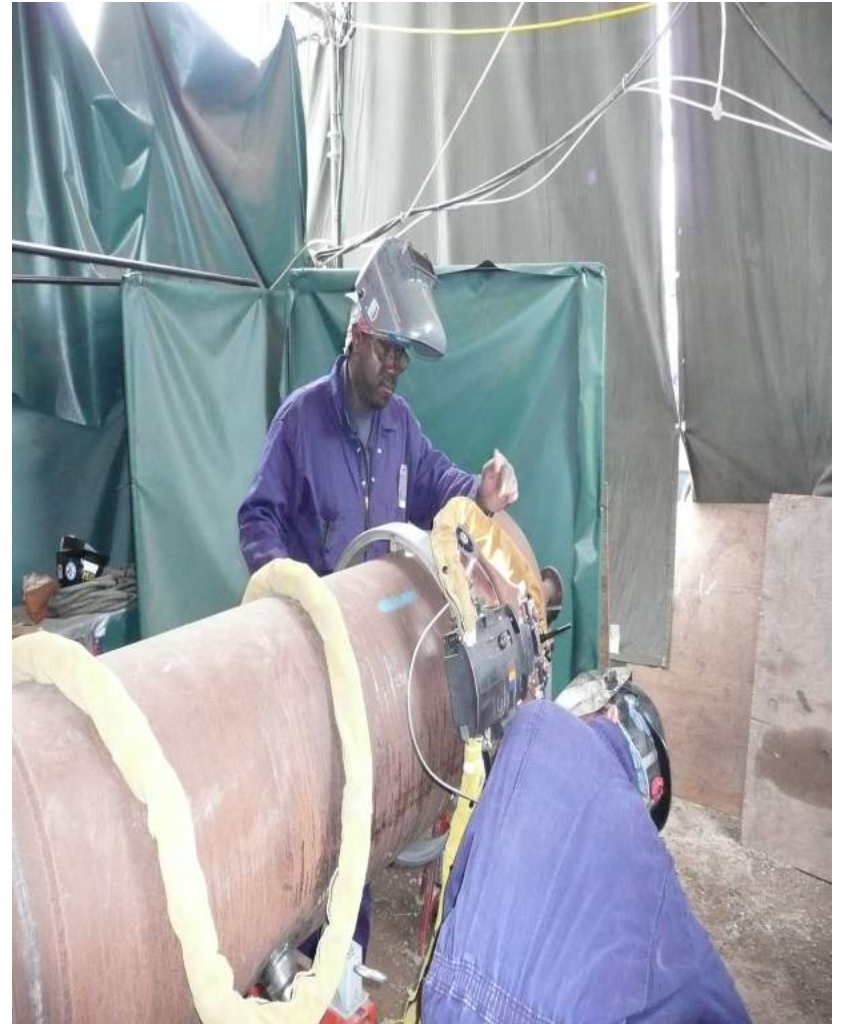
- Performed 300+ welds with only 3 minor rejects in cap pass
- Reduced schedule 5 days
- Reduced Headcount by 45 Pipefitters compared to GC
- Safety: Zero lost time accidents
