Refineries at Risk

The Critical Link between Reliability and Safety Drives Global Acceptance of New Inspection Technologies for Fired Heaters

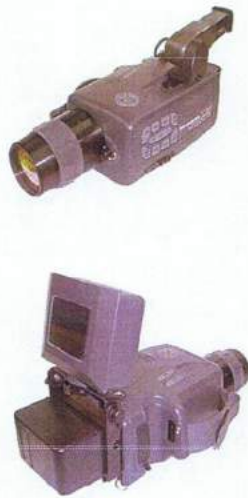
Flir Systems ThermaCam SC1000

- Handheld portable radiometer camera
- Electrically cooled FPA imager
- Temperature range: 14 to 2732 deg F
- Color LCD Display
- Digital Video Output
- ThermaCam Reporter Software

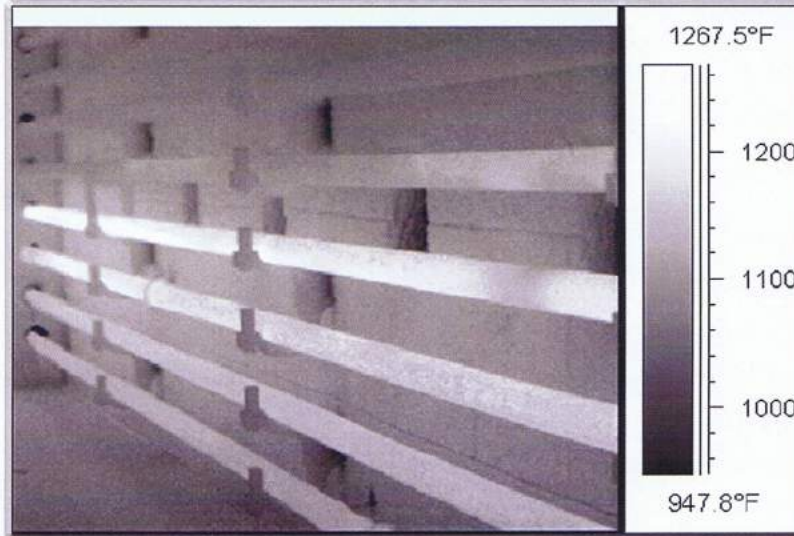
Coker Charge Heater During Steam-Air Decoke

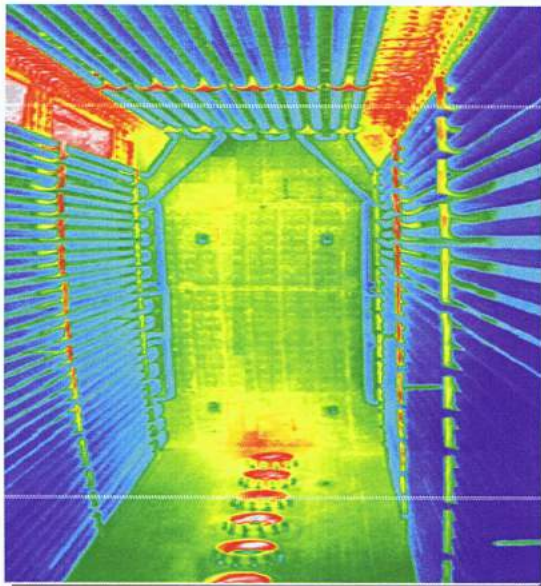
Crude Charge Heater

Observe Heat Distribution Pattern

- heat distribution
- tube temperatures
- burner signature

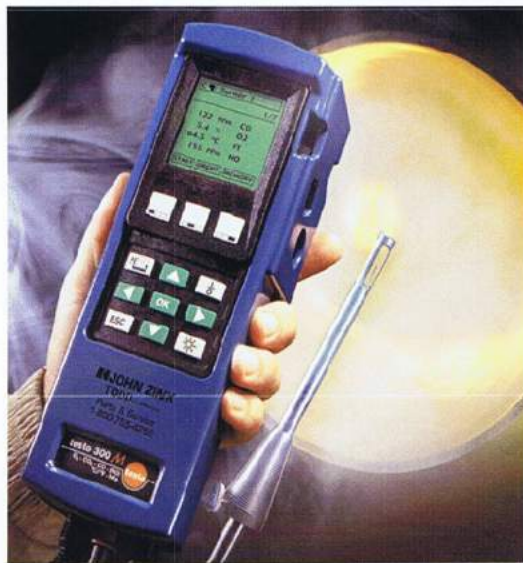
Testo 300 M Analyzer

- ▶ Handheld portable flue gas analyzer
- ▶ Measures O₂, CO, NO_x and SO_x emissions, draft and flue gas temperature

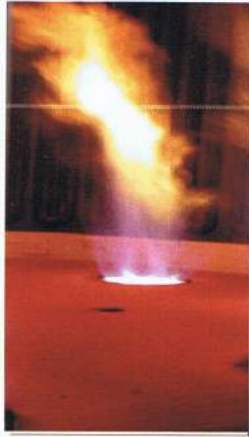
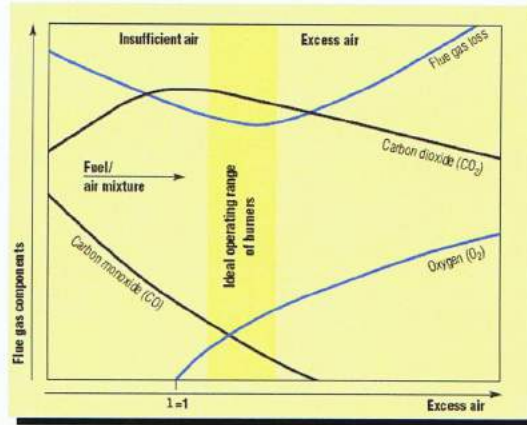
Flue Gas Analysis

- ▶ Burner performance (flame quality, emissions)
- ▶ Heater efficiency monitoring

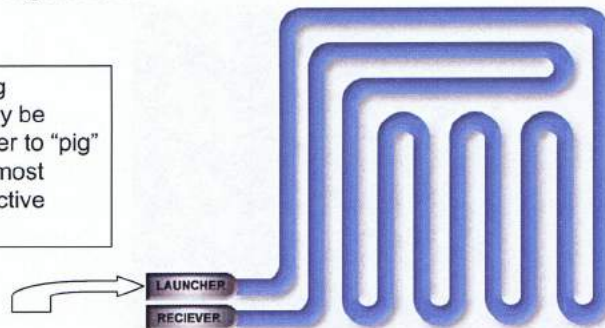
- Untethered intelligent pig utilizing Ultrasonics (UT) to rapidly inspect both the radiant & convection section as well as other piping configurations.

Inlet/Outlet piping modifications may be necessary in order to "pig" a furnace in the most efficient and effective manner.

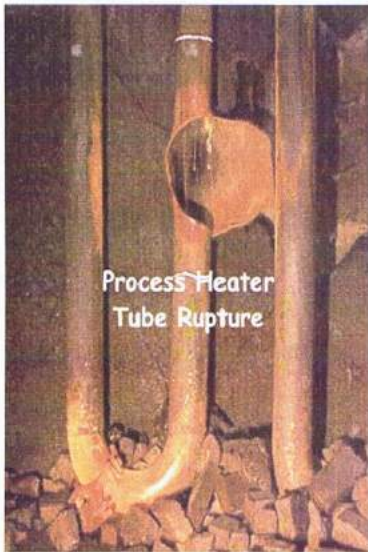
FTIS™ Detectable Failure Mechanisms

- **Pipe/Tube Wall Loss**
 - Corrosion (*Int. or Ext.*)
 - Erosion (*Int. or Ext.*)
 - Pitting (*Int. or Ext.*)
 - Mechanical Damage (*Int. or Ext.*)
- **Deformation**
 - Bulging (*i.e. Flame Impingement*)
 - Swelling (*i.e. Creep Strain*)
 - Denting
 - Ovality

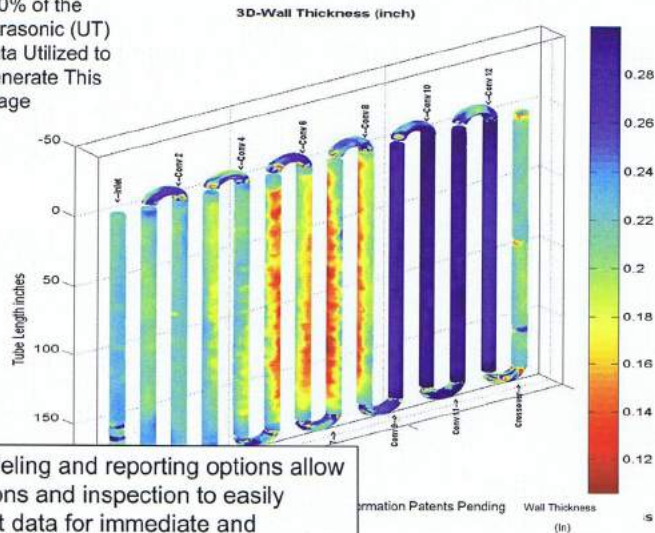
3D Modeling of FULL Serpentine Coil

100% of the
Ultrasonic (UT)
Data Utilized to
Generate This
Image

3D modeling and reporting options allow operations and inspection to easily interpret data for immediate and accurate corrective actions

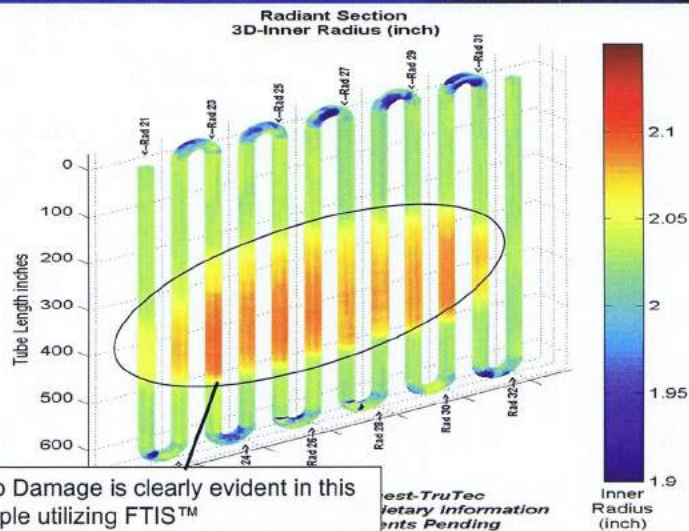
3D Modeling of FULL Serpentine Coil

Creep Damage is clearly evident in this example utilizing FTIS™

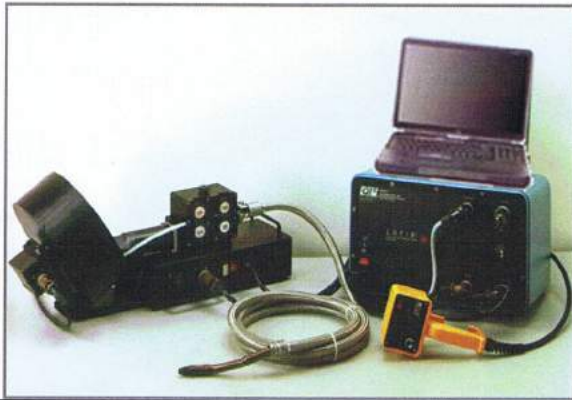
Internal LOTIS™ System, Model - 400M

0.460" to 5.64" (11mm to 143mm) ID
Accuracy of plus/minus 0.002" (0.05mm)

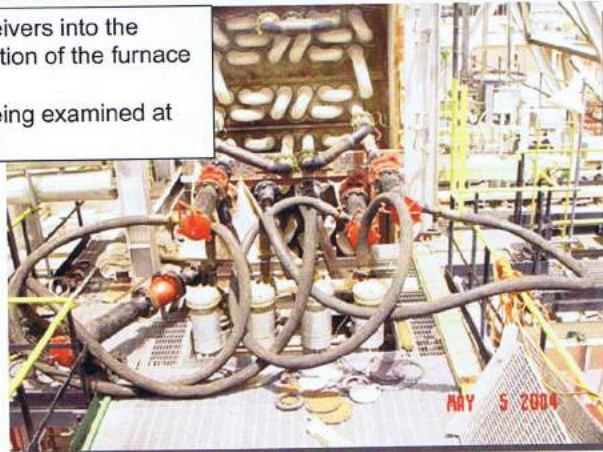
Case Study #2: Pigging Set-Up

Launcher/Receivers into the convection section of the furnace

Two passes being examined at the same time

Typical Launcher / Receiver Set-up

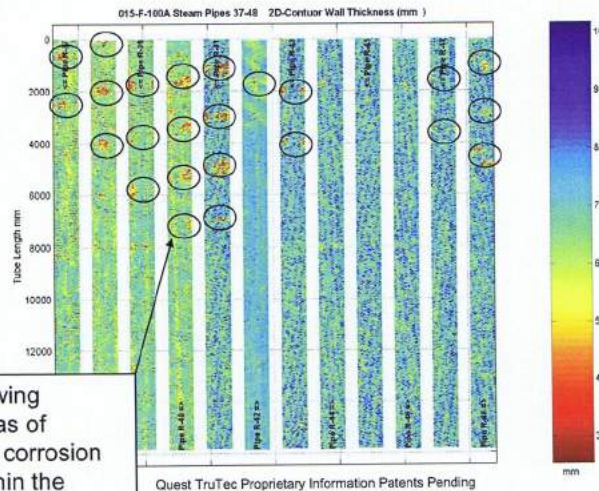
Case Study #2: FTIS™ External Damage

2D plot showing isolated areas of EXTERNAL corrosion damage within the studded region

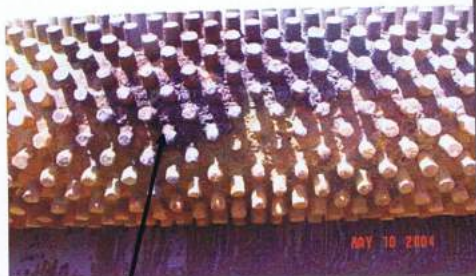
Soot blowers caused damage on OD of pipe
Note that the external studs are corroded away

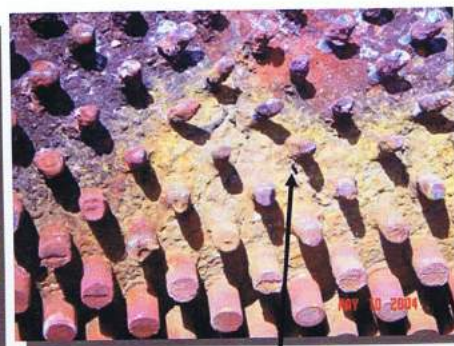
Through wall hole in pipe where water was leaking from convection section

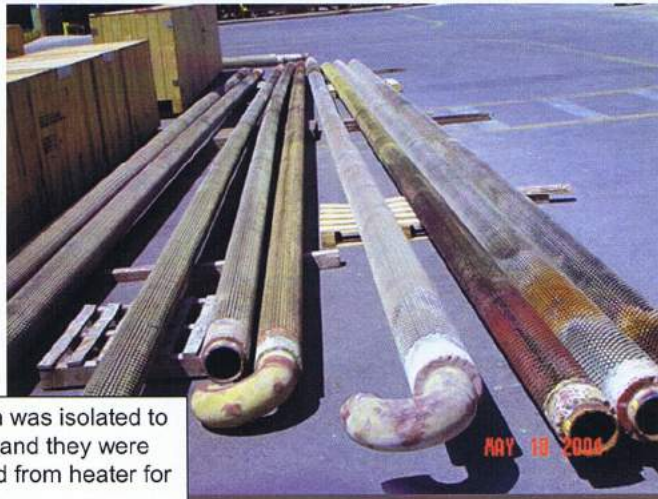
Case Study #2: Removed Piping

Problem was isolated to 8 tubes and they were removed from heater for repairs

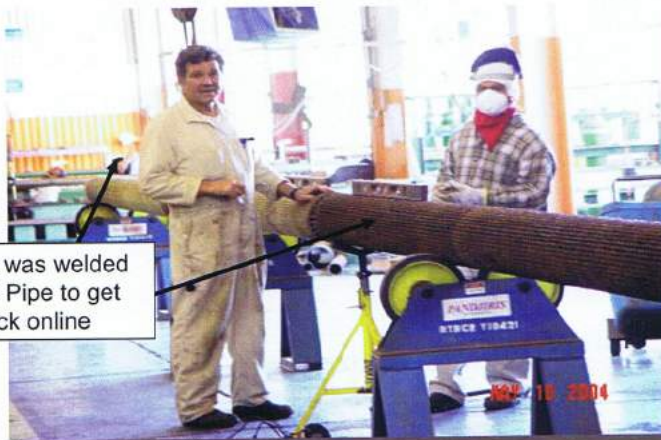
Case Study #2: Tube Repairs (1/2 New - 1/2 Old Material)

New Pipe was welded to the Old Pipe to get heater back online

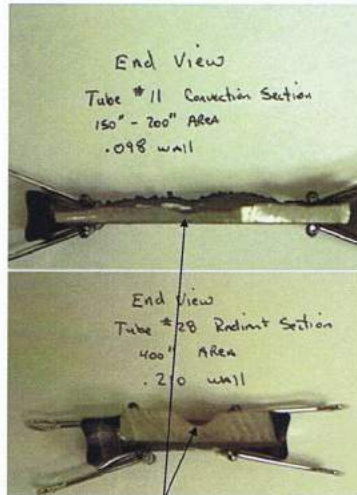
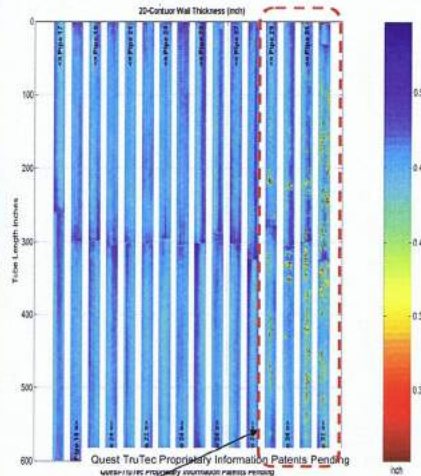
Case Study #3: (2D Plot) Corrosion in Radiant Section Piping

Photos show cross section views of coupons cut out by client

Notice that damage is isolated to all 4 tubes on the right.

1.) PIPE # 11 - 150"-200" AREA ----	FTIS™ REPORT ----	0.095- INCH
	MANUAL UT ----	0.095- INCH
	DRILLED HOLE w/CALIPER --	0.098- INCH
PIPE# 11- 400"- 450" AREA----	FTIS™ REPORT ----	0.095- INCH
	MANUAL UT ----	0.110- INCH
	DRILLED HOLE w/CALIPER --	0.098- INCH
2.) PIPE # 28- 400" AREA ----	FTIS™ REPORT ----	0.247- INCH
	DRILLED HOLE w/CALIPER --	0.248- INCH
3.) PIPE # 29 - 200" AREA ----	FTIS™ REPORT---	0.185- INCH
	DRILLED HOLE w/CALIPER -	0.188- INCH

- ▶ Thickness checks were initially performed by FTIS™
- ▶ Manual UT thickness were taken on exterior after removal
- ▶ Samples were cut out / hole drilled and measured with a micrometer - all readings were very close to the same.
- ▶ The areas showing localized thinning in the FTIS™ report have erosion areas throughout entire pipe length, with scattered deeper pitting.

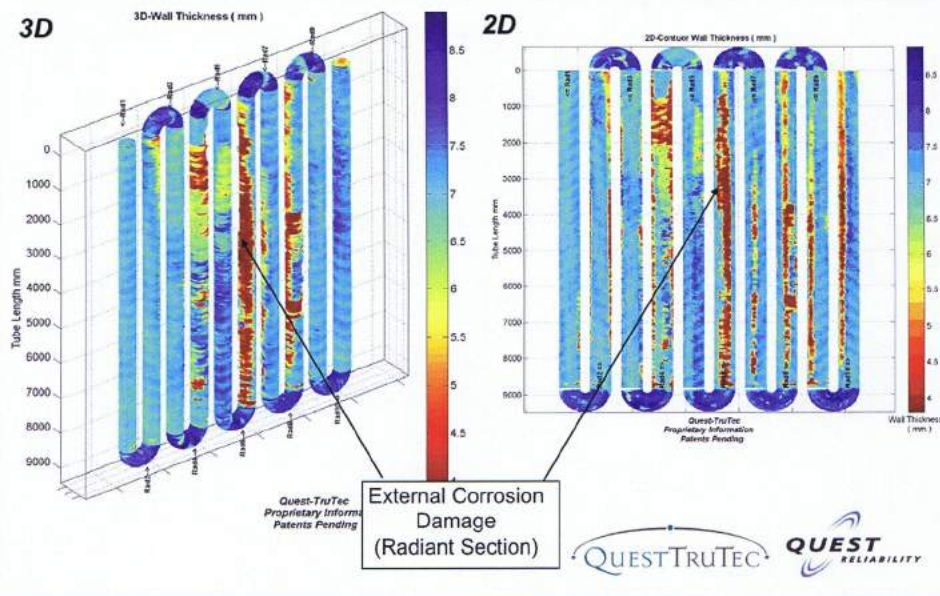
Case Study #4 Radiant Section Corrosion

- ▶ Number of Coils / Passes = 2
- ▶ Pipe Material = ASTM A335 – P5 (6-inch x Sch.40)
- ▶ Heater Vintage = 1976
- ▶ FTIS™ was applied to inspect both process coils.
- ▶ FTIS™ inspection results detected extensive “external” corrosion damage in the radiant.
- ▶ Visual inspection found tightly adhered scale on piping exterior surface.
- ▶ FTIS™ results were not impacted by tightly adhered scale
- ▶ Large broad areas with 56% “external” wall loss was noted.
- ▶ Plant engineers utilized FTIS™ test results to make decision for replacement of several pipe sections

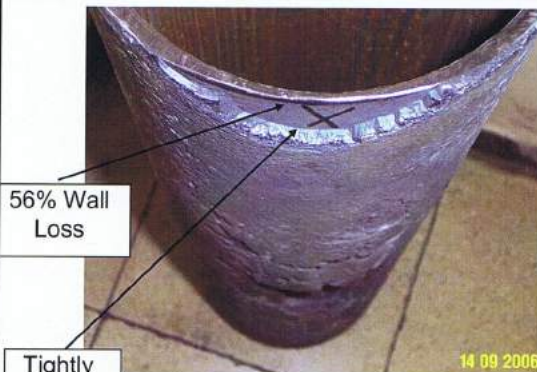
Case Study #4

Tightly Adhered Scale
