Repairs on 40 Year Old
Drums at Suncor

MATERIAL SELECTION ISSUES IN COKER UNITS

Coking.com Safety Seminar,
Calgary, Alberta

September 17-20th, 2007
By Lutz Josefiak and Wes Witmer

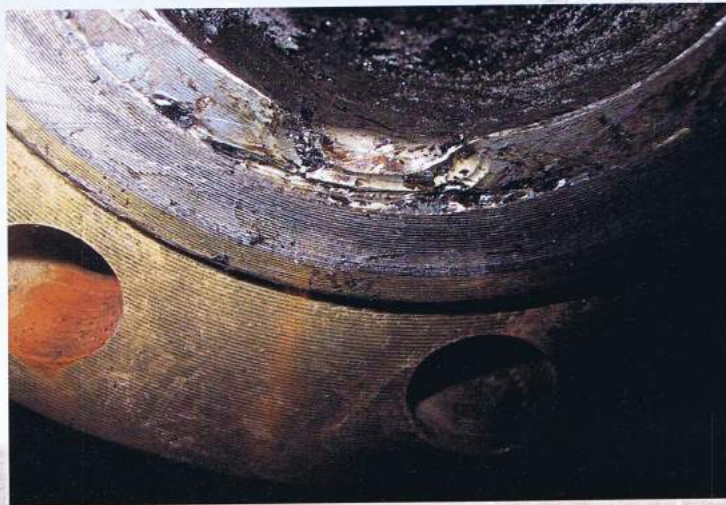
Erosion Problems in Coker Units

- Valves Downstream of Charge Pumps

- Heater inlet valves
 - Typically 317SS
 - Can experience high erosion due to coke fines
 - Consider hardfacing of all wetted surfaces

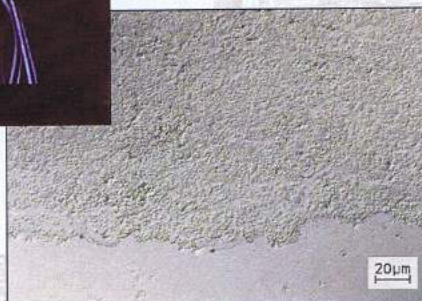
HVOF / Hard Metal Coatings

Carbide
Coatings

WC/10Co4Cr

Hardness: **HV_{0.3} 1000**
Service Temp.: **up to 930 °F**

Cr₃C₂/25NiCr

Hardness: **HV_{0.3} 1000**
Service Temp.: **up to 1800 °F**

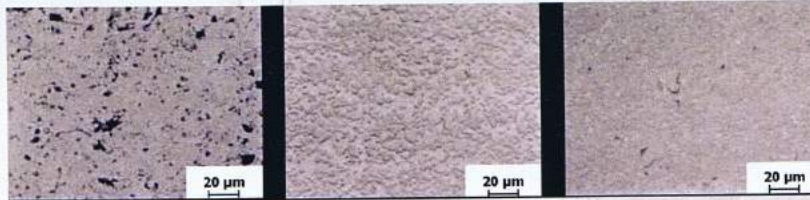
Influence of Chamber Pressure/ Particle Velocity on Impact

WC/Co 83/17

Jet Kote

K2

Sintered
Hardmetal

- Carbon Loss: 60 %
- Hardness: 950 HV_{0.3}

- Carbon Loss: 37 %
- Hardness: 1490 HV_{0.3}

- Hardness: 1630 HV_{0.3}

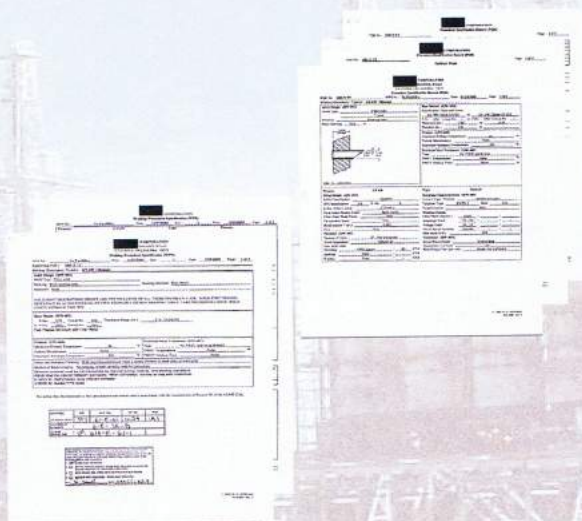
Coating Quality assurance by plant operating and designing company

Decisive Spray Parameters:

1. Chamber pressure
2. Kind of Fuel
3. Method of Media Control
4. Fuel/Oxygen Ratio
5. Gun Nozzle Length
6. Powder Size
7. Powder Composition
8. Powder Morphology
9. Feed Rate
10. Spray Distance
11. Spray Angle
12. Surface Speed
13. Substrate Preparation
14. Substrate Cooling
15. Coating Thickness
16.

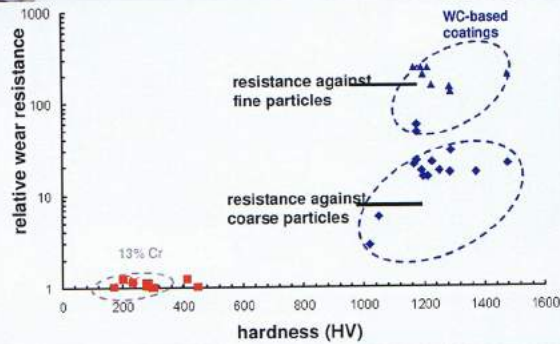
HVOF / Coating tests

Application-specific materials testing

High pressure water jet pump for coke cutting

- DLC versus HVOF WC/CoCr and WC/267
- slurry jet erosion test with neutral pH slurries, metallurgical

Ball valve in "severe" service (Coker Furnace Charge Line)

- hot bitumen and bitumen hydrogen mixes
T: 300 - 450 °C, P: up to 15 MPa
ppH₂: up to - 12MPa, ppH₂S up to - 1.1Mpa
S: 2-5%, Solids: ≈ 2000ppmw, Coke deposits
- DLC, HVOF WC/CoCr and WC/267, Laser clad stellites, spray and fuse Co based SFA
- high temp. and pressure sulphidation test in autoclave
- pin-on-disc, thermal shock, 3-point-beam, metallurgical
