Development of CIA's Remote Robotic Crack Detection Service

COKING .COM

Jacqueline Cameron & Les Harold

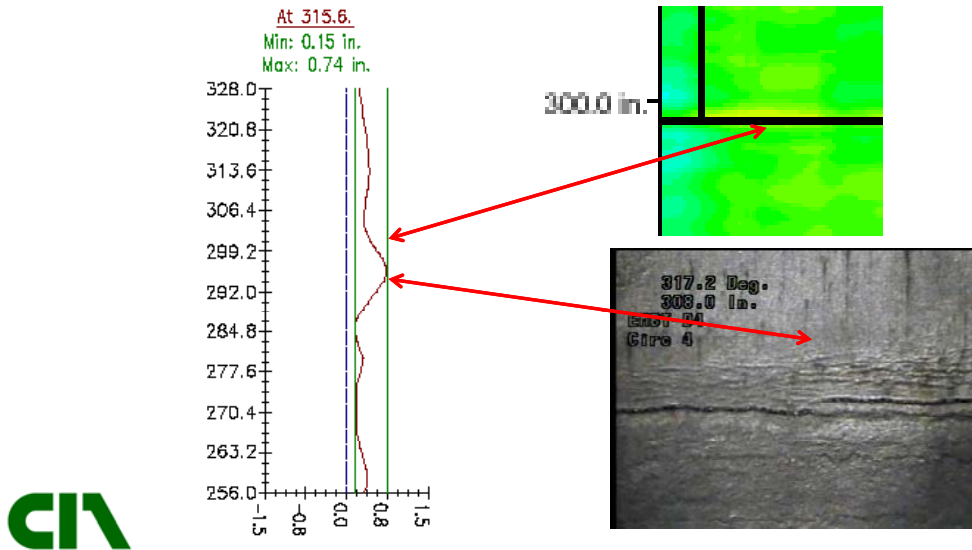
Inspection Results

- Is This A Crack?
- If so, how deep and how long is it?

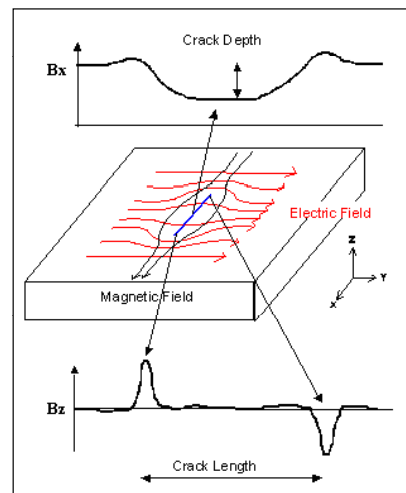
- ACFM operates by inducing a locally uniform AC field into the test surface. This field flows in a thin skin in the surface of the material and is disturbed by the presence of surface breaking defects.
- These changes are detected by two sensors mounted in the probe which measure the magnetic field resulting from the applied electric field

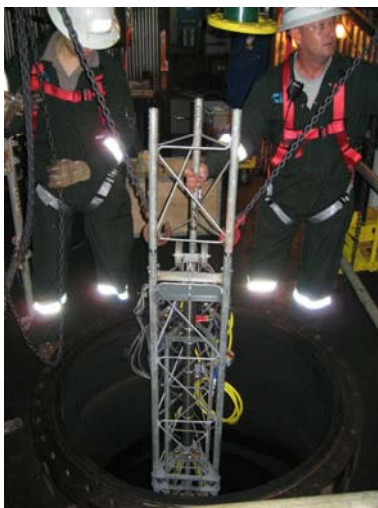
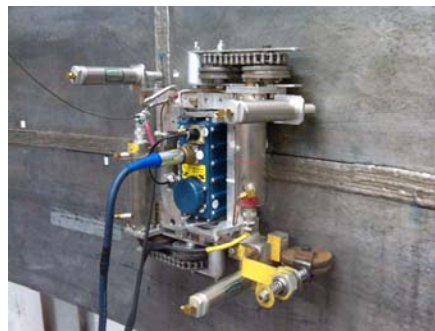
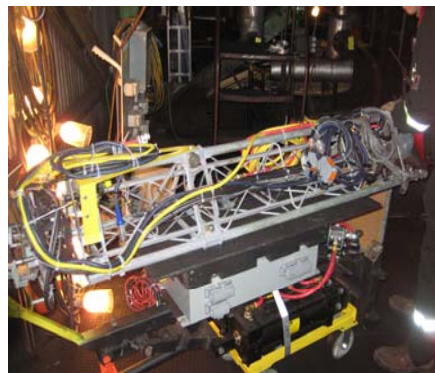
ACFM Equipment

- Deploy ACFM probe remotely from drill stem similar to existing inspection system & used in conjunction with laser scanner – retracting boom
- Crawler mounted probe placed inside coke drum wall directly at areas of interest to allow quick local surveys
- 16 sensor pair probe (4.25" wide) customized by TSC for use in coke drums & tuned to detect defects as small as 0.330 inches in length & 0.04 inches in depth
- Several field trials – top entry, bottom entry, crawler & probe

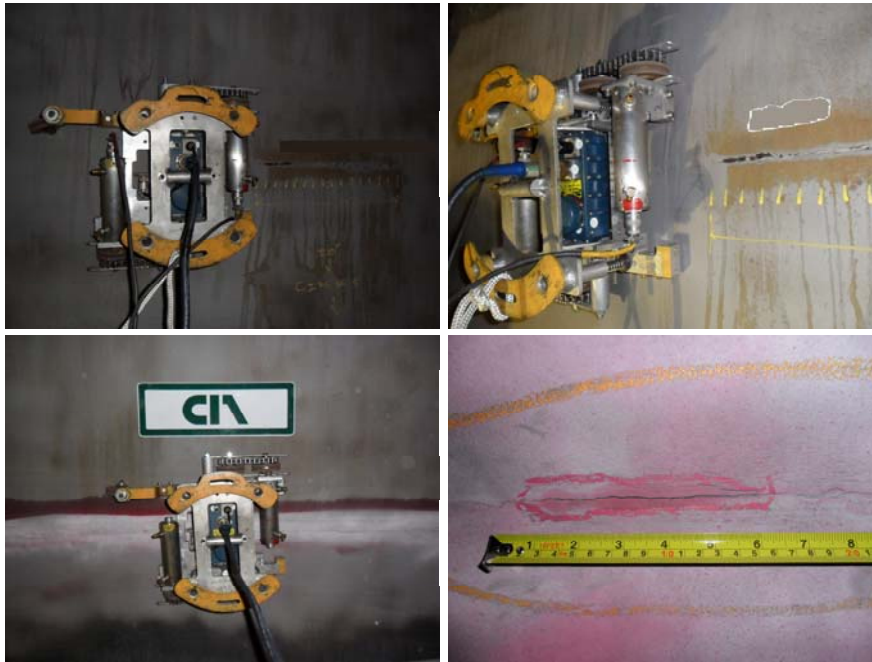
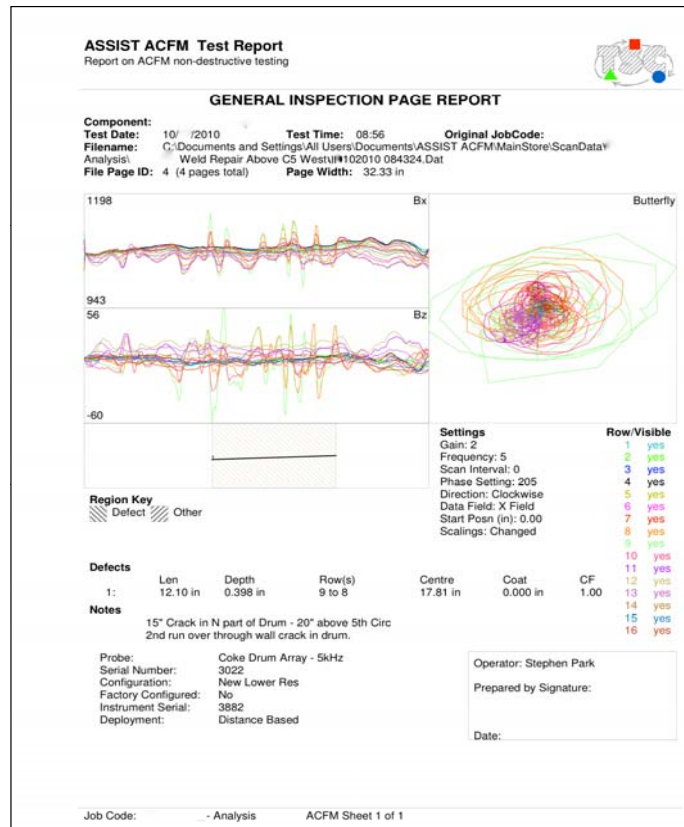
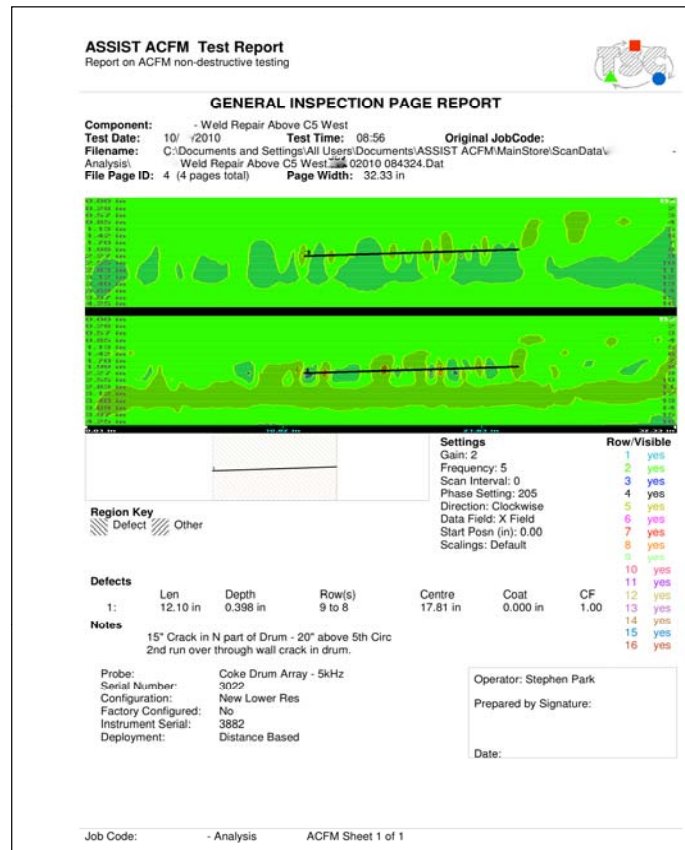
Field Trial – crawler on drum wall

- October 2010
 - Refinery in Canada
 - Drum was out of service (crack repair)
 - Swing stage built inside drum – ACFM probe & crawler driven across known, verified indications
 - Collect data & correlate findings with existing indications (correlated with grind out depths at indication sites)

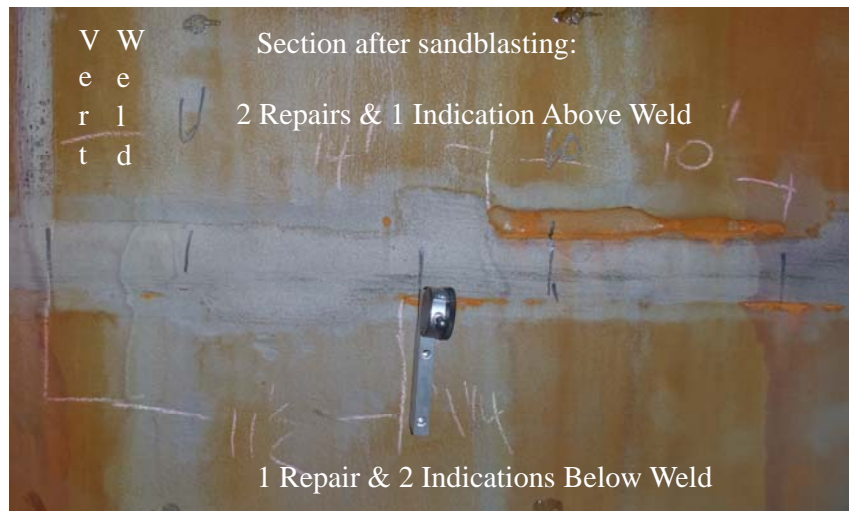
CIA results

Page	Defect ID	Defect Length	Defect Depth	Probe Rows	Inches to Defect Start	Client Identifier	Client Findings	Measured Depth	ACFM / Measure Delta
8	28	2.84	0.87	12	19.06	C303	1.25' long x .375' wide spall	0.262	-0.195
8	8	9.43	0.324	5	14.22	C304	10' long by 1.125 wide spall	0.380	-0.057
8	11	9.43	0.361	8	14.78	C304	10' long by 1.125 wide spall	0.380	0.001
8	30	1.27	0.86	11 to 12	23.93	C305	1.0' long x .183' wide spall	2.35	-0.149
