Unexpected Hazard of Switching into a Close Drum Isolation Valve

Mike Kimbrell – BP Coking Advisor

Summary of Incident

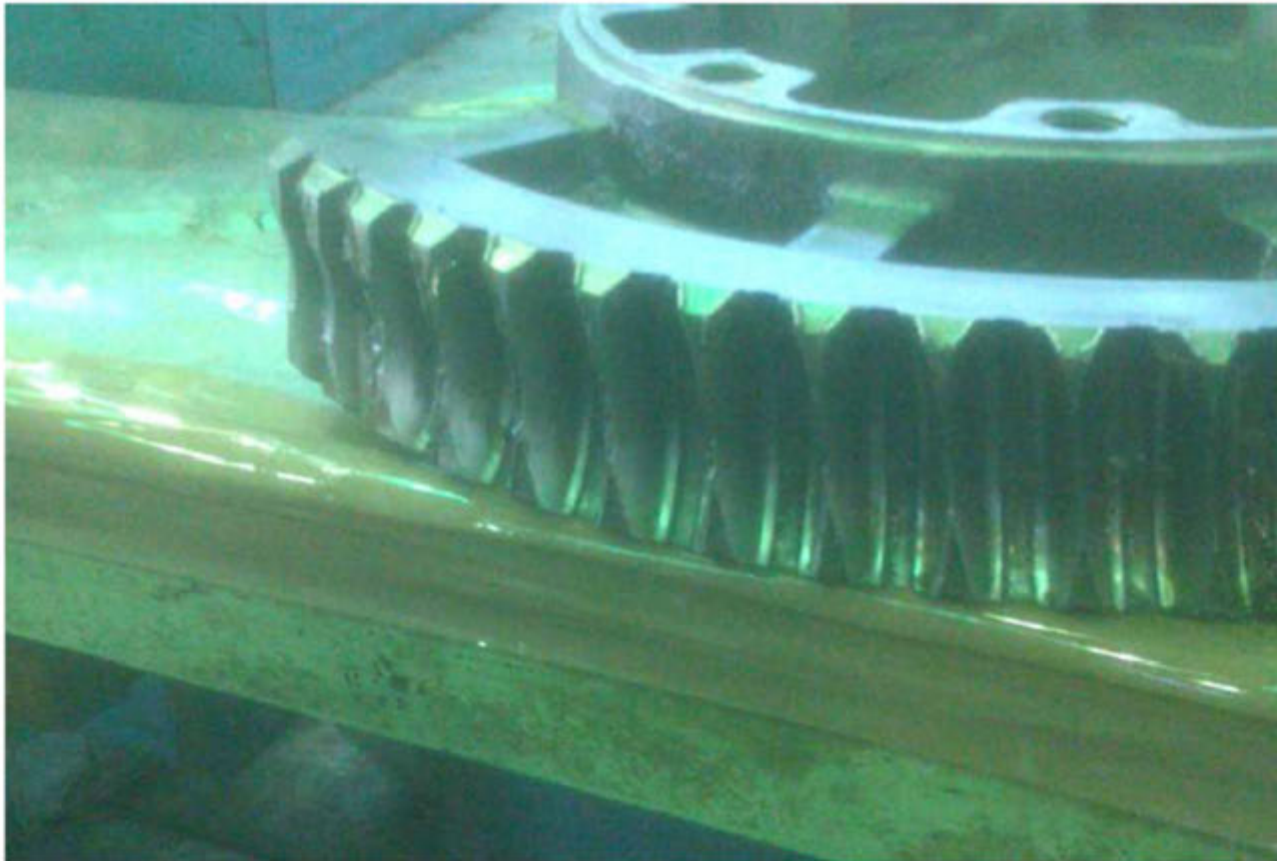
Actuator gear wear

- Initial start-up of this unit was Feb 2009
- Inlet isolation valve involved in incident required more torque to turn starting May 2010, one year prior to the incident
 - Site had been in contact with valve manufacturer. Had increased the available torque from the actuator to move valve
 - In Aug 2010, a pneumatic assist was used to get the valve to close as the actuator was not always able to close the valve. Limited the air pressure to 70 psig.
 - March 2011 the actuator had the gears replaced as they were severely worn due to the excessive force required to close the valve
- Steam purges for this valve came from steam generated on site from the HCGO steam generator

- Resize restriction orifices on steam purge to hot valves
 - Need to be sized on minimum differential between steam header pressure and process pressure
- Modify interlock logic to monitor drum inlet temperature and not allow switch to be completed if inlet temperature does not increase
- Monitor torque required to move valves. Repair or replace valve when torque value exceeds pre-set limit
- Monitor purge steam flow rates. Ensure purges are flowing when needed
- Reduce the time from loss of flow to burner trip from 20 seconds to 10 seconds

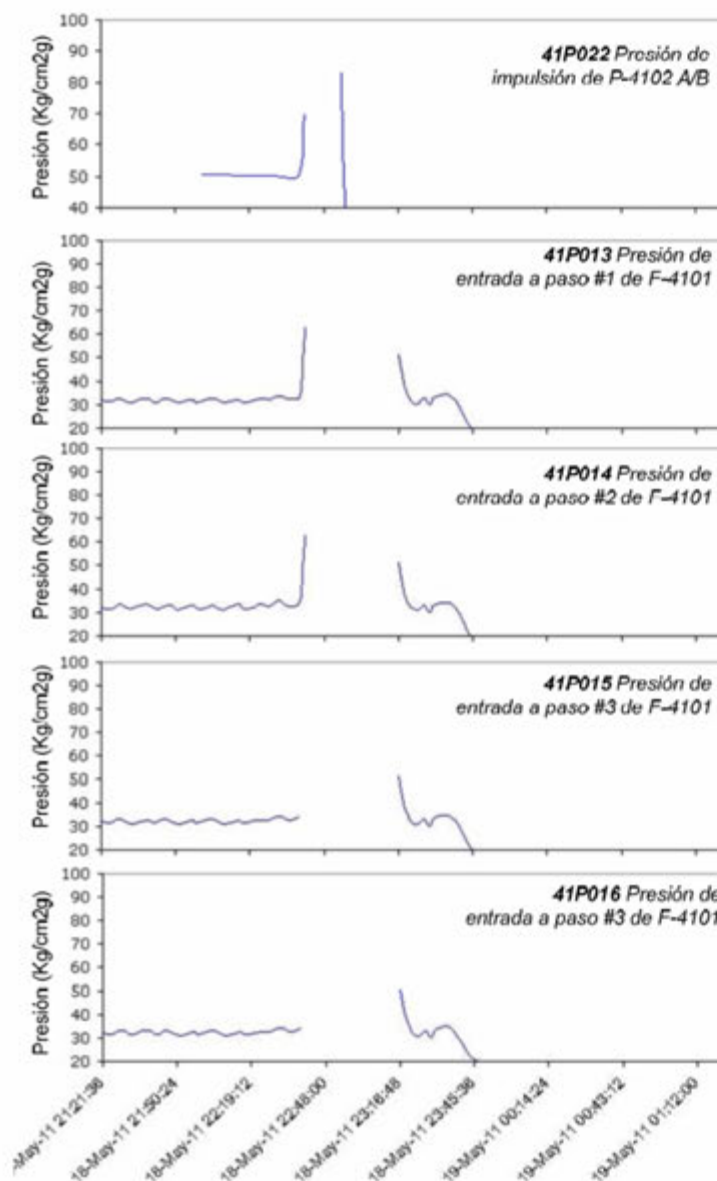
Pressures at Feed Pump and Heater Pass Inlet – Unexpected pressures

Heater feed pump shut off
Pressure is 58.5 kg/cm² (832 Psig)

Pressure at heater feed pump exceeded 84 kg/cm² (1195 psig)

Pressure at the heater pass inlet exceeded 60 kg/cm². Transmitters were at the maximum range

- The rate of pressure increase was faster than what could be justified by thermal cracking
- Heater feed temperature at the point of velocity BFW injection is 300°C (572°F)
 - Vapor pressure of water at this temperature is 87.6 kg/cm² absolute (1246 psia)
 - Required heater feed temperature to reach 101.6 bar-g is 313°C (595°F)
- Most likely cause was liquid water used as velocity media entering the heater and vaporizing with the heater feed pump isolation valve closed.

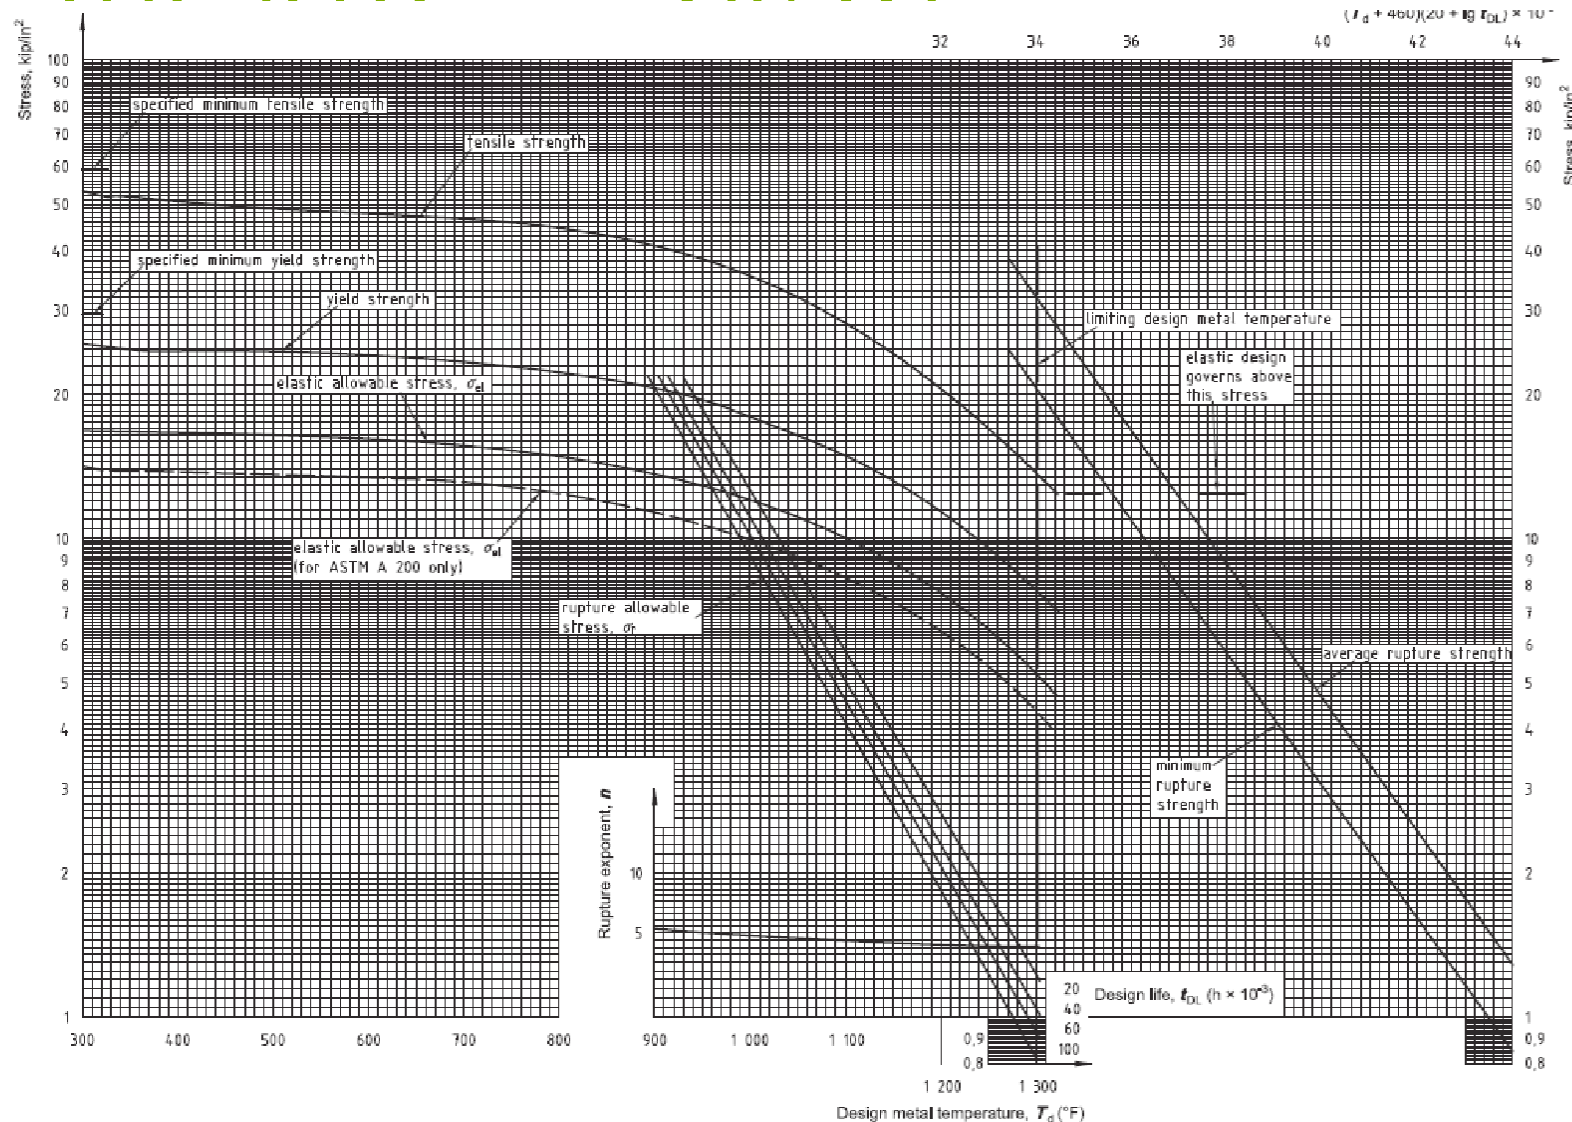
Allowable stress curve for 9% Cr – 1% Mo Heater tubes – API Std. 530

ⓘ Broken lines indicate the elastic allowable stresses for the A 200 grade. This figure does not show the yield strength of the A 200 grade. The yield strength of the A 200 grade is 83 % of the yield strength shown. The tensile strength, rupture allowable stress, rupture strength, and rupture exponent for the A 200 grade are the same as for the A 213 and A 335 grades.

Figure F.10 — Stress curves (USC units) for ASTM A 200 T9, ASTM A 213 T9 and ASTM A 335 P9 9Cr-1Mo steels
