Coke Drum Workshop and Safety Seminar

# Using Acoustic Emission Testing to inspect Coke Drums

**Presented by: Claudio Allevato**

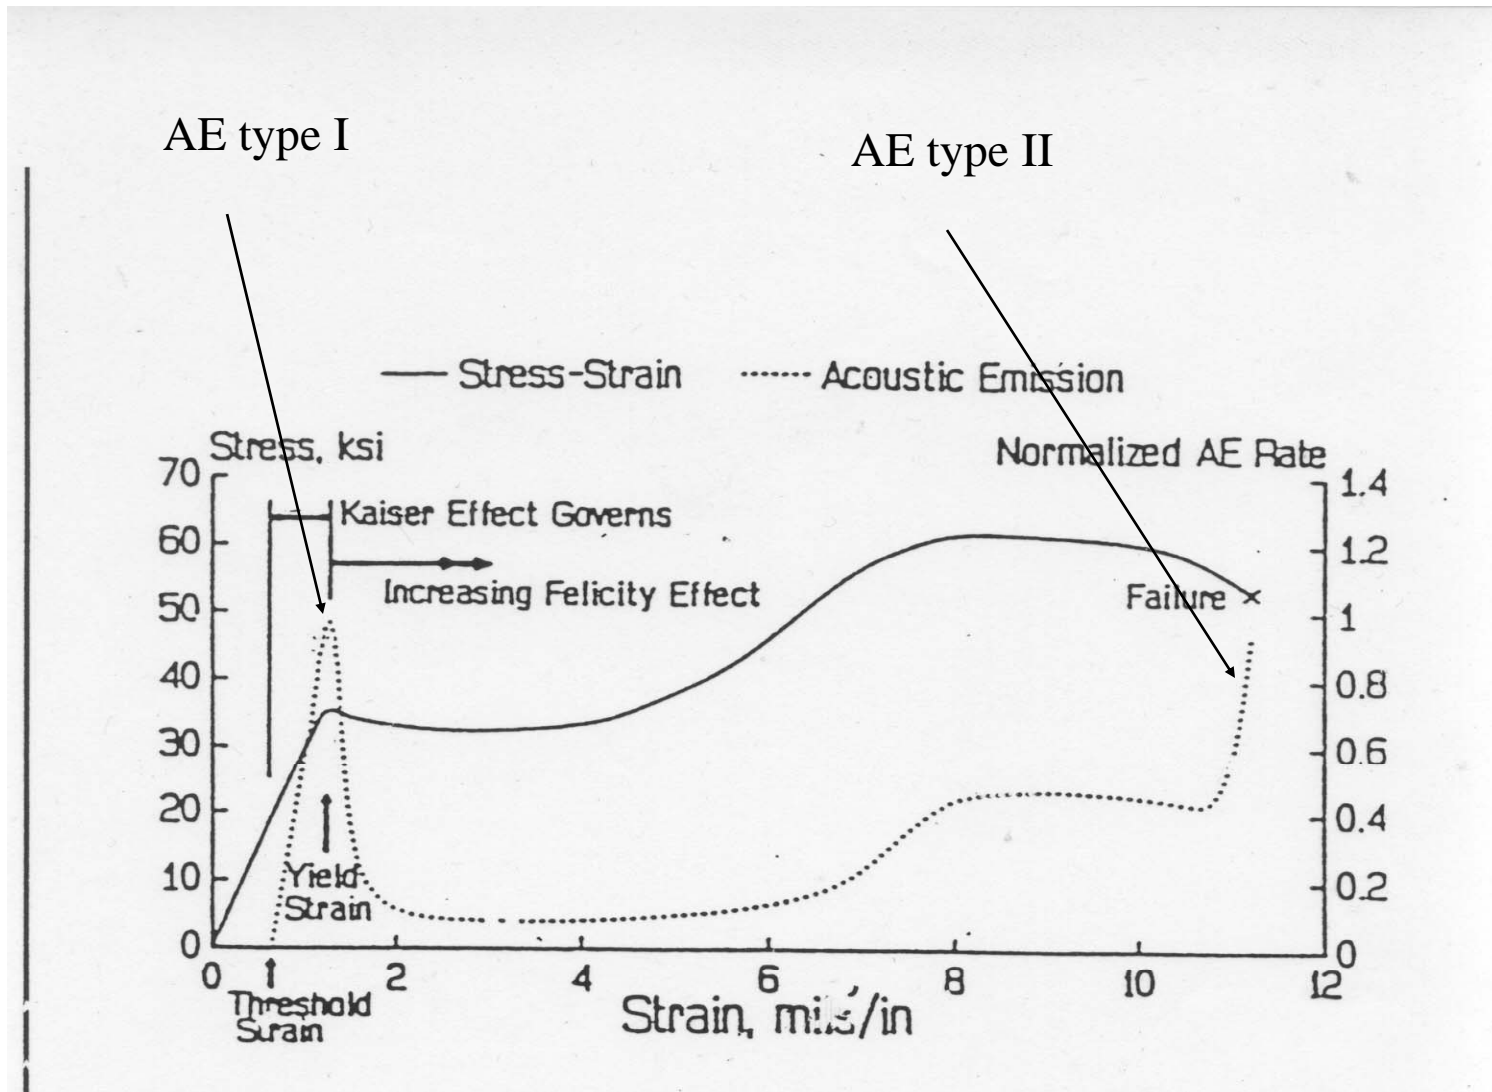
*There are primarily 2 types of AE from “flawed” metals:*

- **AE type I** – Associated with plastic deformation (yielding) near stress risers
- **AE type II** – Associated with actual damage progression/crack propagation

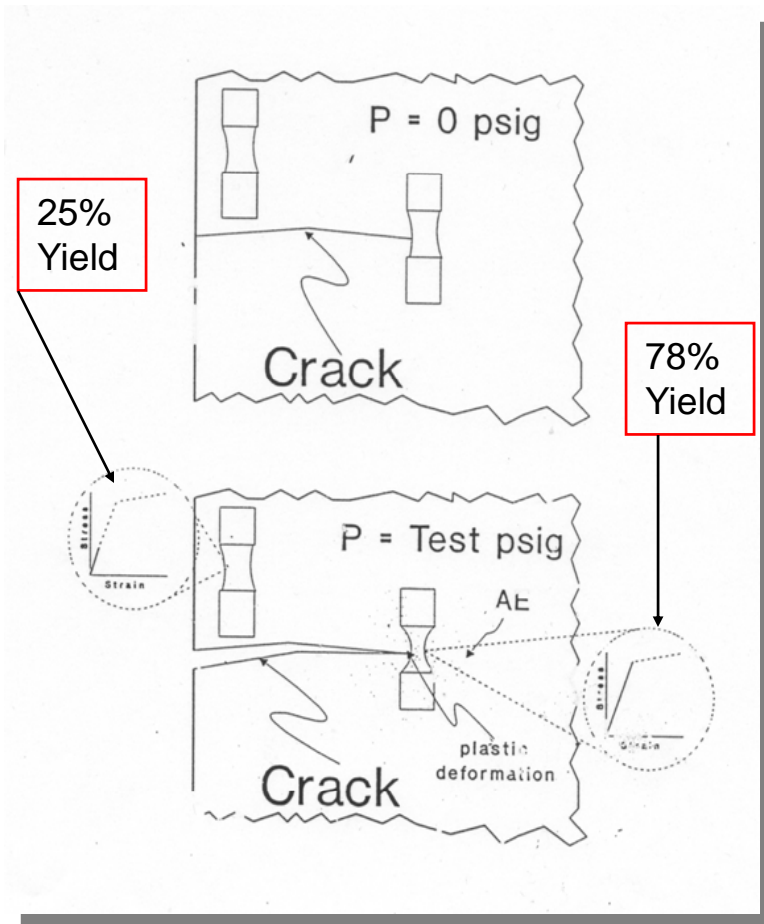
AE type I comes from elastic deformation/yielding !

**No load = No AET signals**

**Under load + crack free  
Material = NO AET signals**

**Under load + cracked  
Material = AET signals**

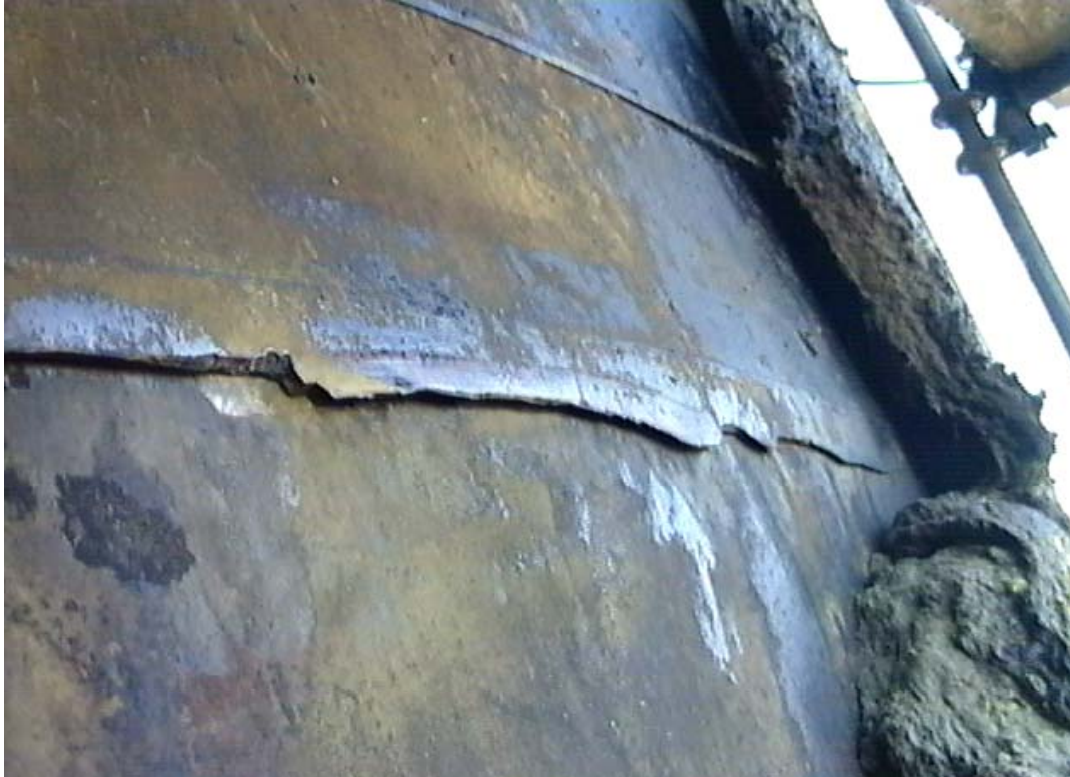
Thermally induced  
fatigue crack in circ.  
weld of a coke drum

Don't need AE to find  
that...

...but crack had been  
growing for a while.

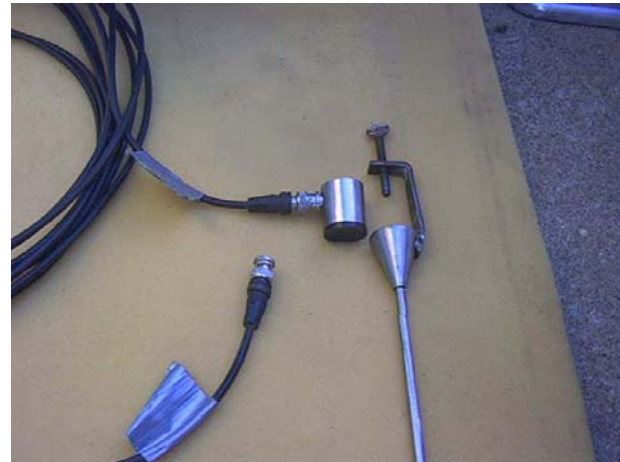
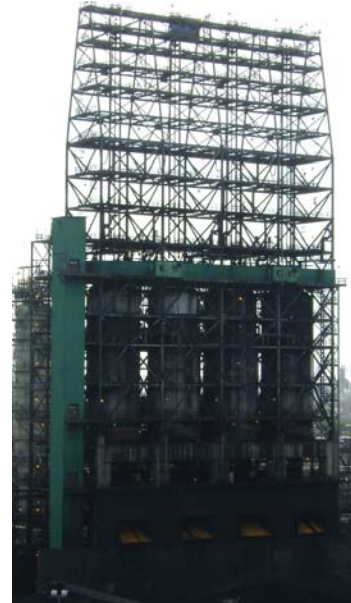
Vallen Digital System  
TÜF Certified

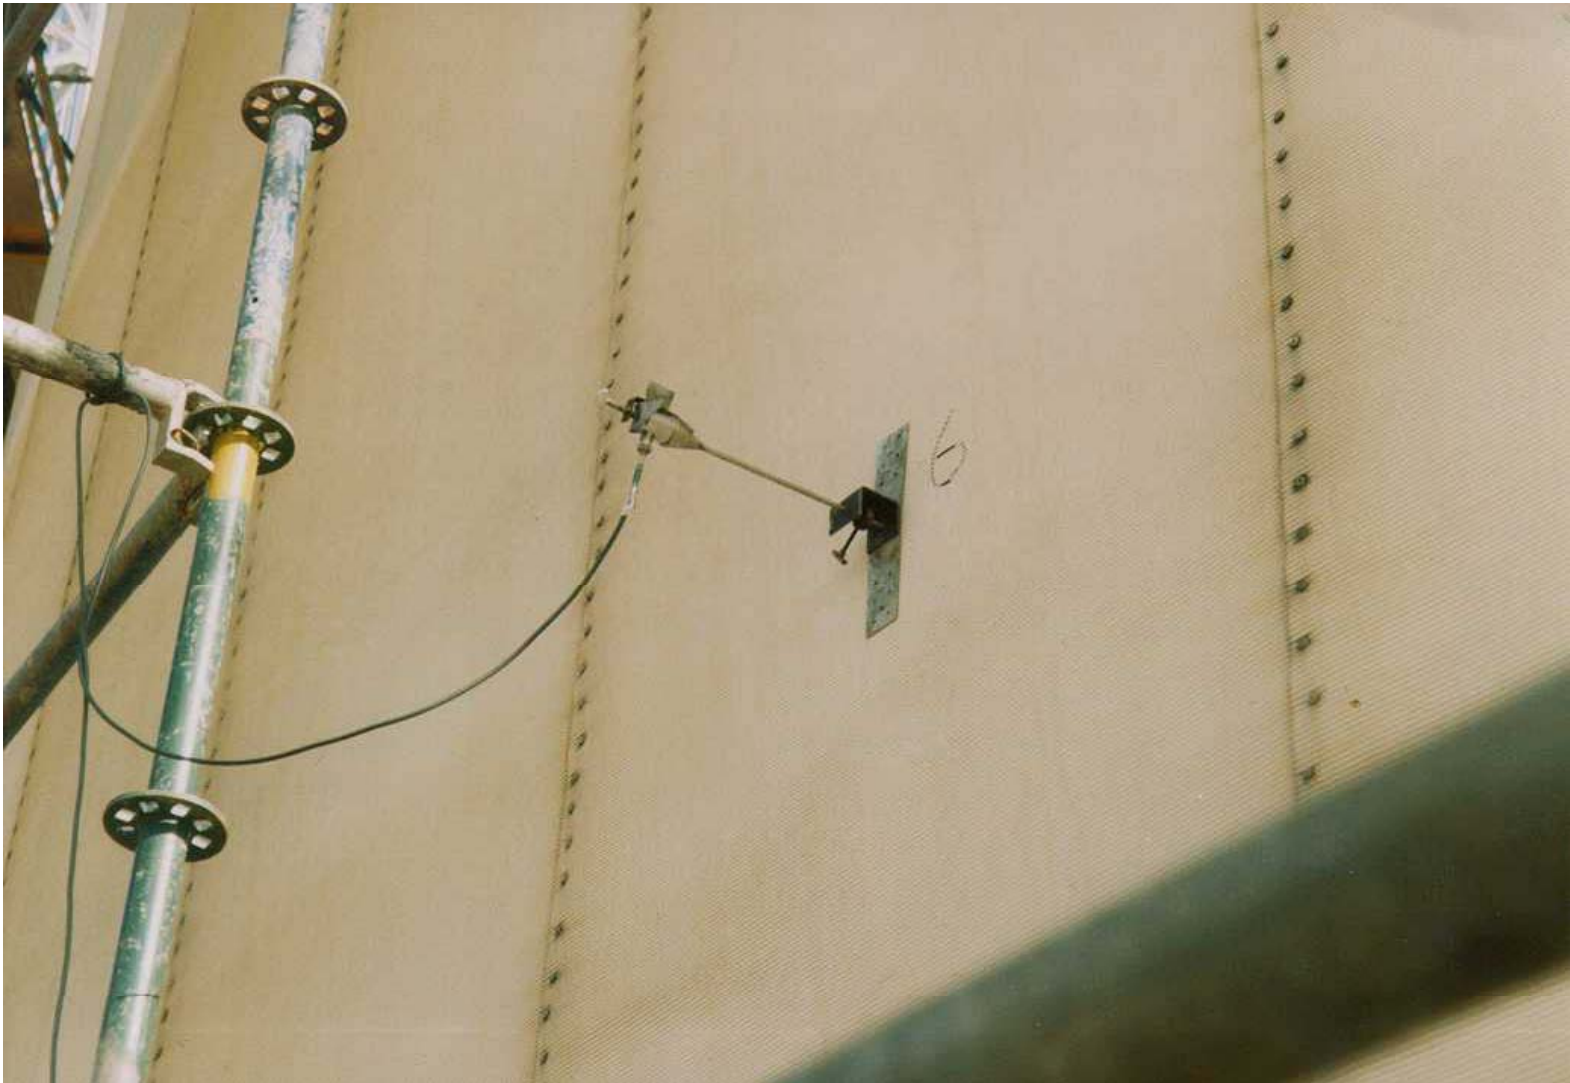
Four drums  
Covered with  
56 AET  
probes  
each

Use of waveguide avoids damaging of transducers.  
Loss of 8dB at contact point is known and compensated for

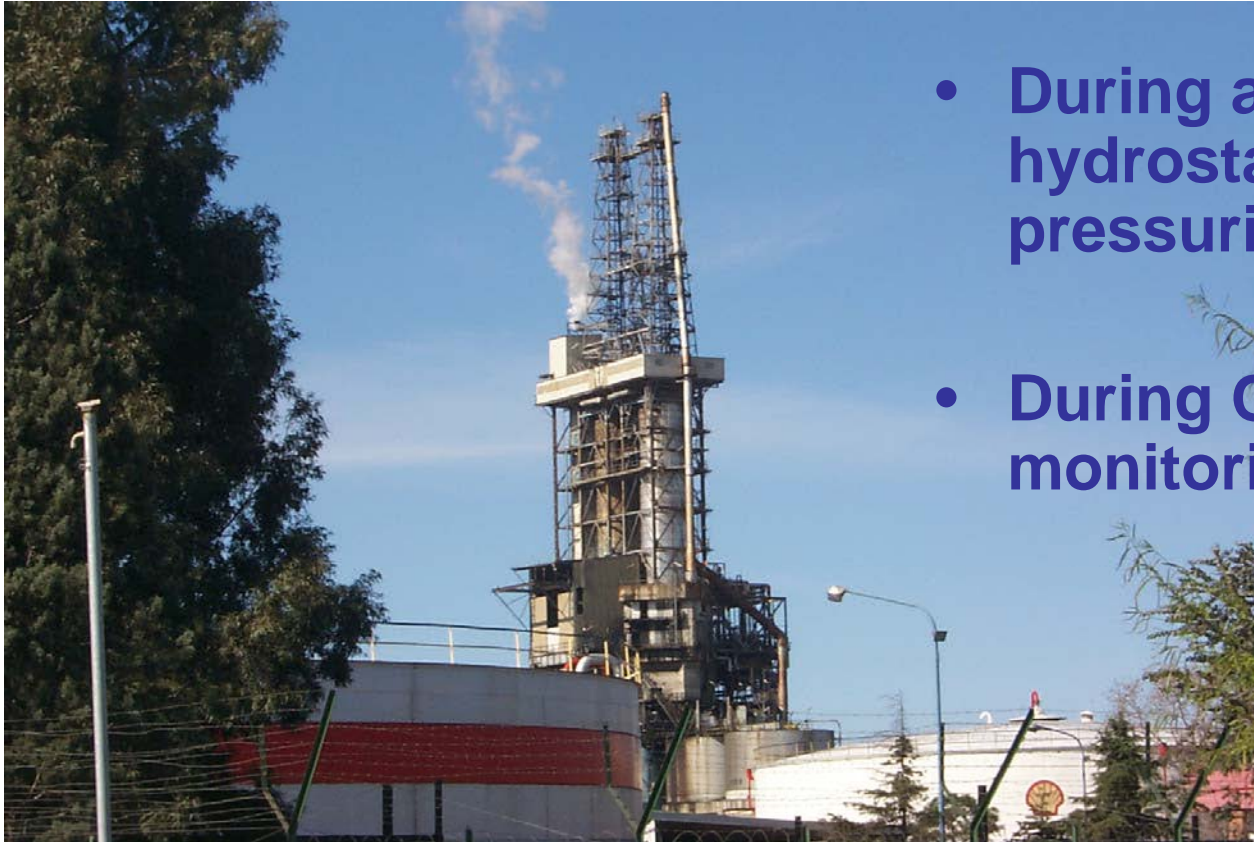
# AET applied to coke drums

- During acceptance code hydrostatic pressurization
- During On-line monitoring

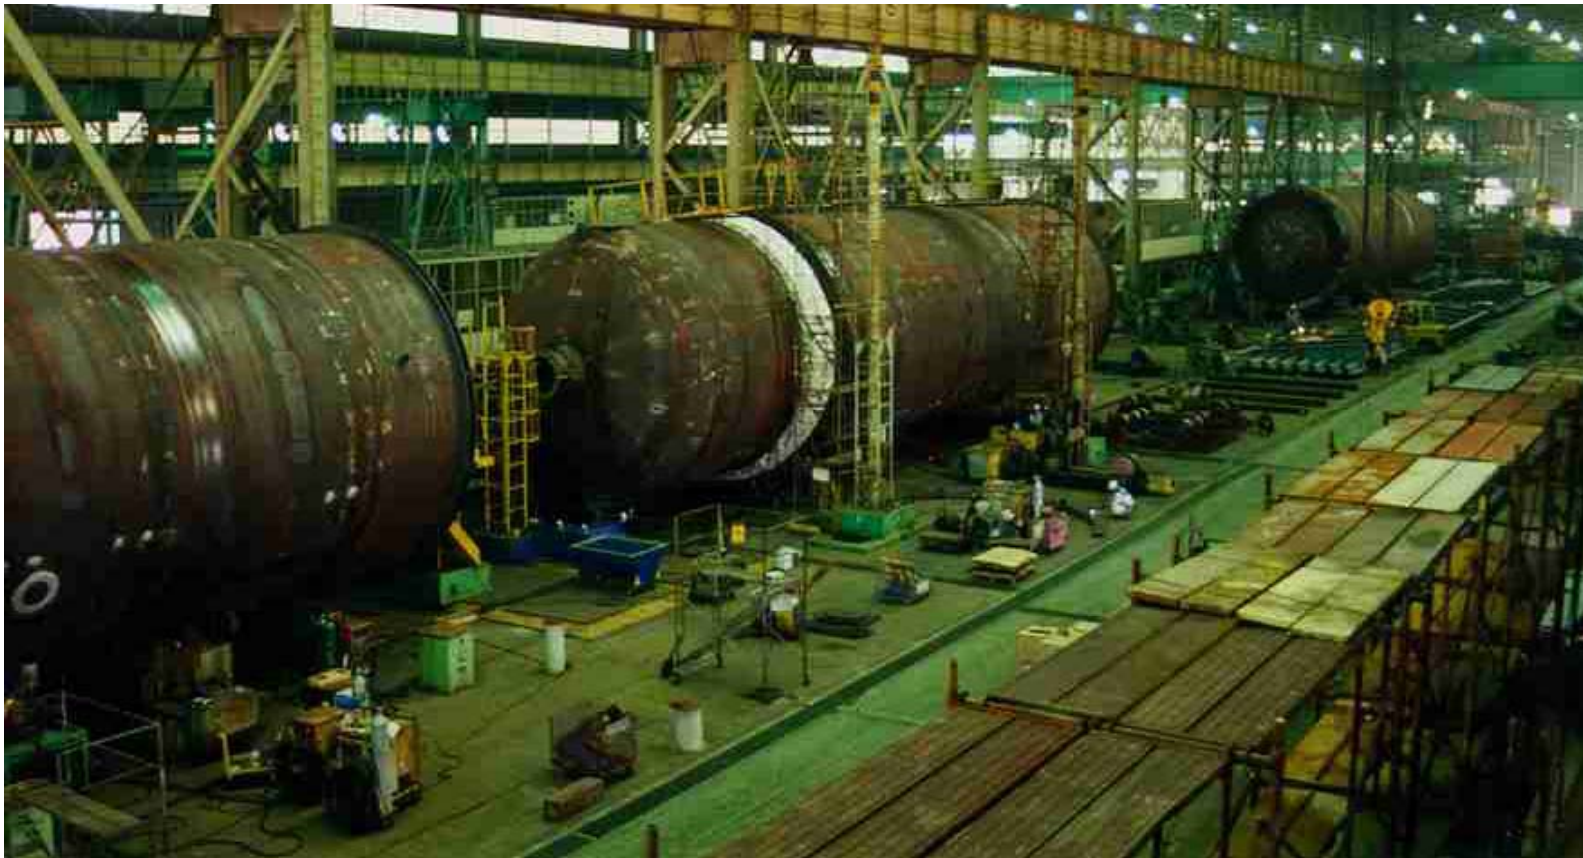
# Code AE hydrotest of new coke drums - 1<sup>st</sup> 3% Cr shell

(Code Max. Press. Modified to reach past 1 ½ Design to find smallest defect possible)

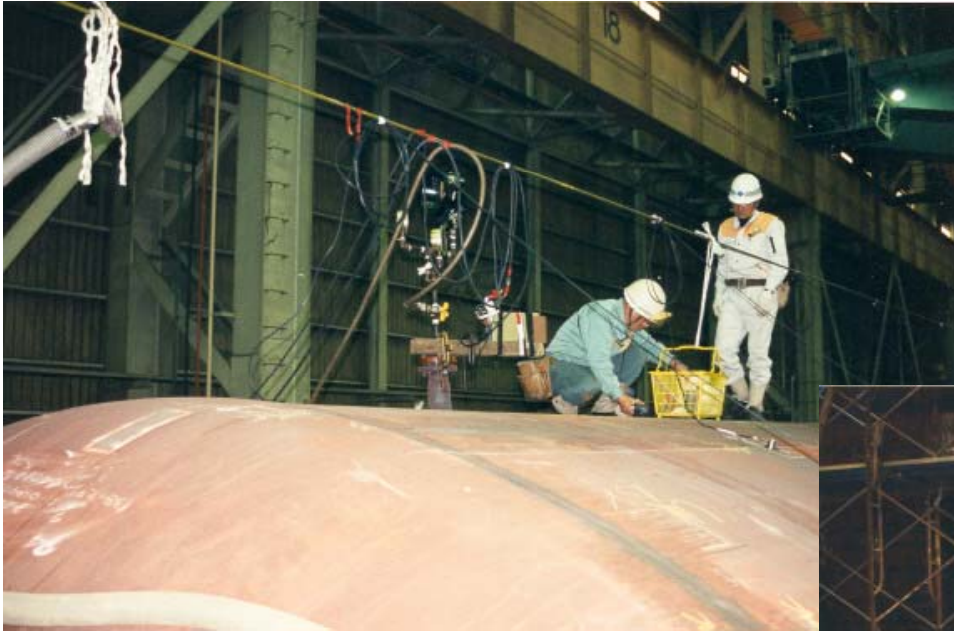
Sumitomo UT inspectors checking  
AET indication

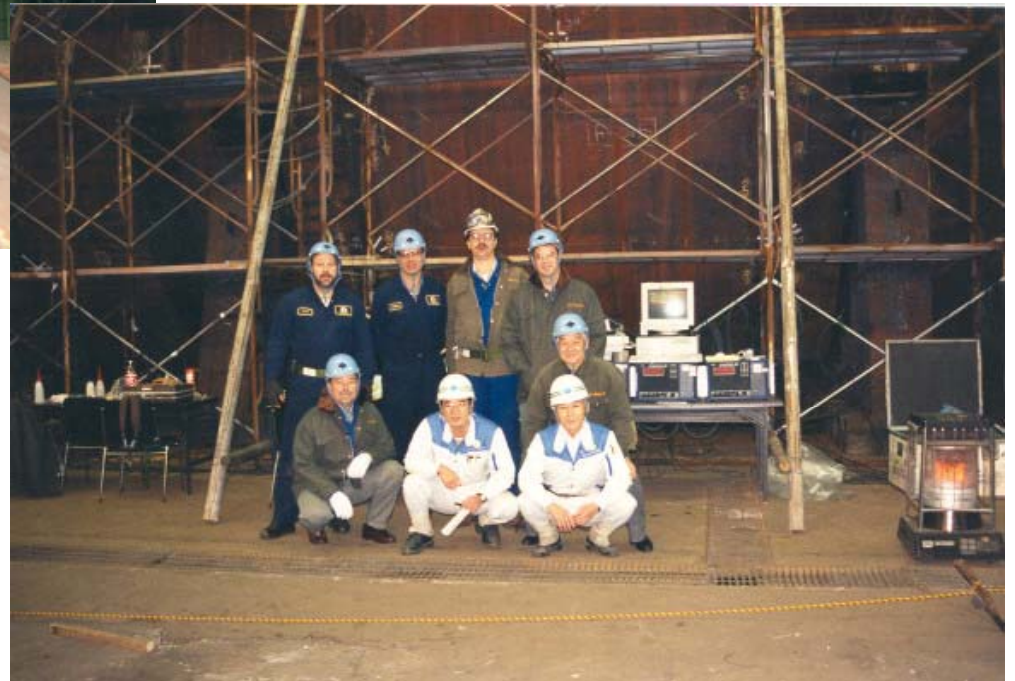
Team from Sumitomo,  
and Citgo Petroleum

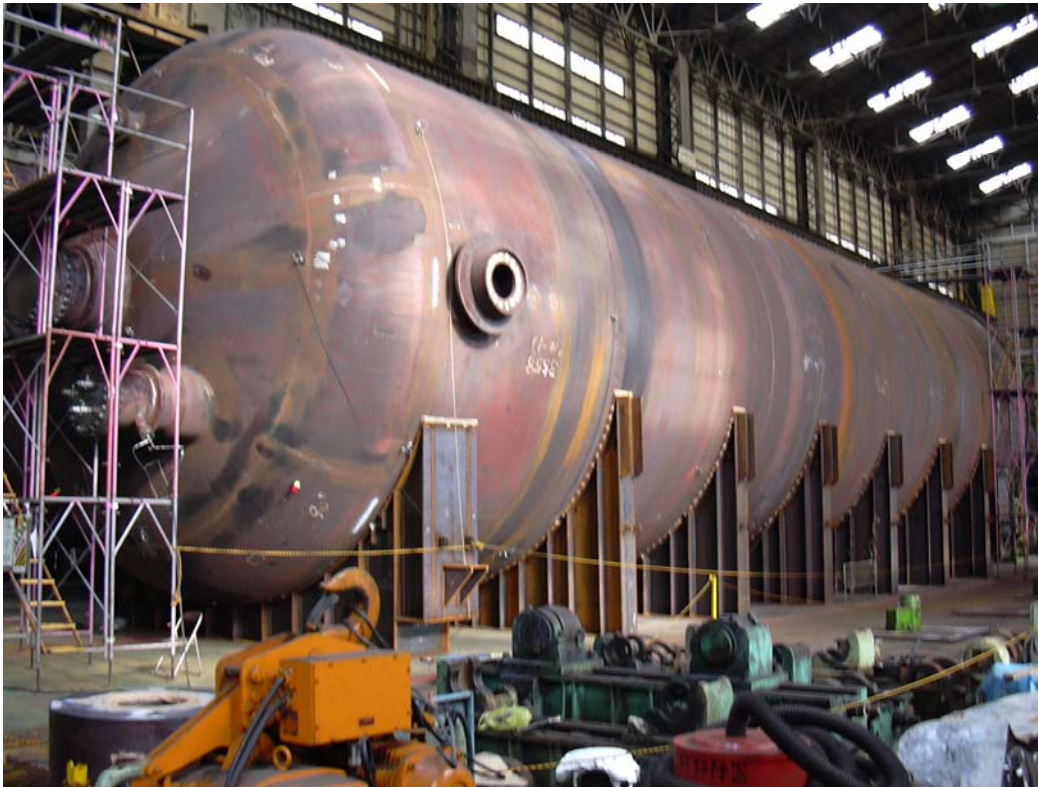
# Code AE hydrotest of new coke drums – SES' designed skirt attachment for JSW built drums for Citgo Petroleum

**Hydrostatic pressurization sequence for Acoustic Emission monitoring of coke drums  
326F201A/B and 326F202A/B at JSW's facilities in Muroran, Japan. Modified from  
ASME Div.1 code.**

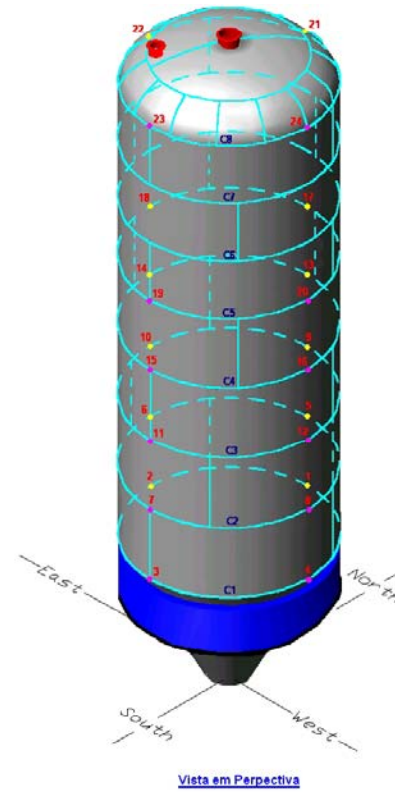
Typical AE  
transducer  
distribution

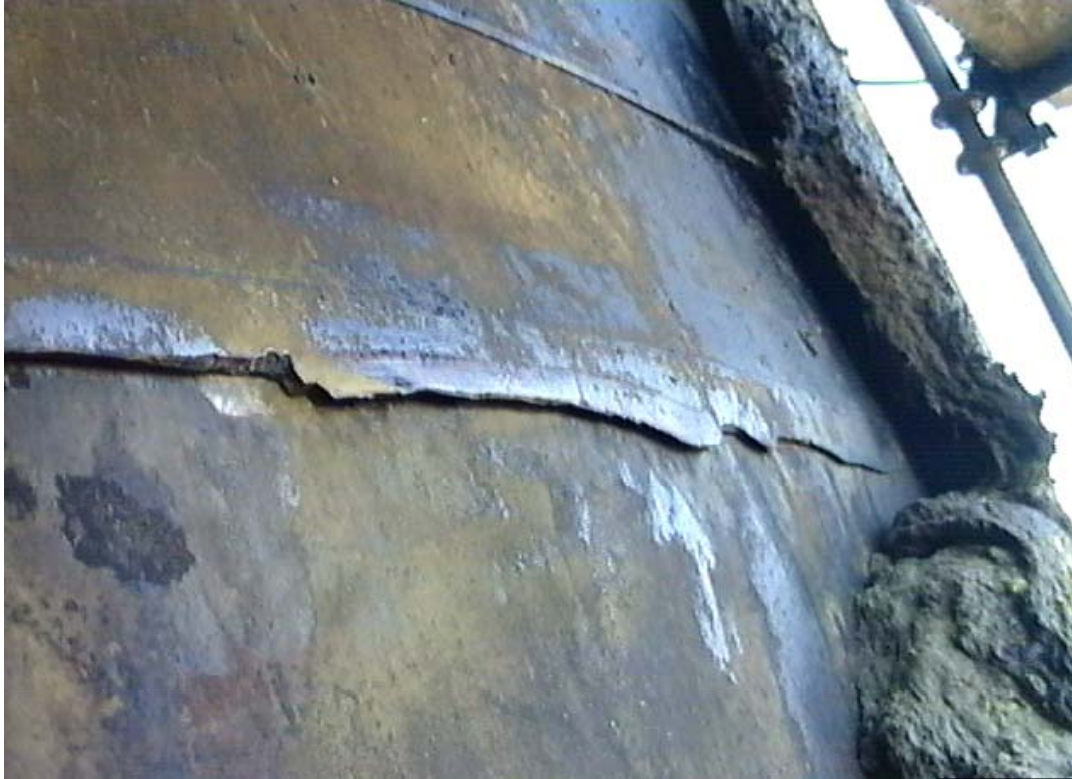
Thermally induced  
fatigue mechanism

Designed as Div.1  
vessels, without fatigue  
considerations

Costly S/D if through-  
wall cracks develop

AE used to map cracks,  
often with SG's and  
TC's.

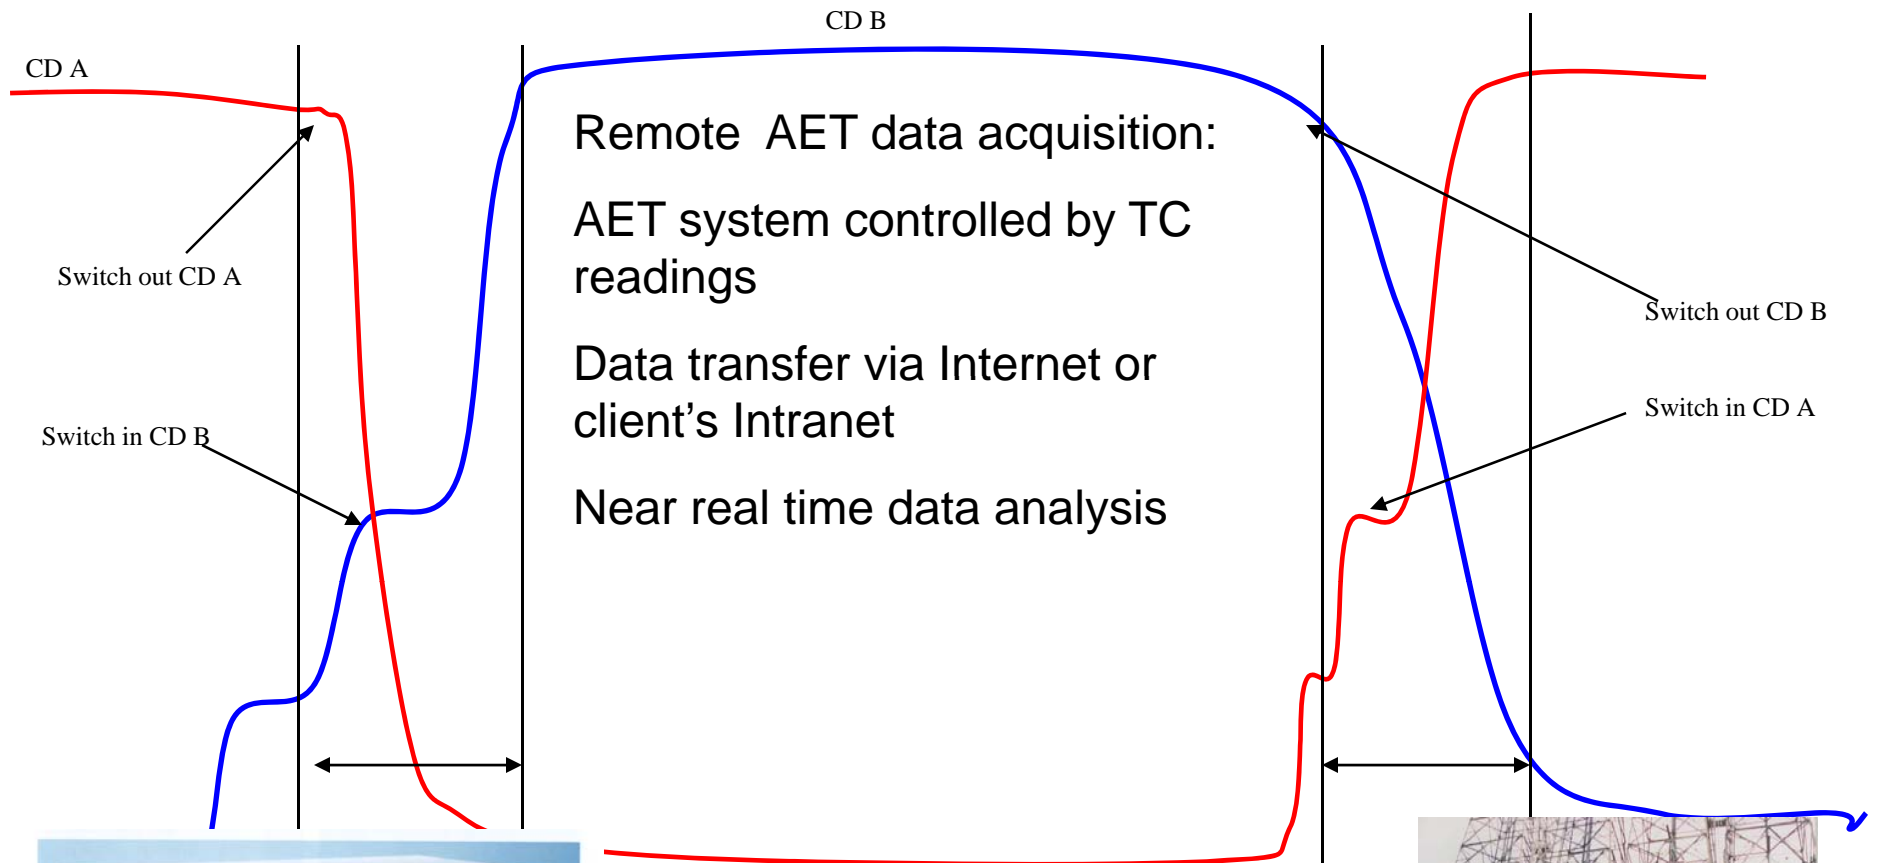
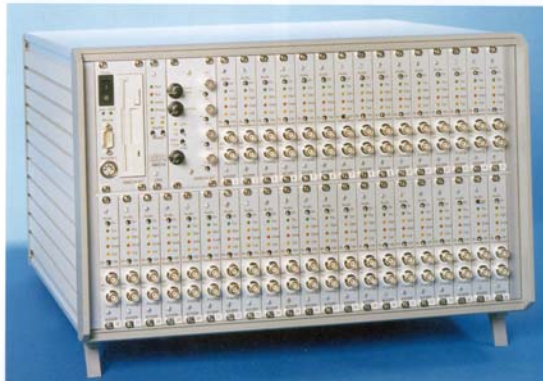
Data acquisition when TC's A and B (both)  
are above 300 F  
Two TC controlling data acquisition (TC-A,  
TC-B)  
Six TC's monitoring skin temperatures for  
thermal gradients  
State-of-the-art Digital AMSY4 Vallen  
System, remotely operated

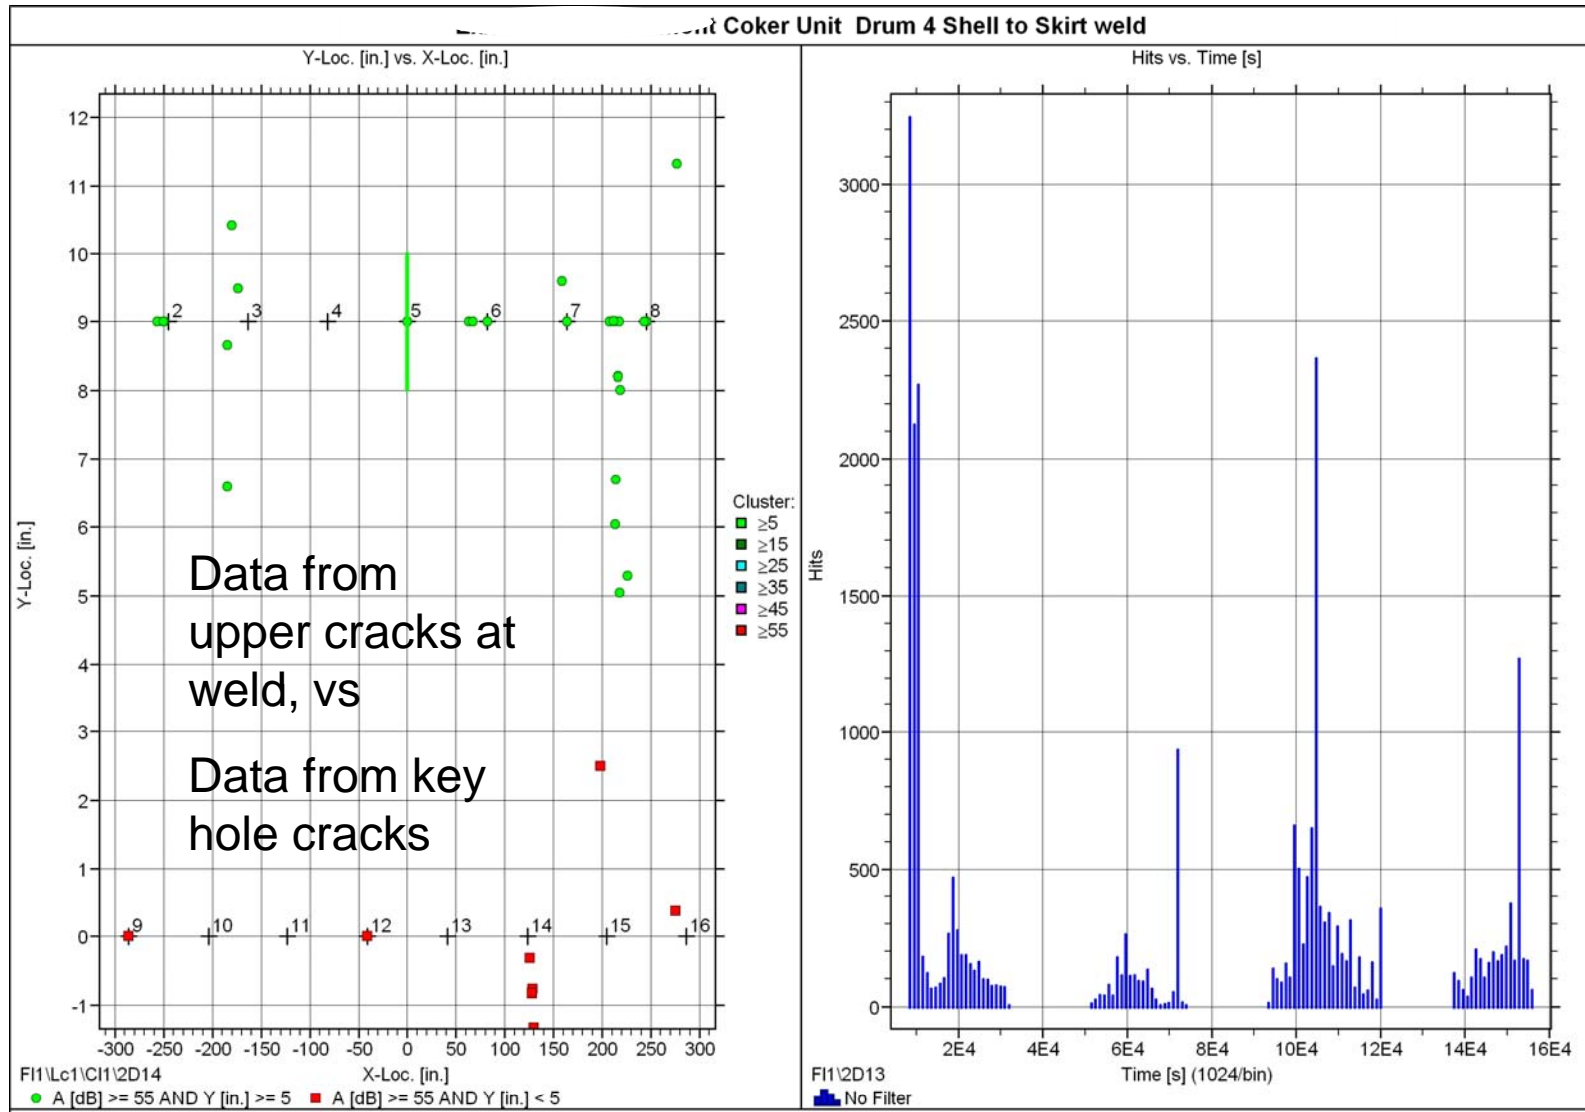
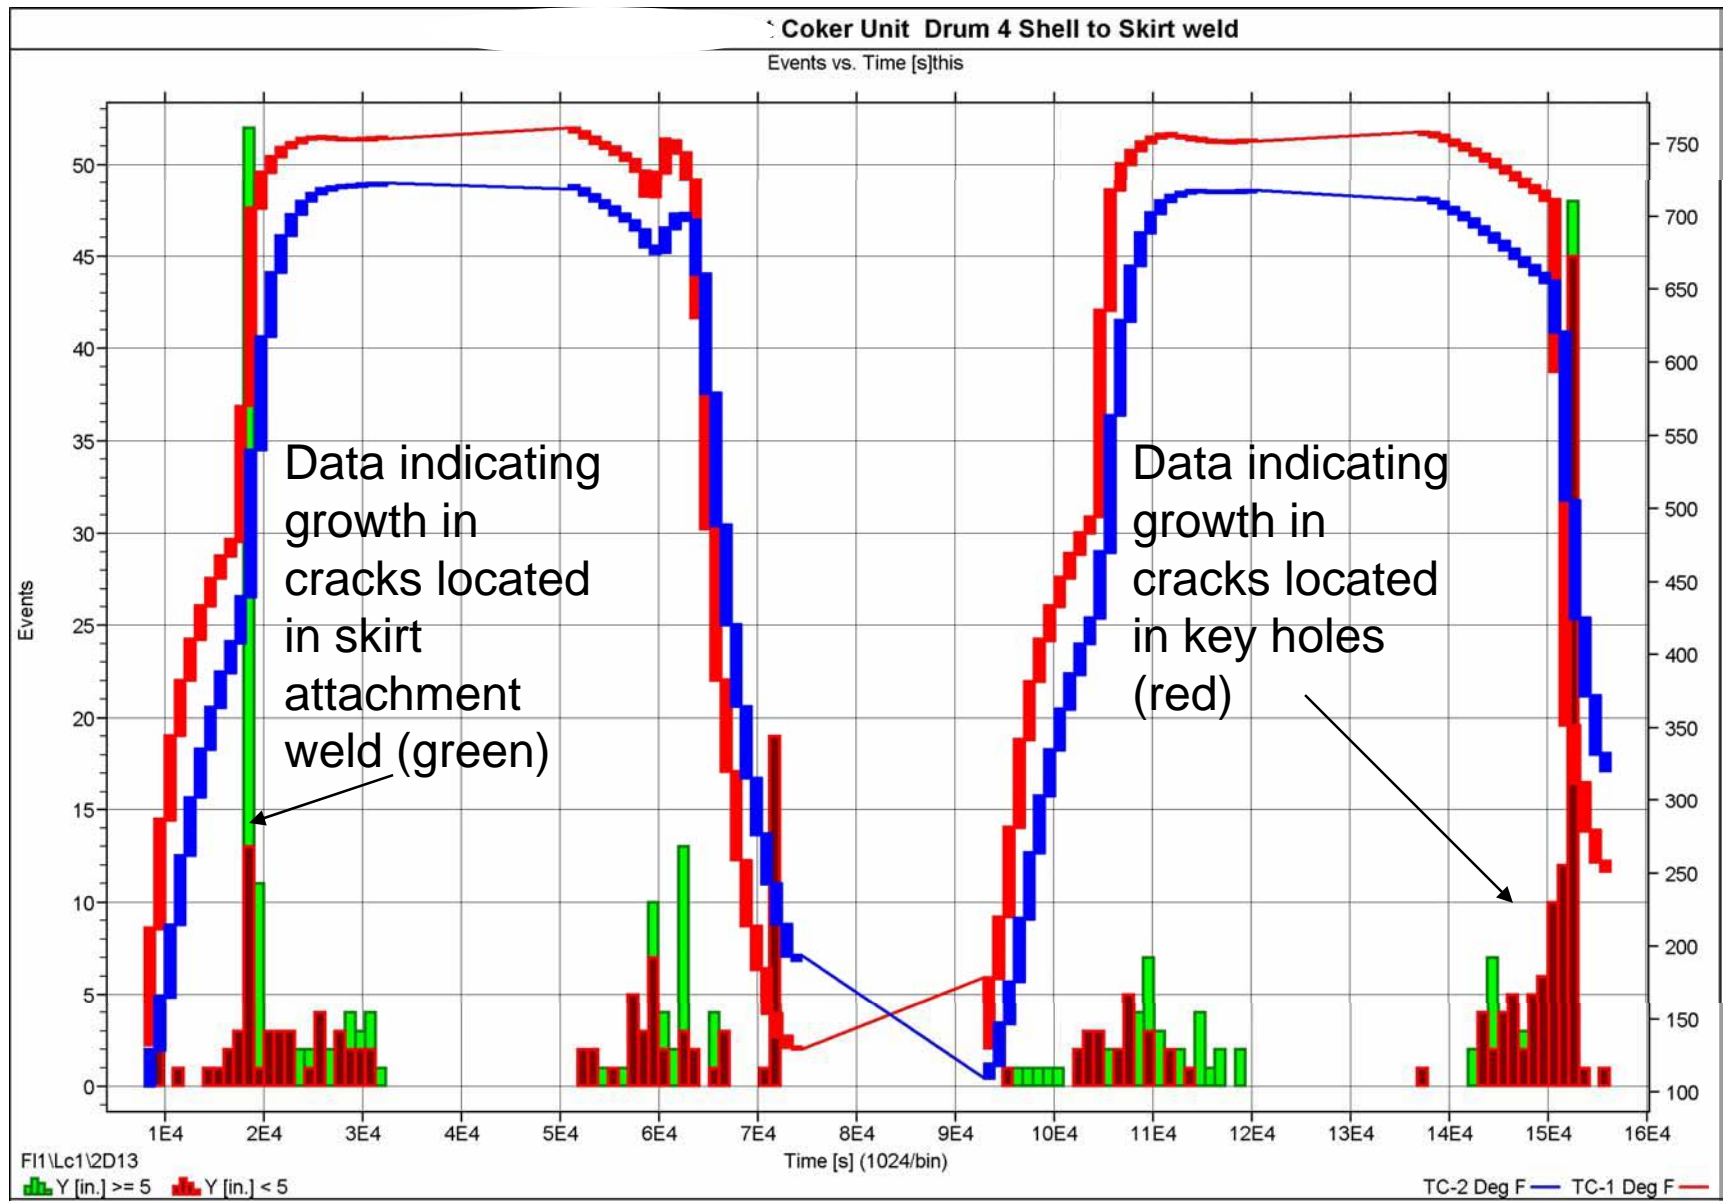
- Cracked skirt attachment weld
- Cracks in “key hole” slots
- Client need to know if and when skirt cracks are growing
- AE needs to separate AET signals from these 2 elevations (9” apart)

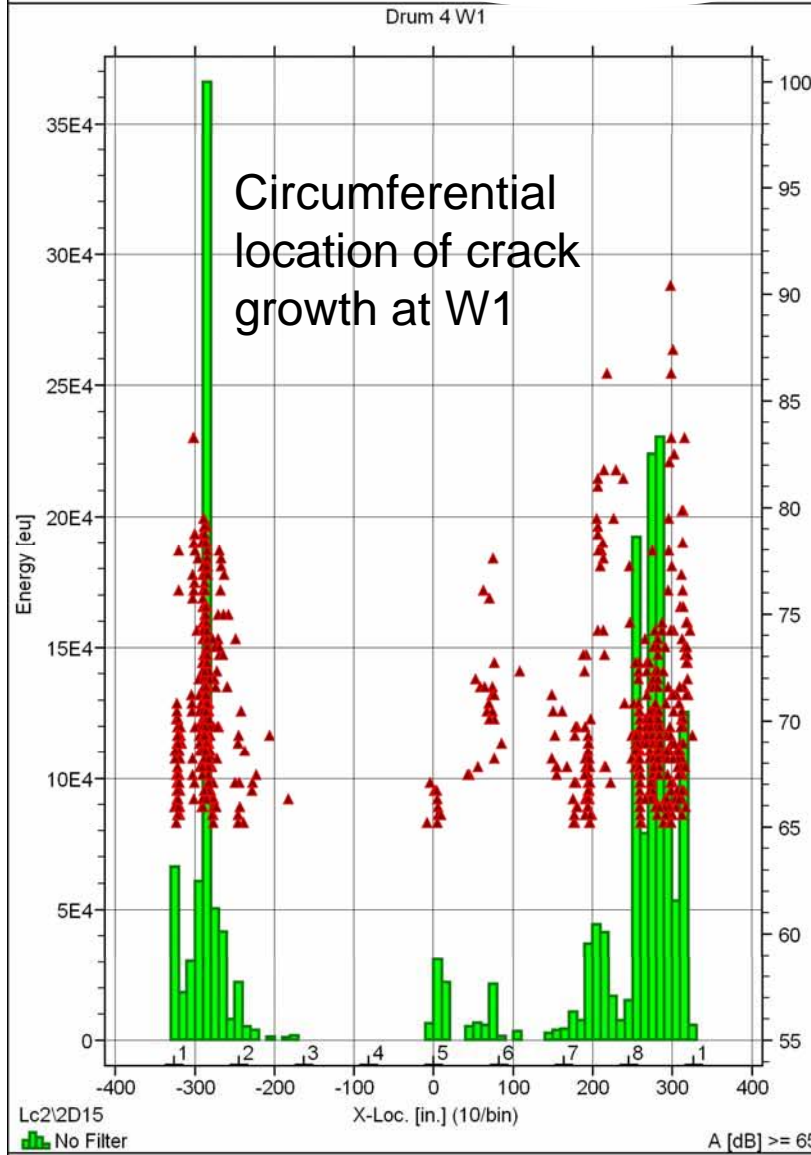
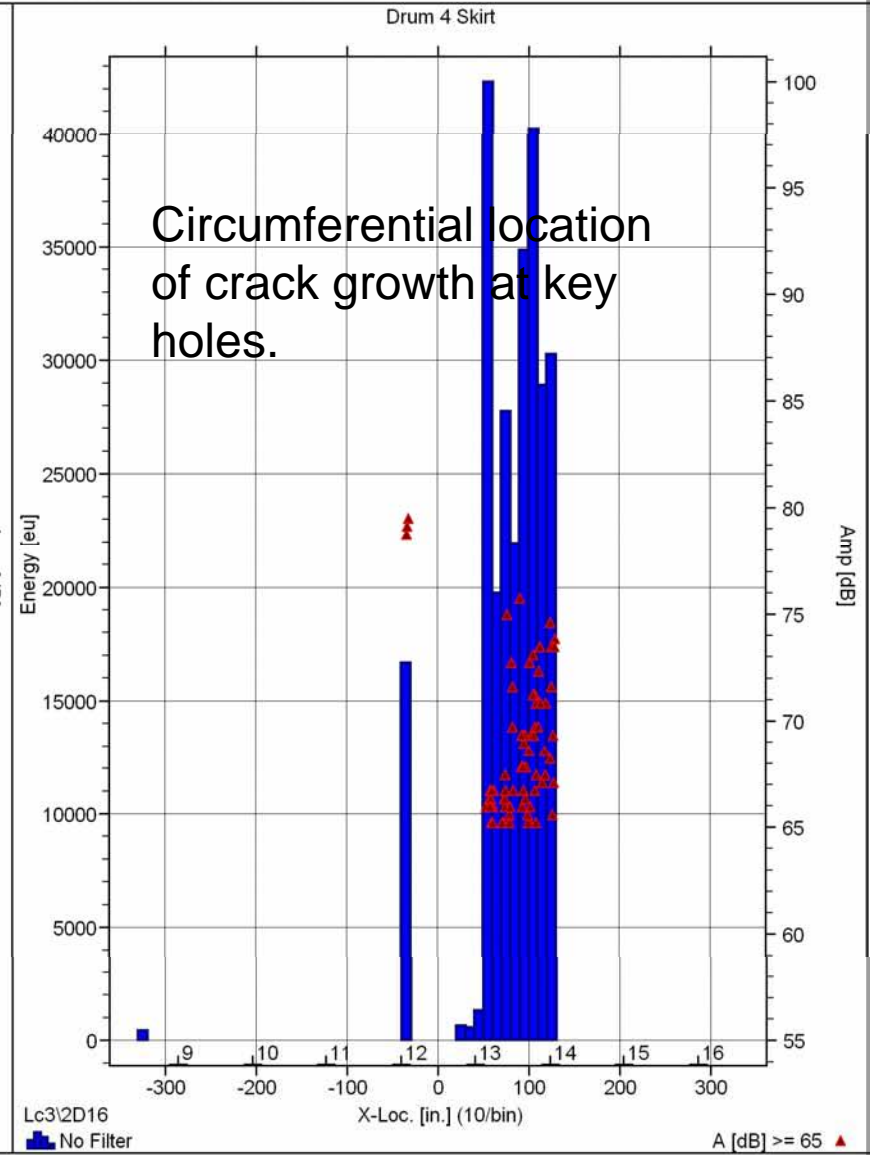
# Hot Coker Unit Drum 4 Shell to Skirt weld

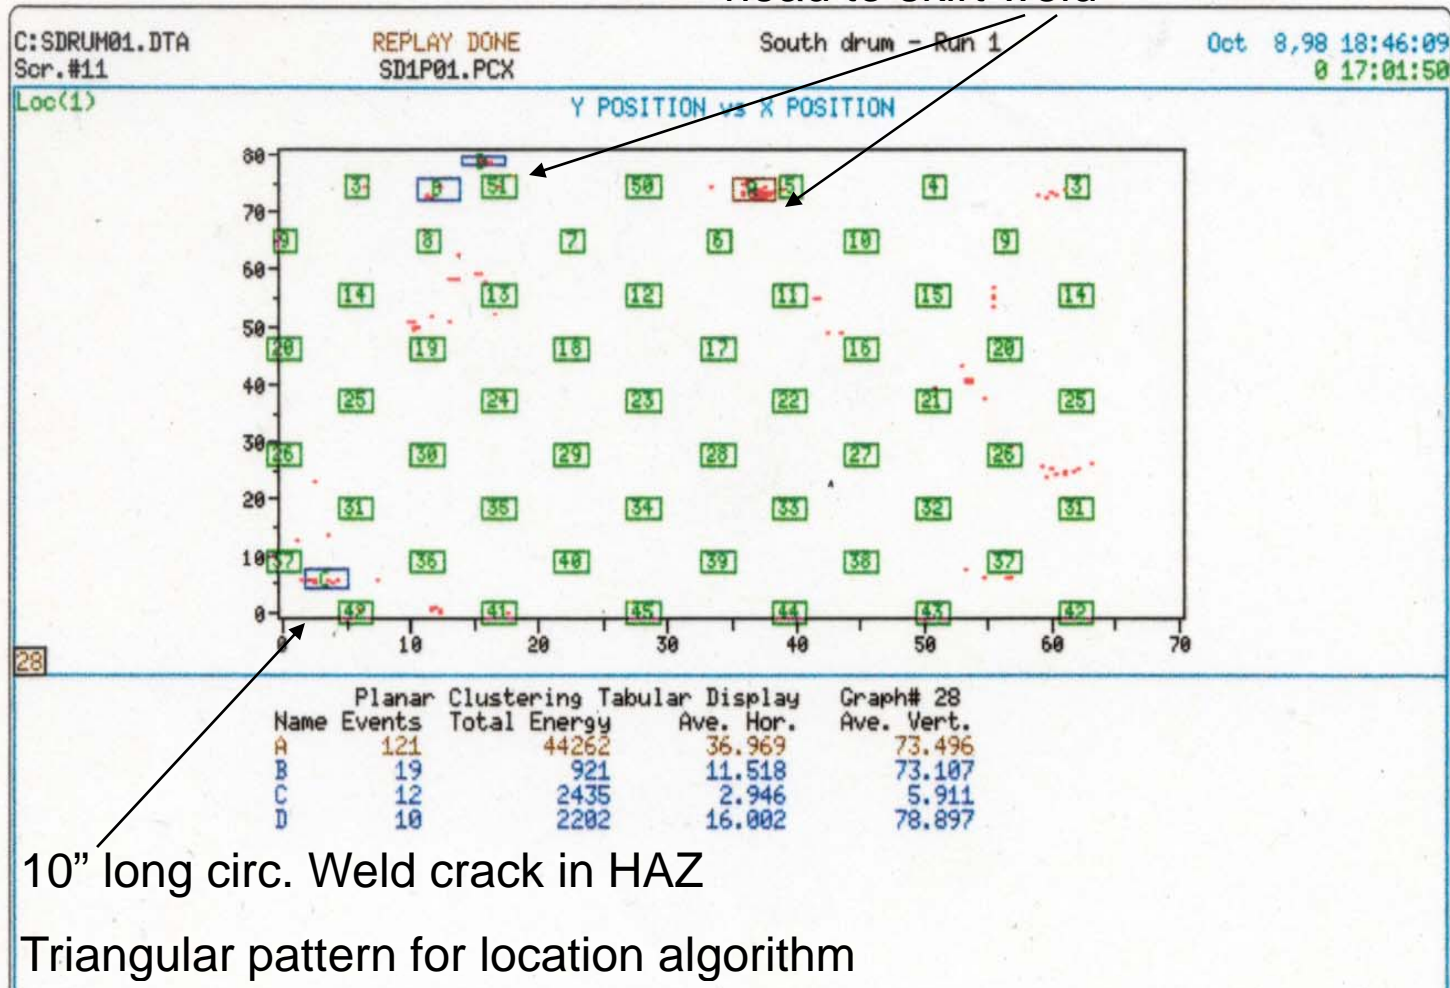
- In-service monitoring of coke drum for 6 cycles.
- Rare design with top derrick supported by top head by means of a cylindrical skirt.
- Significant cracking found at top skirt-to-head attachment welds
- Difficult location to inspect, not planned.

Severe cracks in top  
head to skirt weld

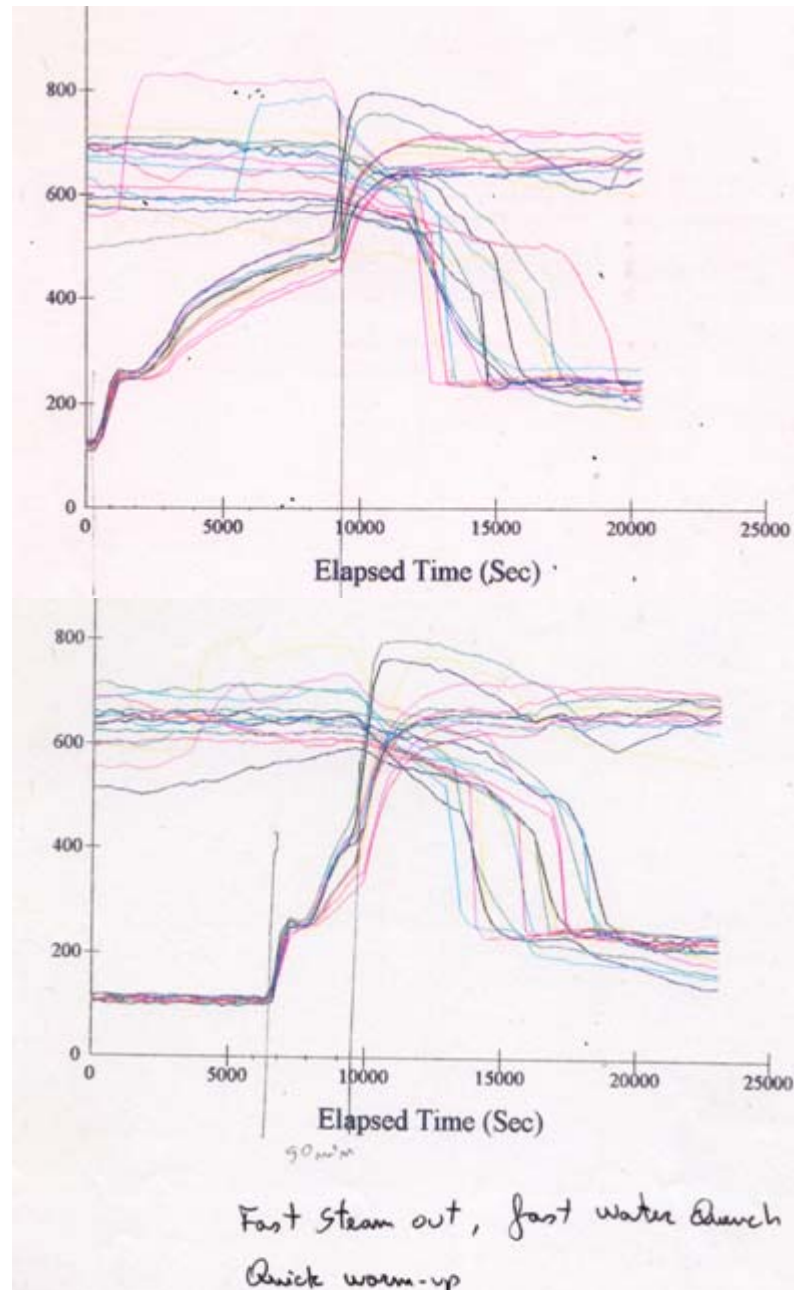
US West Coast refinery  
Wanted to know what would  
Happen if “heat-up” times  
Were shortened by 2 hrs.  
AET and SG indicated  
No significant damage being  
Caused by operational  
change

Shell thermocouples only

- Owner wanted to investigate consequences of reducing heat-up time from 3 hr to 45 minutes
- AET and strain gages were used to measure short term (immediate) consequences
- Results indicated no significant changes on AET activity level and strain magnitudes (not a long term assessment)
