Coke Drum Workshop and Safety Seminar

# Using Acoustic Emission Testing to inspect Coke Drums

**Presented by: Claudio Allevato**

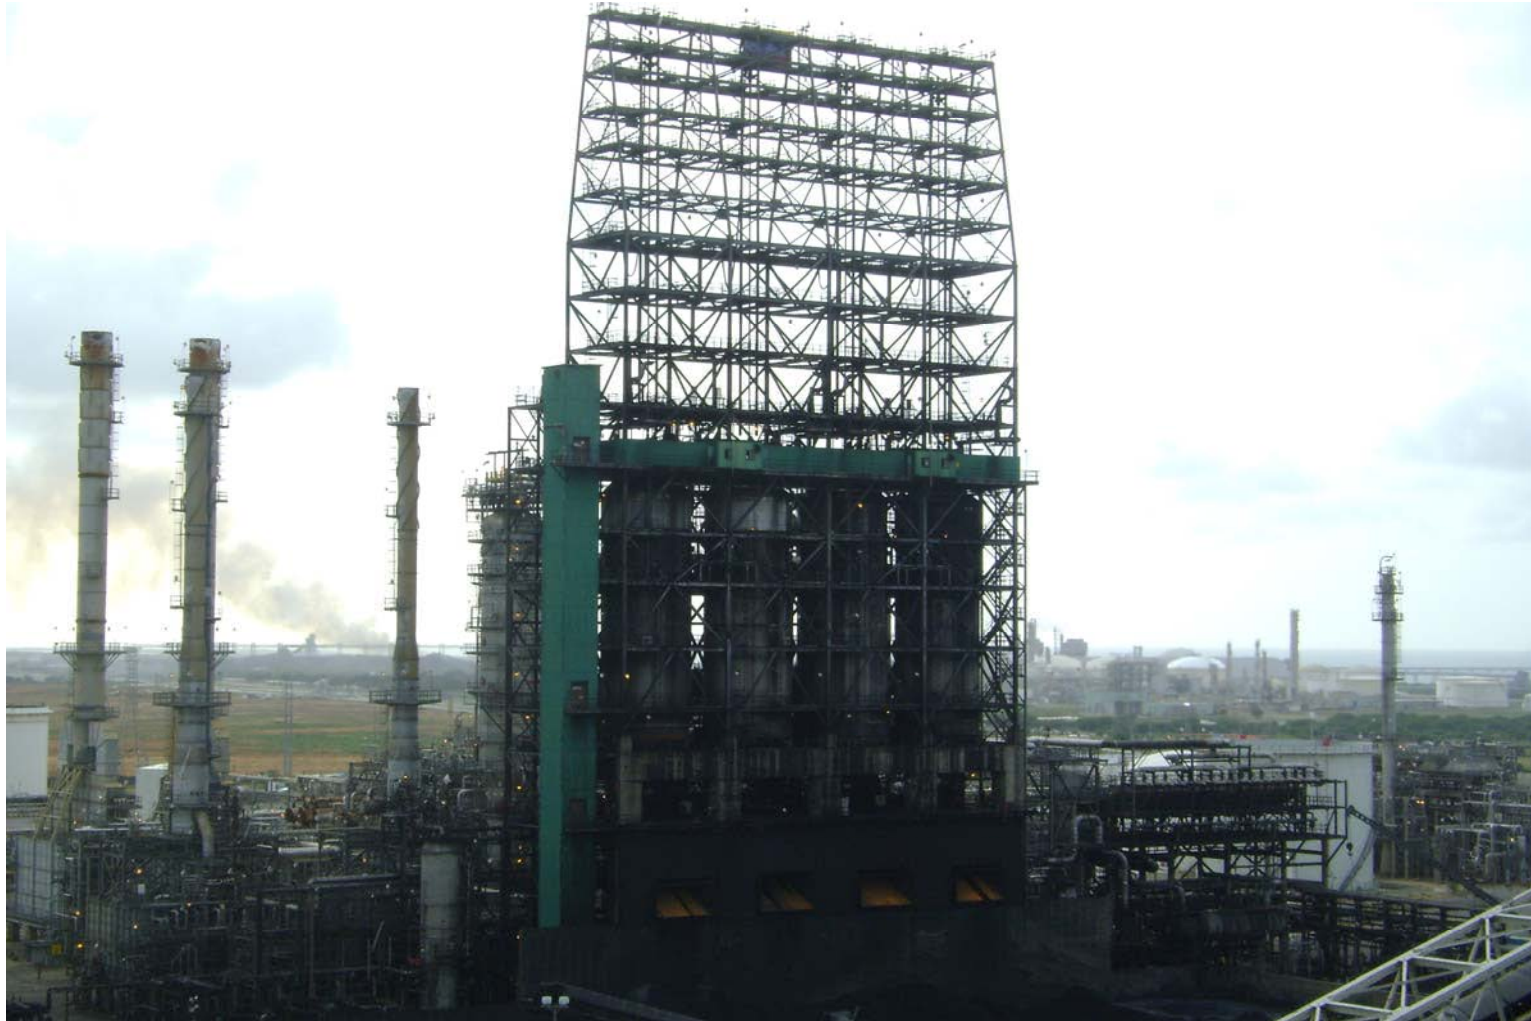
# Four coker unit

- New coker unit with severe vibration issues causing mechanically induced fatigue cracks on overhead vapor lines and nozzles, and foam injection piping.
- Three through-wall failures prior to AET monitoring activation on August 2006.
- AET continuous monitoring have warned of other cracks, which were promptly repaired between cycles. No other failure as of today.
- SES is currently installing mechanical remediation to reduce vibration.

# Overhead piping system in Coker Unit subjected to vibration induced fatigue cracking
