# Costly Lessons Learned from Inspection Pitfalls of Coke Drums

RefComm  
2019  
Galveston, TX

Mahmod Samman, Ph.D., P.E.  
Houston Engineering Solutions, LLC  
(+1) 832-838-4894  
[info@hes.us.com](mailto:info@hes.us.com)

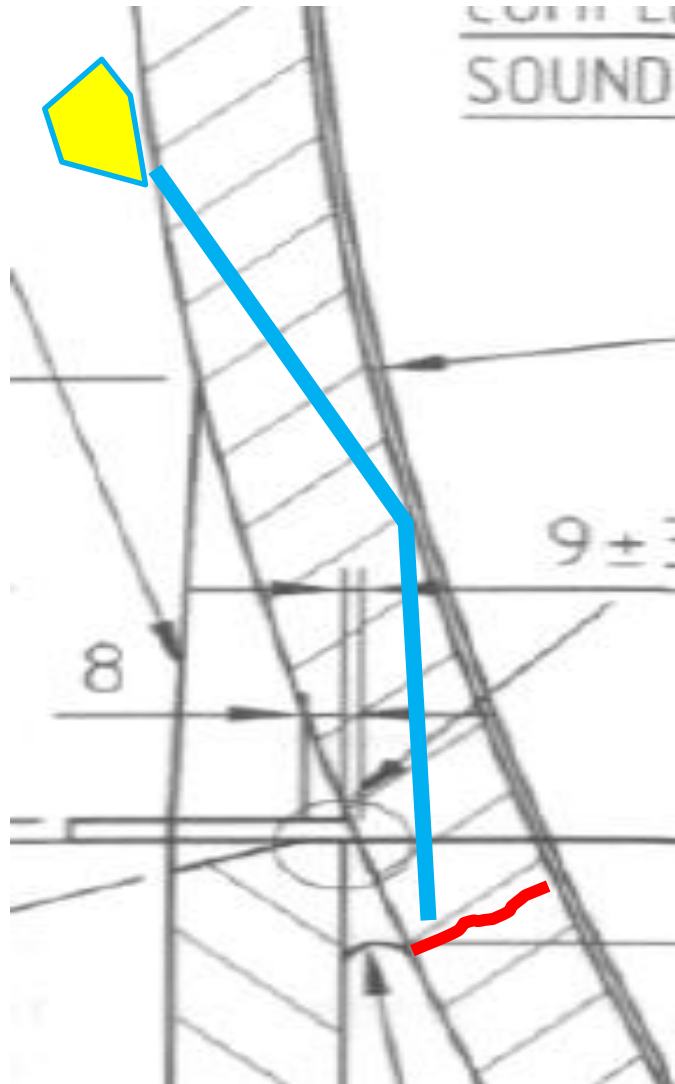
# Case Study

Through-wall crack not detected
