Life Cycle of Delayed Coker Heater Tubes – An Experience

Sujal Surendran
Section Head - Static Reliability
Reliance Industries Limited

- Coker unit of Reliance Industries Limited, Jamnagar-Gujarat DTA Refinery was commissioned in Year 1999.
- Gradual thickness loss from inner wall has been observed in radiant section tubes of the heater coils.

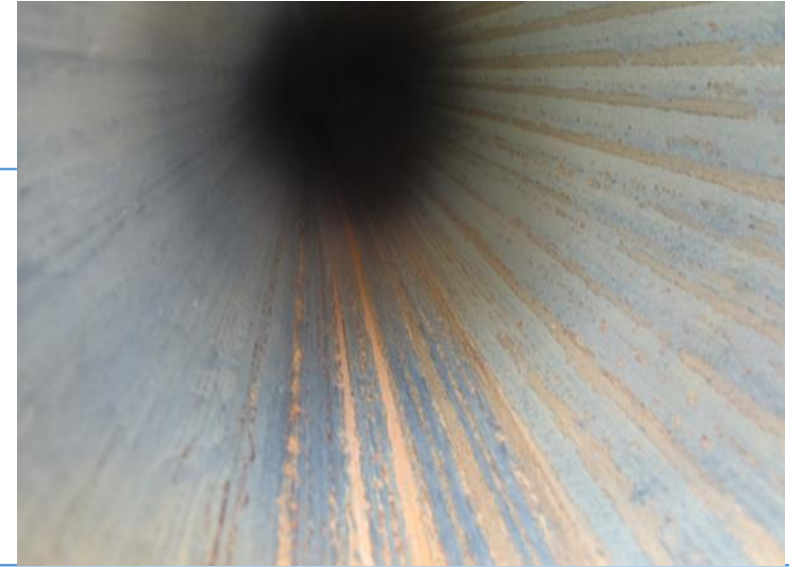
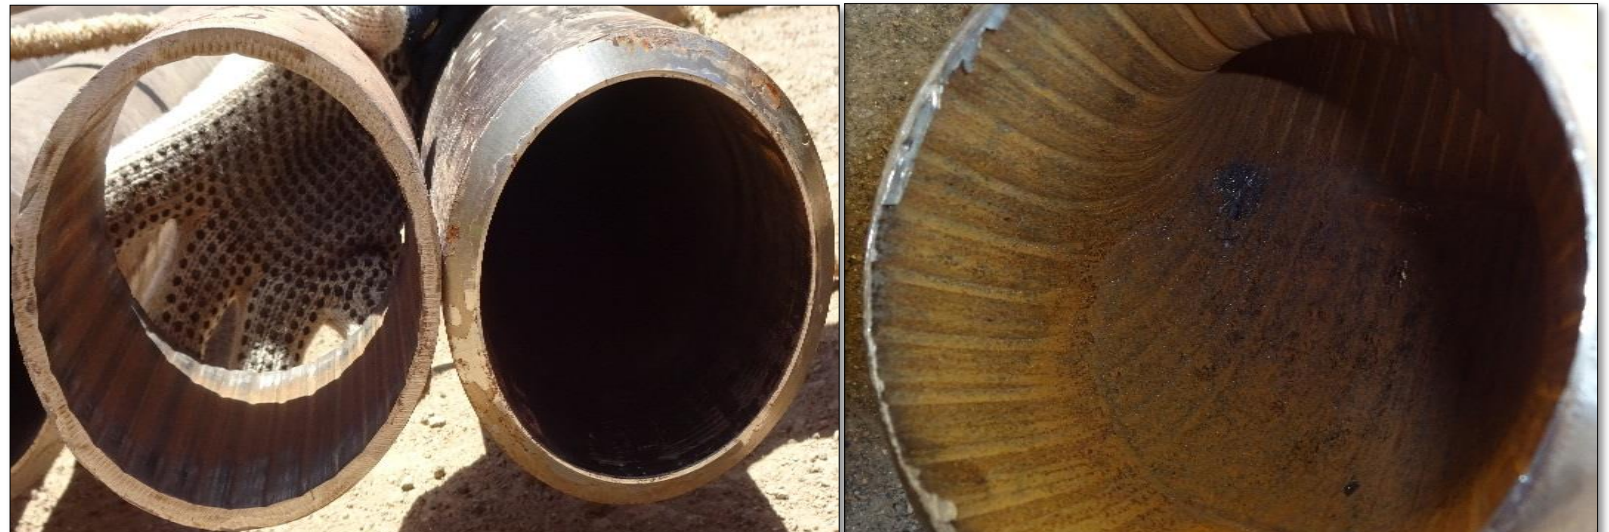
WHY ACCELERATED WALL LOSS?

Hot Sulfidation

- Corrosion of alloy steel by sulfur compounds in high temperature environments.
- Coke deposit is expected to reduce corrosion rate.

Wall loss due to pigging

- Grooves observed on tube ID. Scraper Pigging removed sulfide scales exposing fresh metal again for corrosion again
- **Major contributor for wall loss.**

- Pigging should be done and controlled properly to prevent scrapping of parent metal.
- Periodic thickness mapping/NDT inspection is useful for trending the thickness loss. This can help to decide the tube procurement and replacement well in advance.
- Videoscopy of tubes can indicate metal loss on tube ID due to scrapper pigging.
- Prefabrication (preparation of full length tube) can help to minimize field work and also reduce shutdown time.
