Failures in Coke Drum Overhead Piping

Delayed Coker Unit

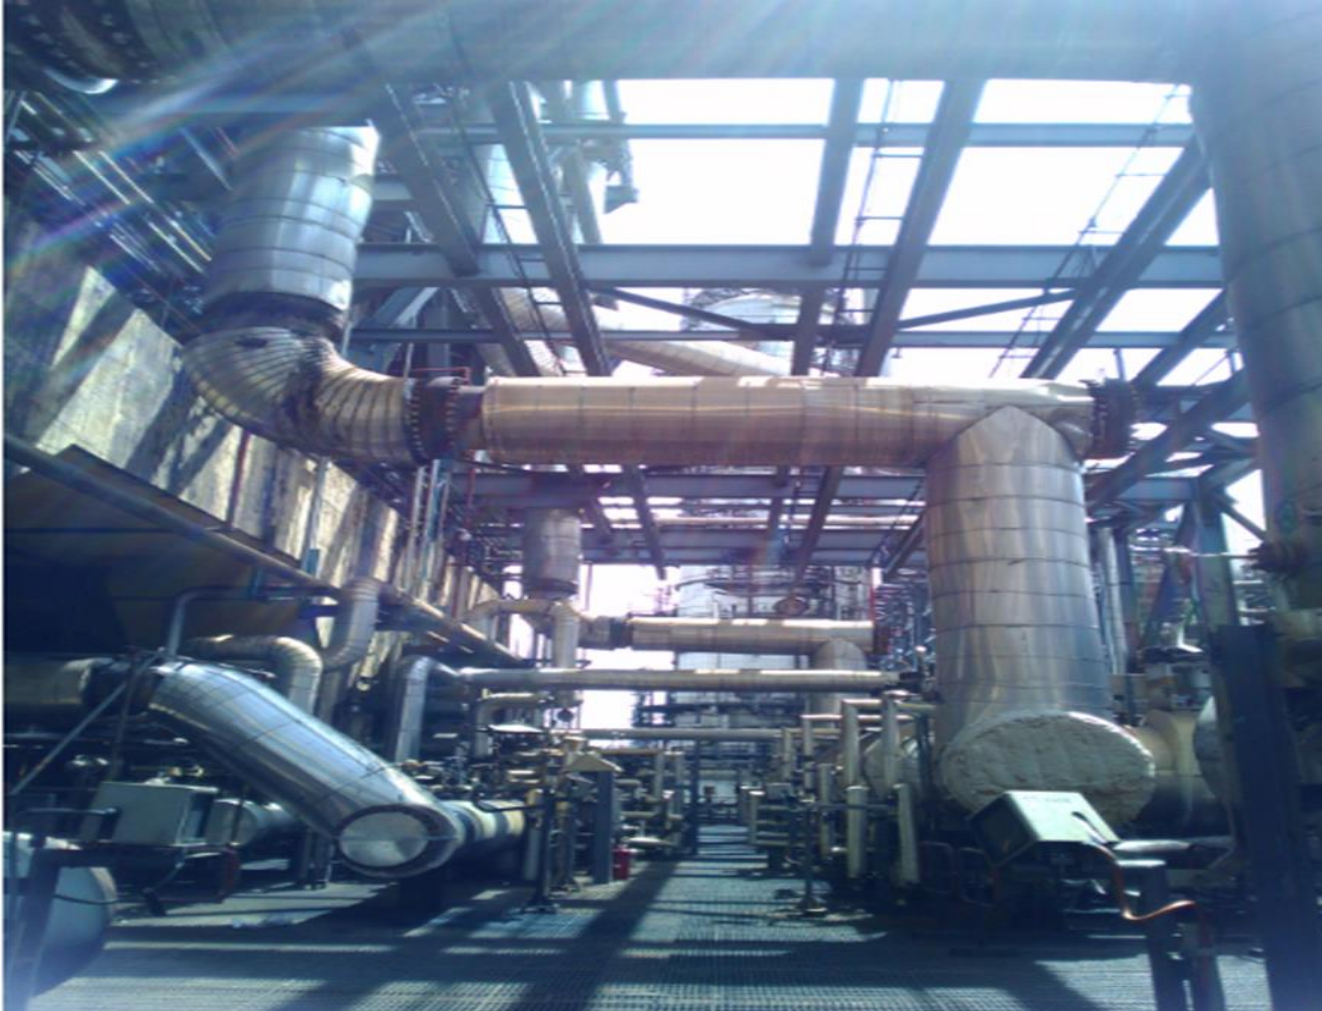
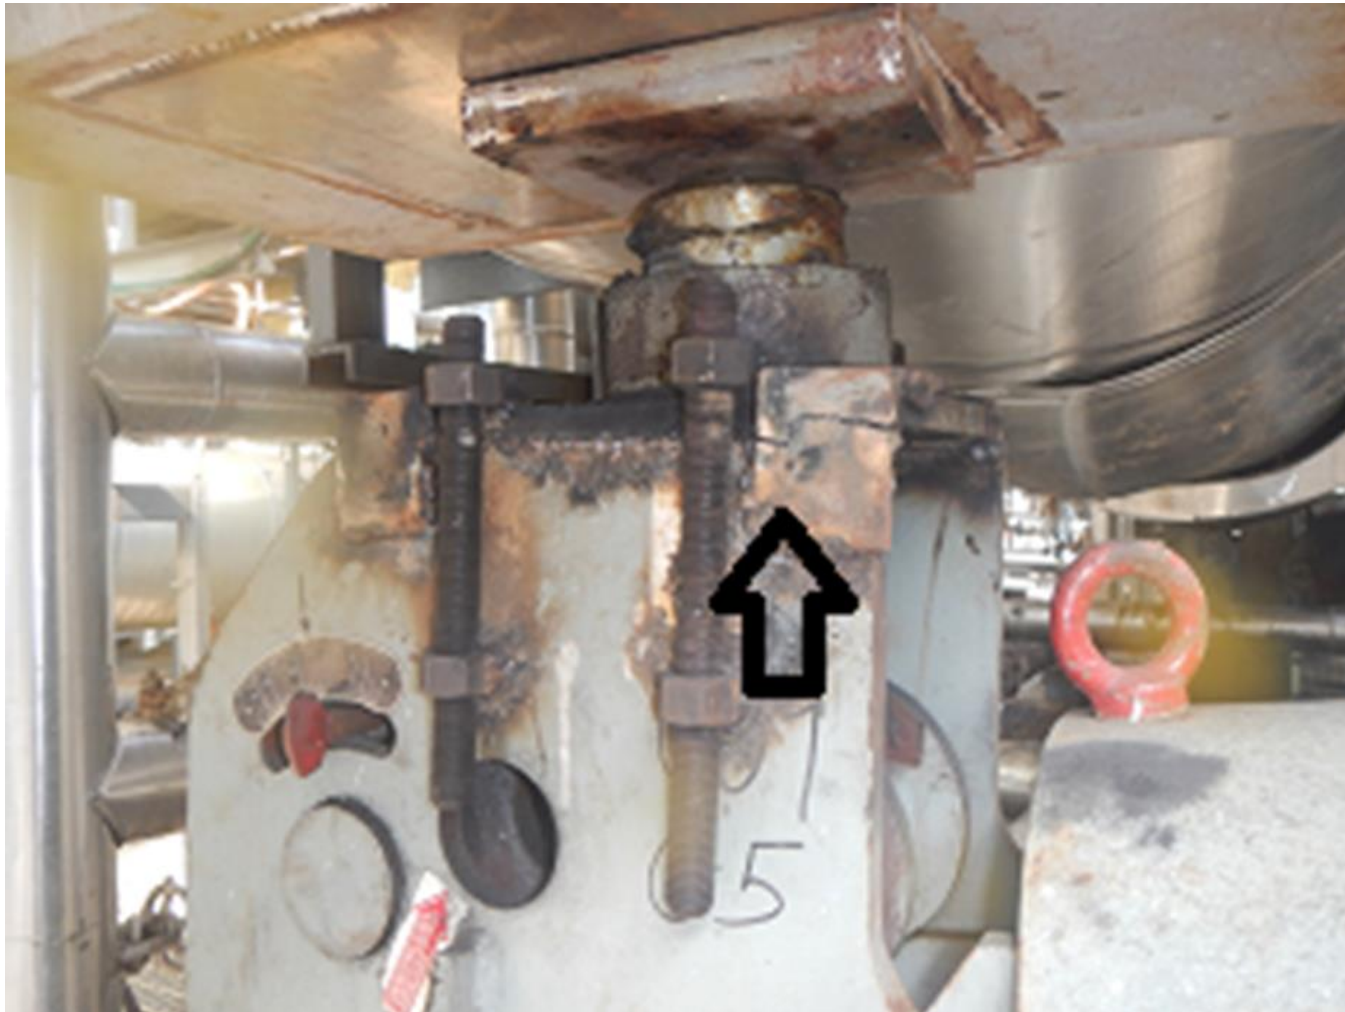
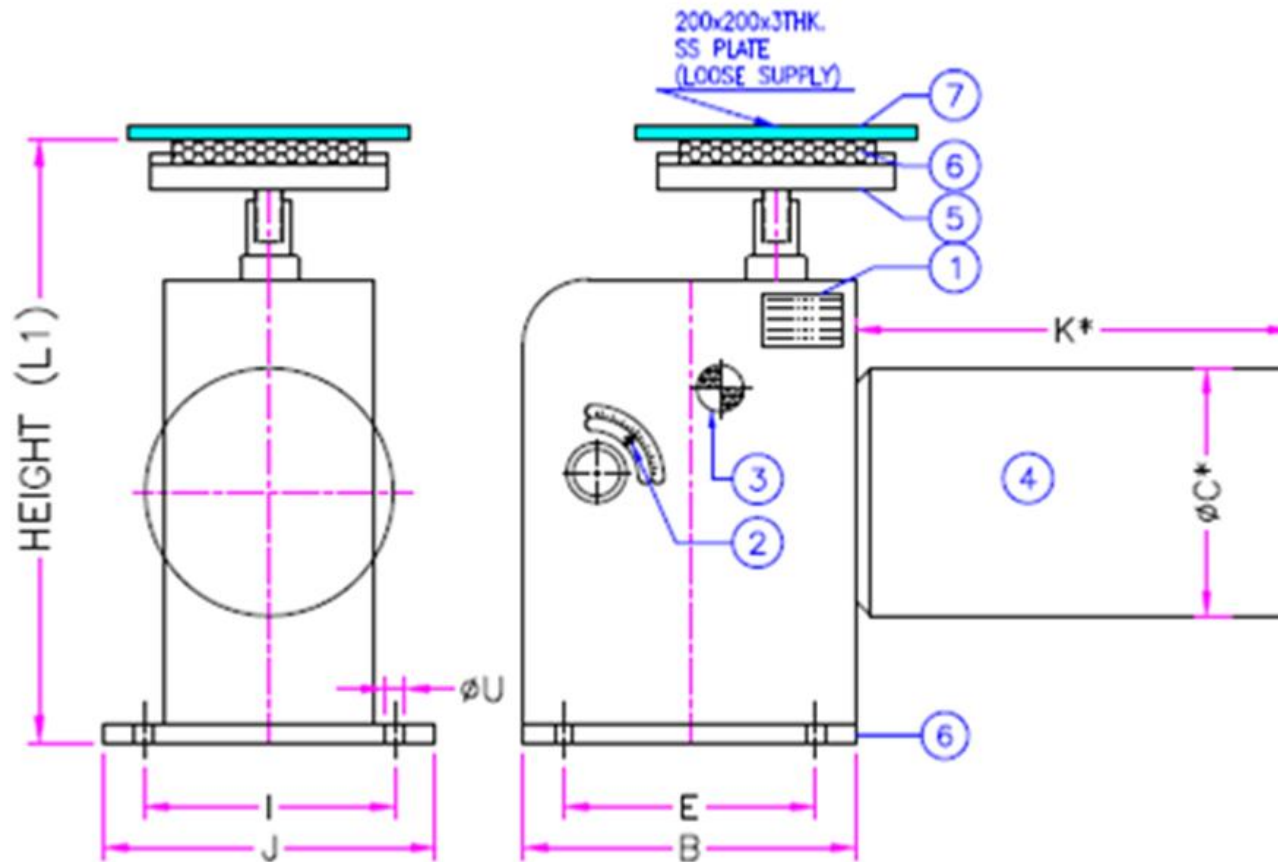
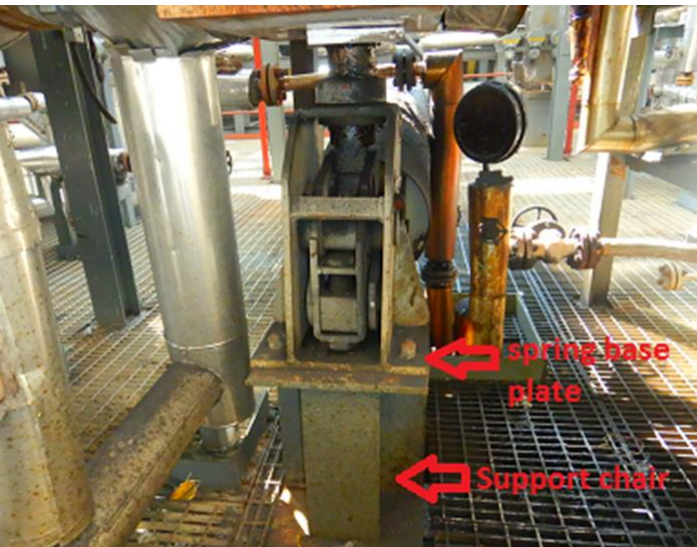
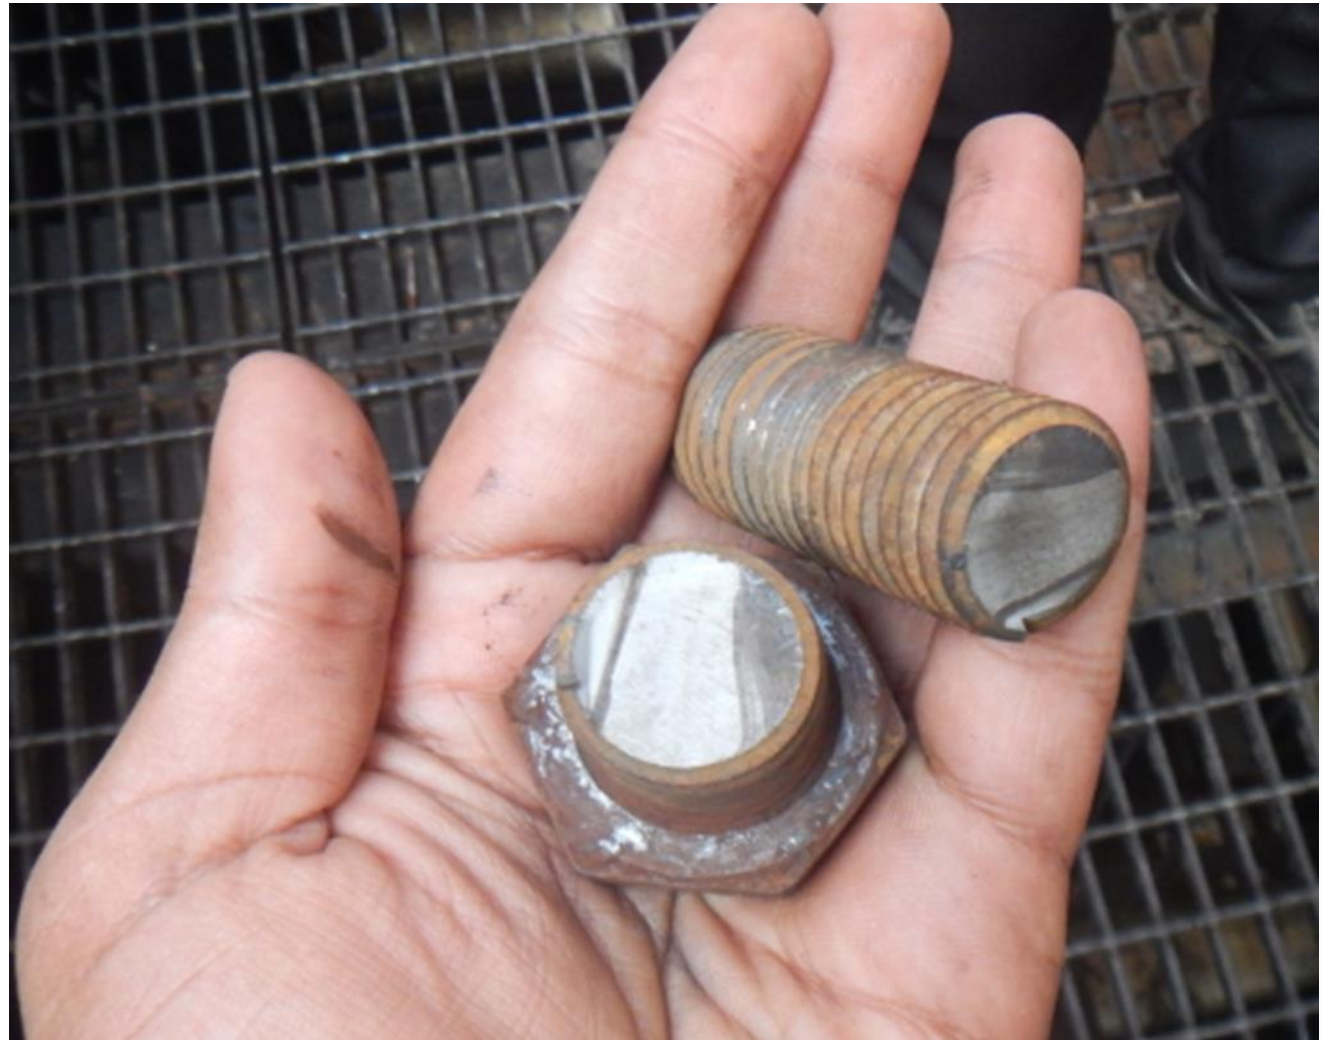
Failure Case-1

Crack was observed in spring support of 36 inch coke drum vapor outlet line at Bottom Unloading Device platform

Spring is CAN type Constant Spring support.
36 inch pipe MOC is Alloy P9, insulated.

Graphite pad provided between flange load and pipe support was found damaged.

Vibration was found transferred to the spring support during coke cutting cycle.

Primary damage mechanism is fatigue crack due to transmission of vibration from 36 inch coke drum vapor outlet line to spring support.

Replace the damaged CAN type spring support.

Mirror finished SS plate/ roller type flange load shall be provided between support and load flange.

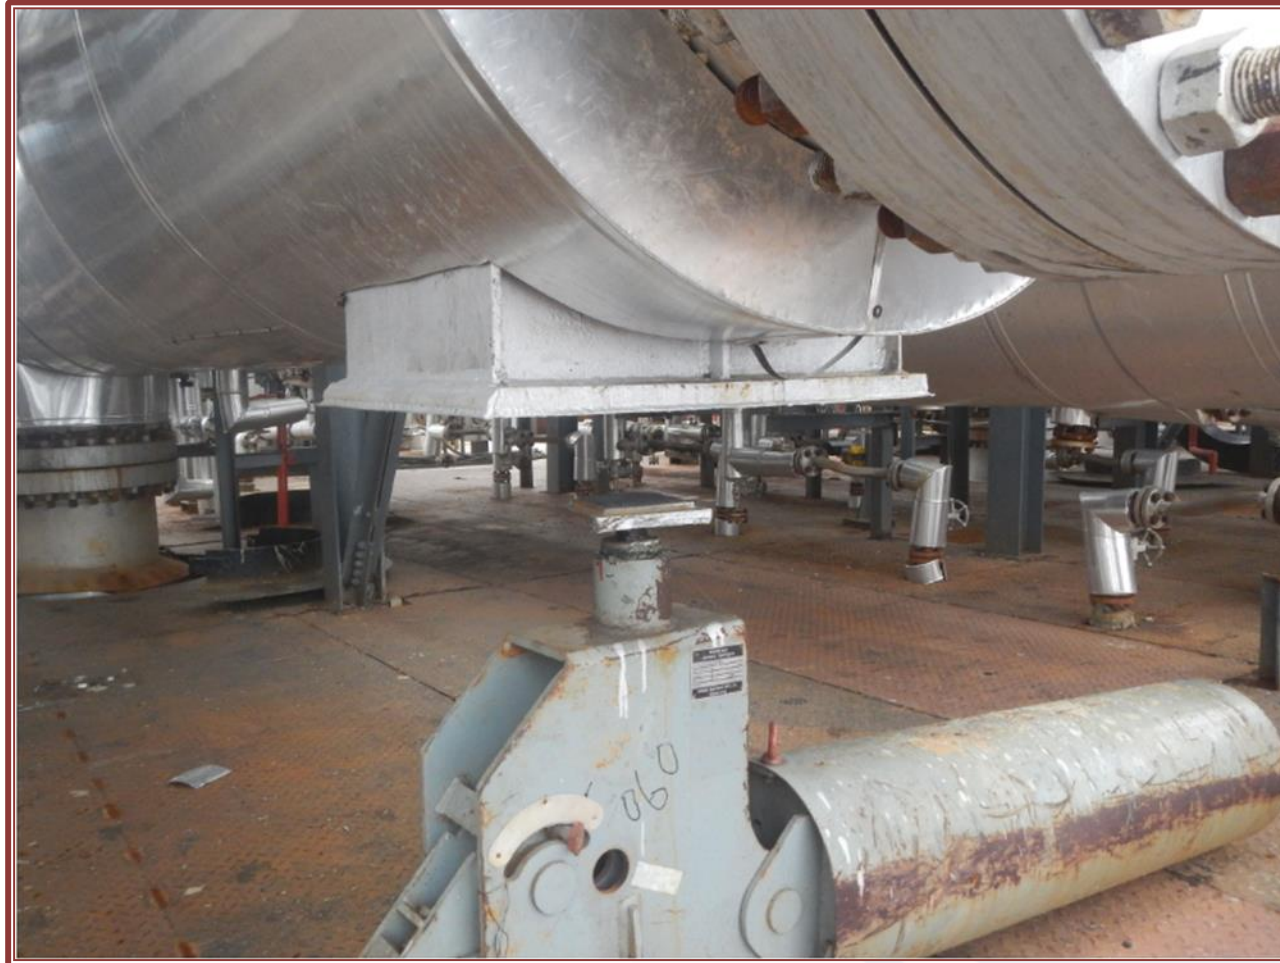
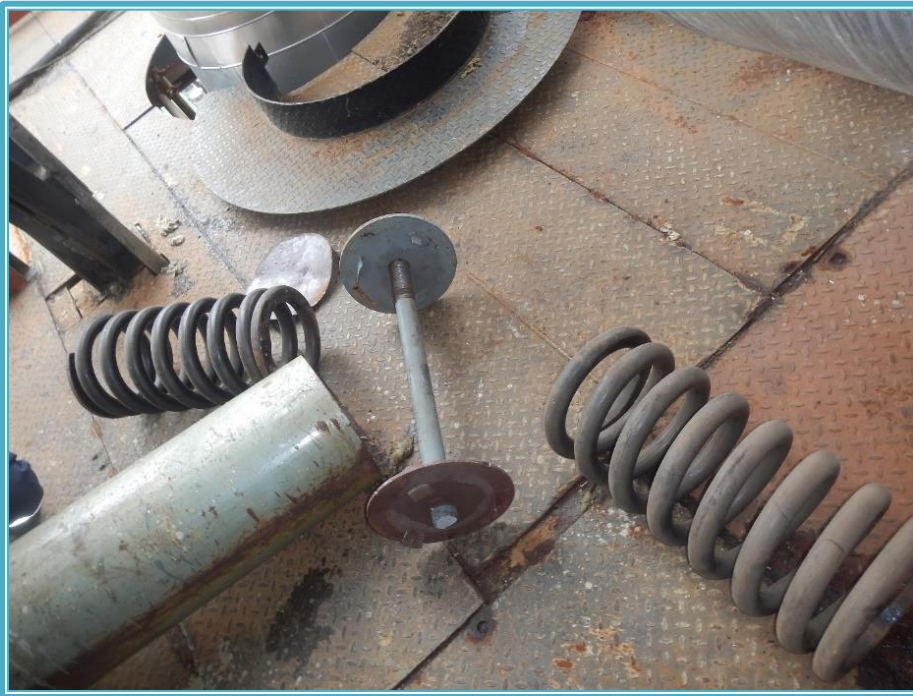
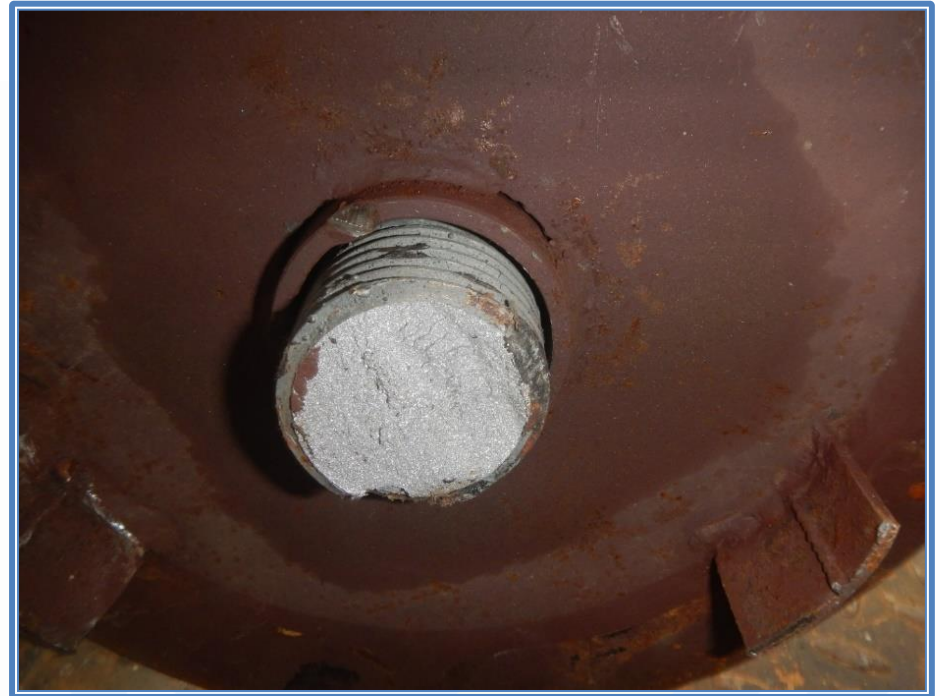
Failure Case-2

Failure of spring support in 36 inch coke drum overhead PSV outlet line .

Spring: CAN type and Constant spring support.

Pipe : Alloy P9 with insulation.

Failure was happened due to inadequate functioning of CAN type spring support

Due to dust environment, the load flange spindle got stuck and hence spring was not able to function properly.

At some point of time, spindle may get released due to any jerk and got hit on overhead line leads to spindle failure.

CAN type spring support shall be replaced with Hanger type spring supports.

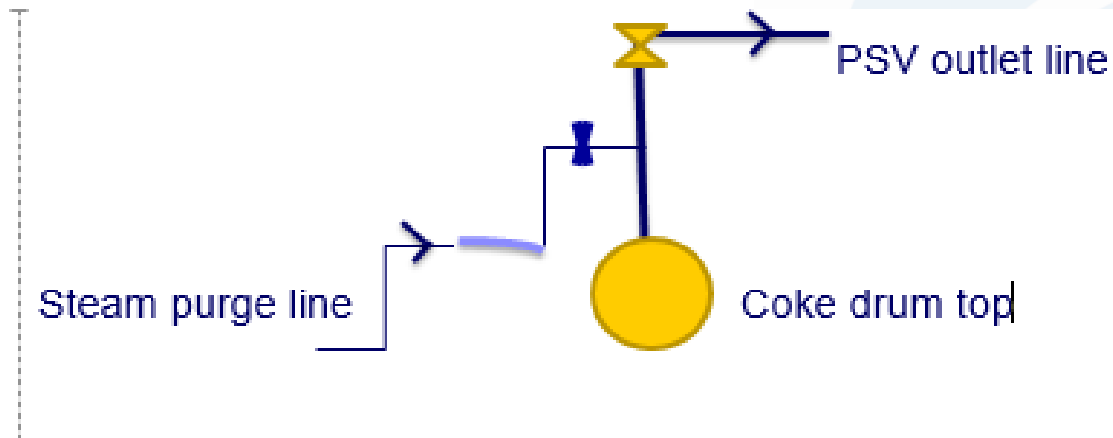
1 ½ inch MP steam purge line to coke drum overhead relief valve line was found failed due to weld crack in half coupling .

Vibration was noticed in small bore piping.

Flexible braided steam hose connected to the 1 ½ inch MP steam line was found damaged and broken

Provide two numbers of stiffeners at 90 degree apart for small bore piping at TUD to impart adequate stiffness to branch connections

Relocate flexible hose on purge steam line towards upstream of isolation valve.

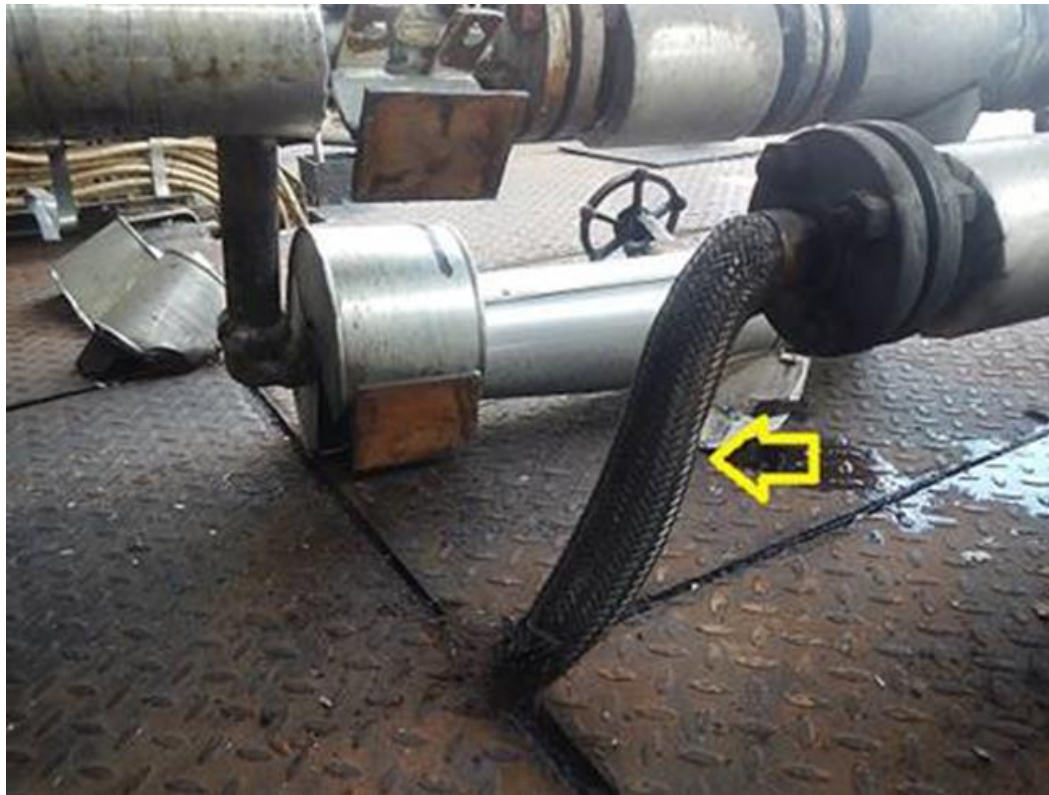
Failure Case-3

- Failure of 1.5 inch steam purge line in coke drum overhead PSV outlet line.
- MP steam purge line: Alloy P9
- Coke drum overhead line : Alloy P9
