TUBACOAT

**ANTI-COKING SOLUTION FOR FIRED HEATERS
IN DELAYED COKER, VISBREAKER & VACUUM DISTILLATION UNITS**

RefComm 2020
September 16, 2020

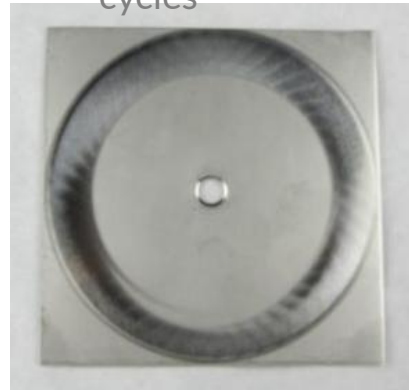
Abrasion resistance
≈ 94% decrease in mass loss

0 cycles

10.000
cycles

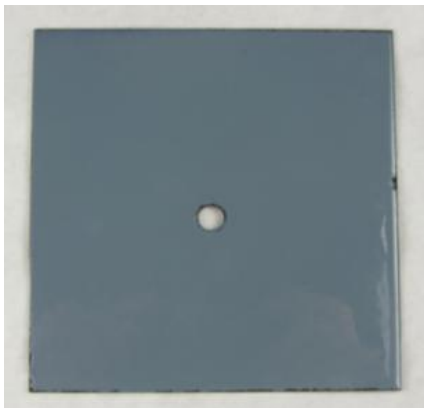
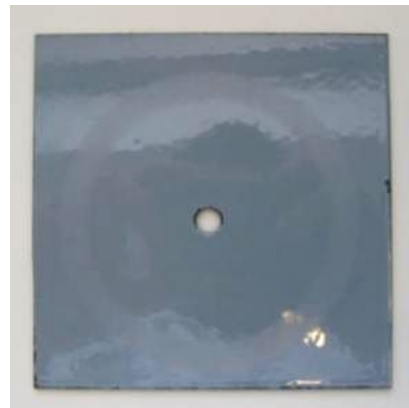
Mass loss for 10.000 cycles

- Substrate

$$\Delta w_{10000} = 94.783 - 94.725$$

$$\Delta w_{10000} = \mathbf{58\ mg}$$

- Ceramic coating (T153)

$$\Delta w_{10000} = 119.377 - 119.373$$

$$\Delta w_{10000} = \mathbf{4\ mg}$$

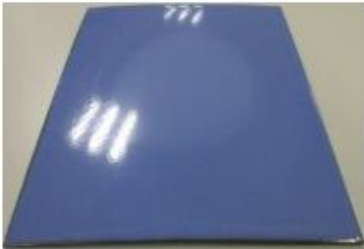
Acid corrosion at boiling temperature

○ *Conditions:*

- Solution: boiling H₂SO₄ (30%)
- 18 h (UNE-EN ISO 28706-2)

Acid corrosion at boiling T	
Liquid Contact

Vapour Contact

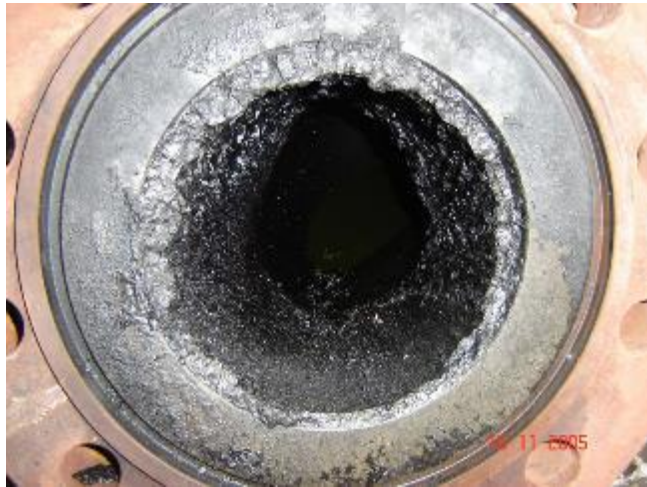
Coke deposition problems

As coke layer grows....

Efficiency loss

- ↓ Heat transfer & ↑ Tube skin temp
- ↓ Effective area & ↑ Pressure drop

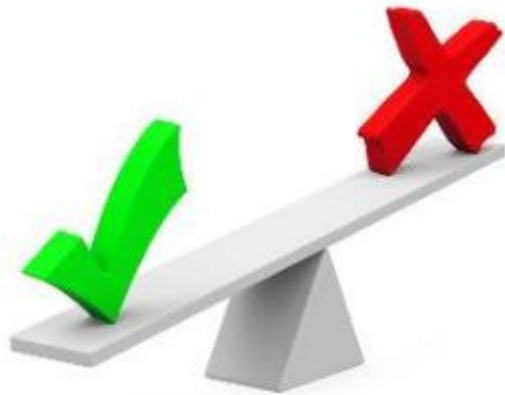
When the coating is applied to the inner surface of heater tubes:

- Minimizes coke formation (chemical inertness)
- Minimizes coke deposition (anti-fouling)

Fired heater with coating applied will obtain:

- Longer run lengths
- Lower fuel consumption
- Increased safety and reliability

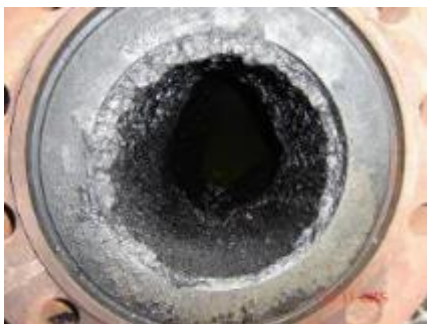
Coke deposition inside the tubes causing:

- **Fired heaters** frequent shutdown for pigging
□ **Huge loss of production cost**
- **Preheat exchangers** constantly taken out of service due to coke accumulation
□ **Tube deformation related to hot spots**
- Poor **Heat transfer efficiency** due to coke layer □
High fuel consumption in the furnace

TUBACOAT TRIAL

ID coated tubes, bends and flanges installed at the furnace outlet line to prove anti-fouling properties.

- **Run lengths without decoking**/online spalling can be **increased between 3 and 4 times**
- **Savings by Customer 1.5 Million USD per year**
 - 1.1 M\$ higher throughput (reduced shutdown time 7days/yr)
 - 0.15 M\$ furnace online spalling/pigging,
 - 0.15 M\$ fuel consumption,
 - 0.10 M\$ Heat Exchanger cleaning

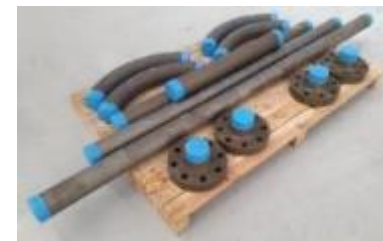
Dimensions: OD 4", Sch. 80 - 317L SS

- **Very thin coke layer** - not detected by Radiographic test - 75% reduction in coke deposition.
- **Coke was much easier to remove** - 3 times lower water pressure than before was enough to remove all the coke.
- **Decoking services** - may use softer pigs and cleaning will be less frequent

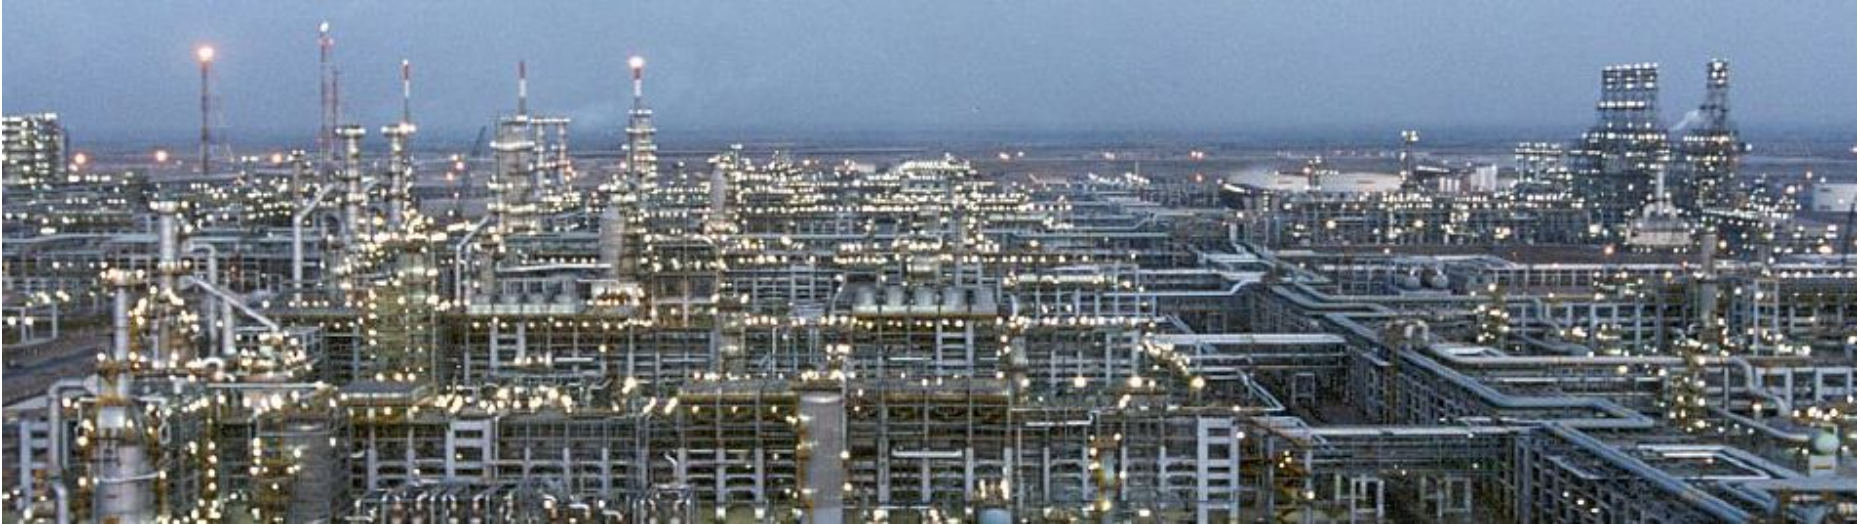
Delayed Coker Furnace

- Refinery operates 1 Delayed Coker, with normal capacity 124,000 barrel/day.
- Delayed Coker has 3 furnaces. Each furnace 6 passes. Each pass 30 radiant tubes
- Heater tube material: P9

- Frequent decoking is required due to coke layer build up leading to:
 - High **pressure drop**
 - Increase in **tube metal skin temperature**
- Each furnace requires **pigging every 3 months and online spalling every 30-45 days in 2 passes/furnace**
- During pigging, **one full furnace is out of service for 3-4 days** □ **unit running at 70% capacity. During Online Spalling, reduced capacity to 93% for one day/pass.**

Every time online spalling is performed in 2 passes of 1 furnace, the cost due to reduced throughput is approximately **125 KUSD/furnace**

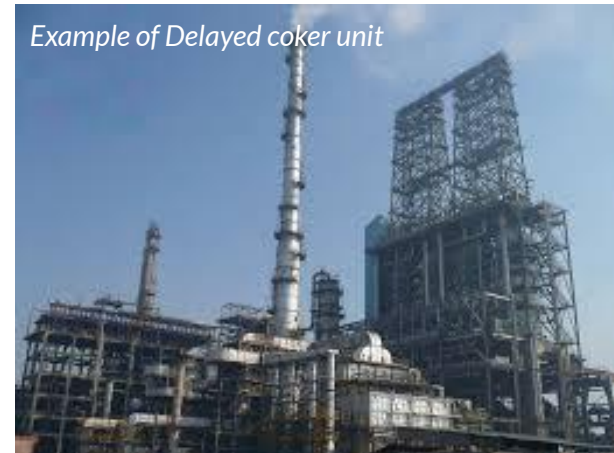
Example of Delayed coker unit

- Heater tube material: 9 Cr 1 Mo
- Currently, their heaters requires online spalling every 50 days when wall temperature is 630°C/1166°F
 - 7 spalls per year
- During spalling operation, 1 of 6 passes needs to be out of service, so overall throughput to the unit is reduced to 85%.
- Spalling time takes approximately 1 day per pass
 - 6 days per spall

- Due to coke deposition, every year throughput is reduced to 85% for 42 days.
- Estimated potential savings by End user around 3 million USD per year based on large size of their DCU.

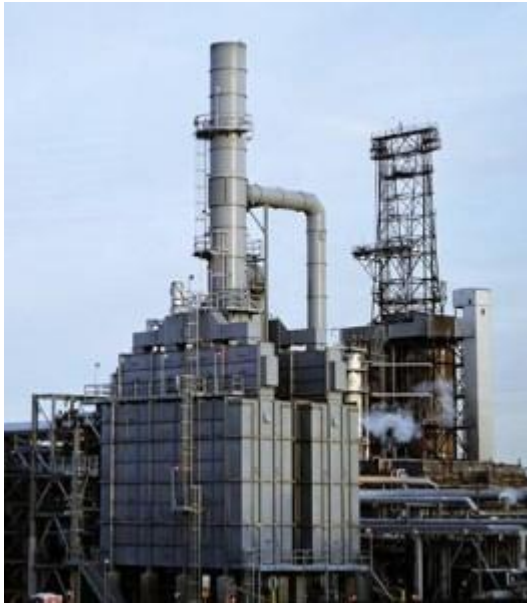
Delayed Coker Furnace

Example of Delayed coker furnace

- Heater tube material: 347H
- Heater requires online spalling every 2-3 months and also mechanical pigging once per year □ 4 spalls per year and 1 mechanical pigging
- During spalling, one pass needs to be out of service, so overall throughput to the unit is reduced to 75%. Spalling time takes approximately 1 day per pass □ 4 days per spall.
- Pigging requires full unit shutdown for 6 days

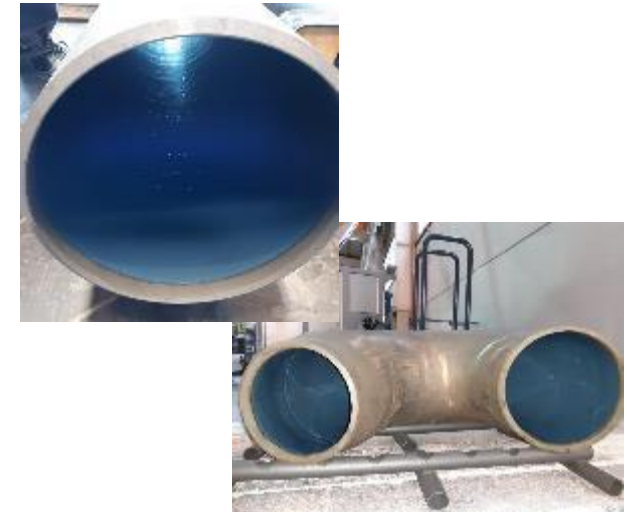
- ❑ Outlet line replacement (8", 10" and 12" OD Tubes) every year
- ❑ Frequent decoking operations by mechanical pigging
- ❑ Traces of Polythionic acid stress corrosion cracking

Base material: 317L SS @ Dimensions: OD 8" and 10" OD Lines

❑ ROI expected in 1.5 Years

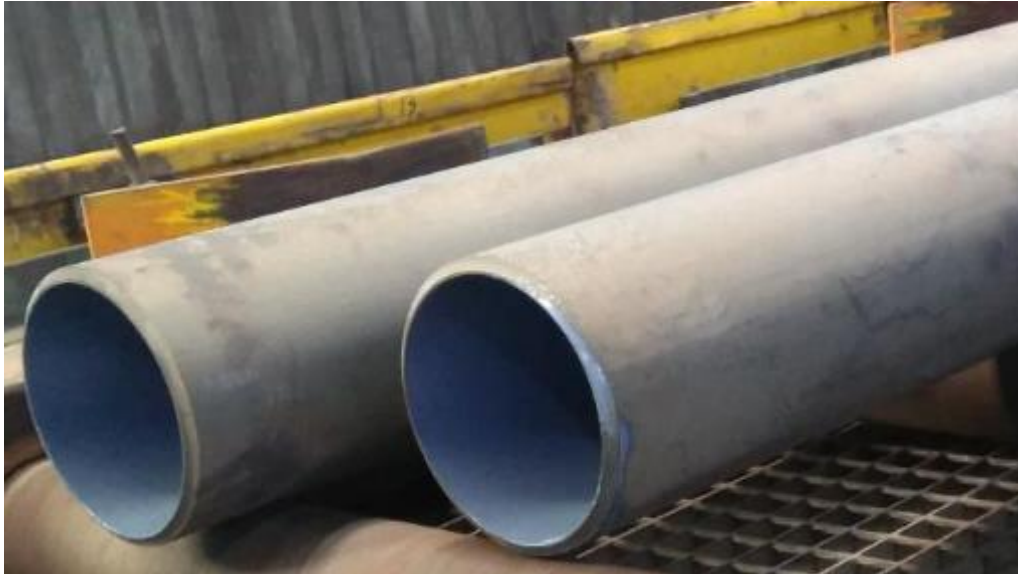
Vacuum Vistillation Unit (Europe)

Tubes installed in VDU furnace

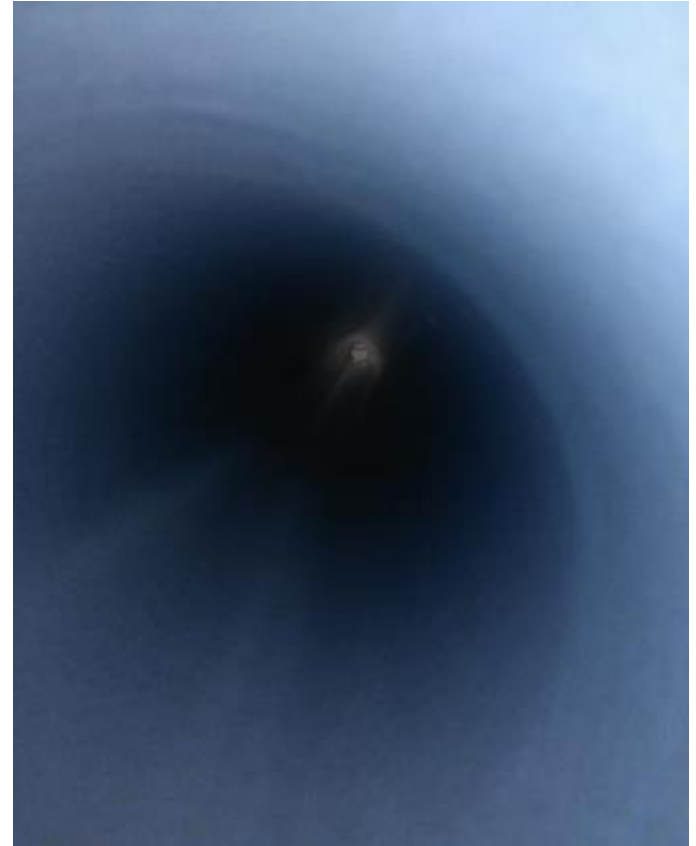
Inner surface view

Tubacoat **inner coated** tubes

Base material: 317 SS @ Dimensions: OD 5", Sch. 40

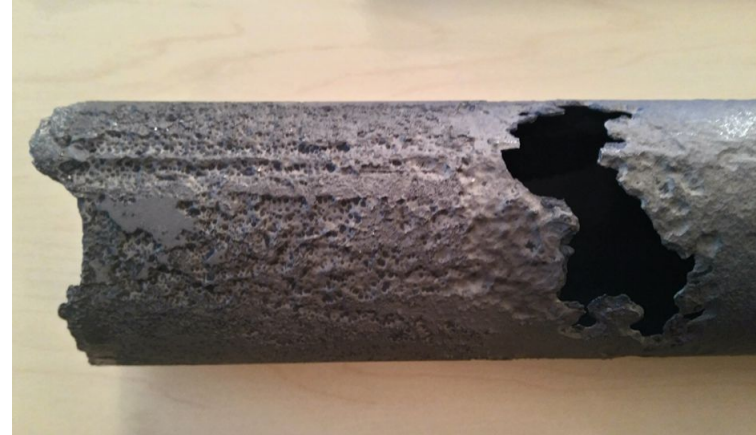
Substrate
Material TP310
(bare)

- **Working Conditions**
 - Oil fumes rich in vanadates at 850°C
 - Metal surface 570°C
 - Low pressure (welded tube)

Chemical corrosion

Efficiency loss

- 9 TP310 (OD63.5;WT2.41) outer coated prototypes were placed in the upper row (the hottest) of the calciner recuperator in May 2015
- Only the 9 coated tubes were remaining in the area, even suffering overheating during last weeks of operation prior to planned plant shutdown
- The rest of tubes were broken and blinded

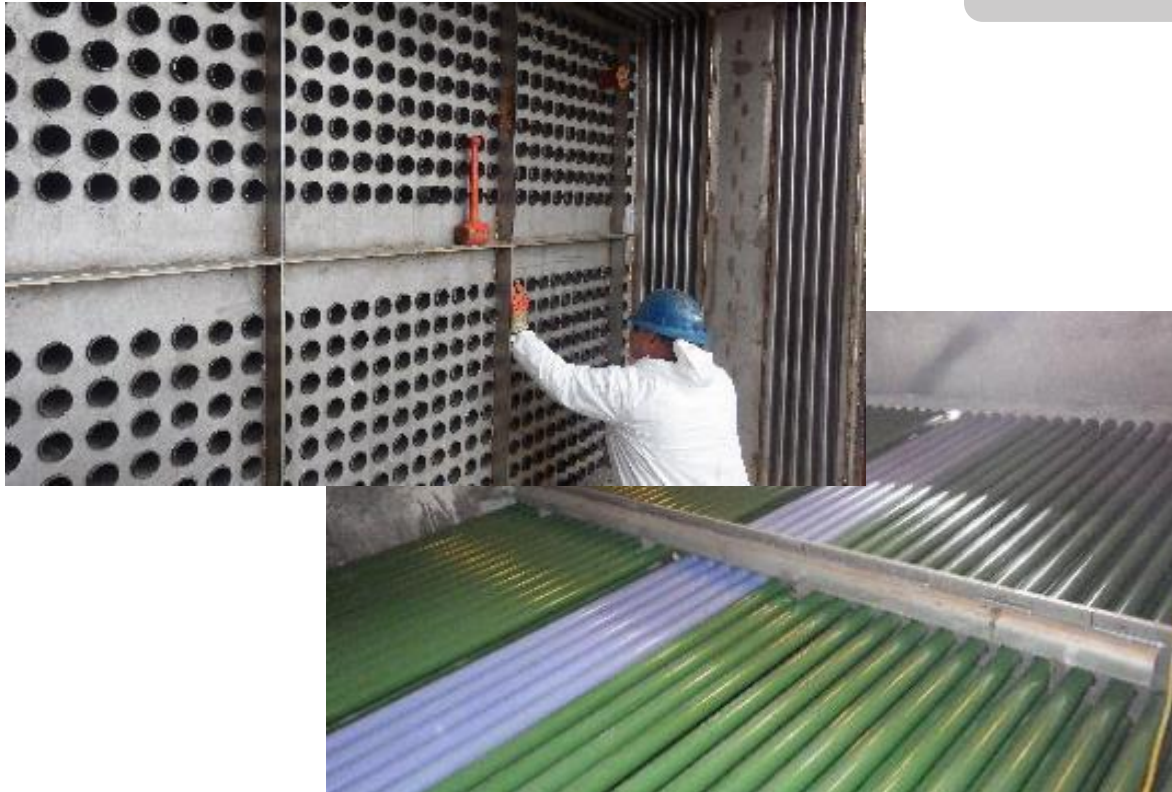
TUBACOAT SOLUTION

≈ 800 tubes (TP310 grade, OD63.5/WT2.41, outer coating), delivered to customer in Jan'2017 and installed in coke calciner in April 2017.

Status: facility in full operation (& continuous performance monitoring)

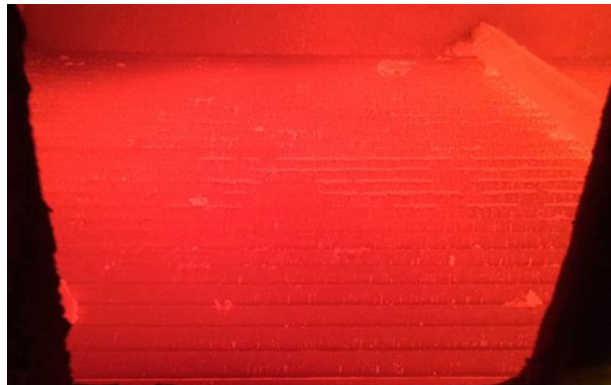
Real pictures of coated tubes in
coke calciner recuperator after
15 **months** running in full
operation

Operator received 3 times cycle length,
savings of US \$2 million/yr.
