TUBACOAT

**ANTI-COKING SOLUTION FOR FIRED HEATERS
IN DELAYED COKER, VISBREAKER & VACUUM DISTILLATION UNITS**

RefComm 2020
September 16, 2020

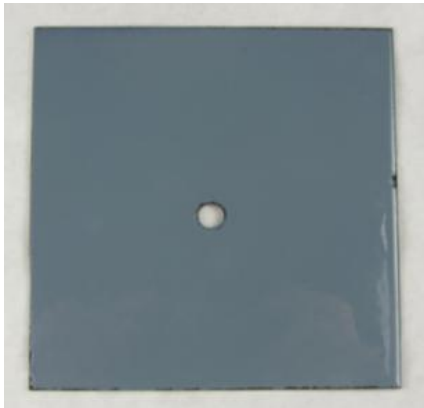
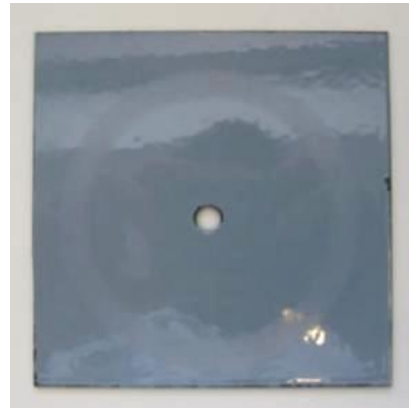
Abrasion resistance
≈ 94% decrease in mass loss

0 cycles

10.000 cycles

Mass loss for 10.000 cycles

$$\Delta w_{10000} = 94.783 - 94.725$$

$$\Delta w_{10000} = 58 \text{ mg}$$

$$\Delta w_{10000} = 119.377 - 119.373$$

$$\Delta w_{10000} = 4 \text{ mg}$$

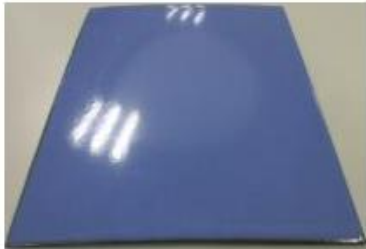
- *Conditions:*
 - Solution: boiling H₂SO₄ (30%)
 - 18 h (UNE-EN ISO 28706-2)

Acid corrosion at boiling T	
Liquid Contact

Vapour Contact

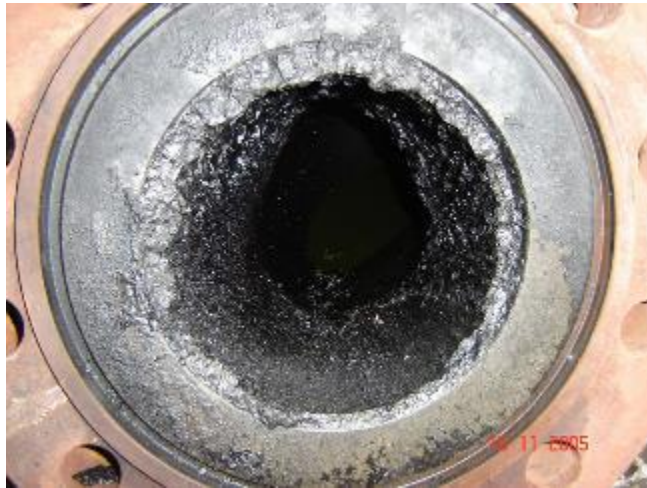
As coke layer grows....

Efficiency loss

- ↓ Heat transfer & ↑ Tube skin temp
- ↓ Effective area & ↑ Pressure drop

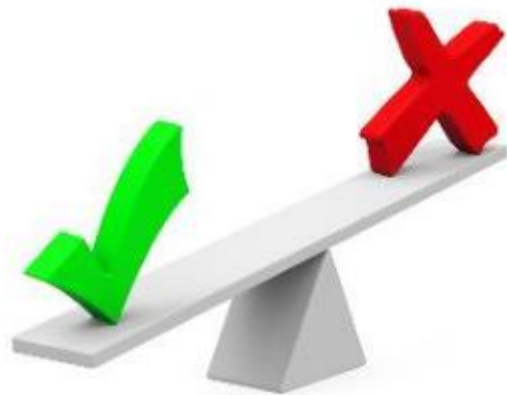
When the coating is applied to the inner surface of heater tubes:

- Minimizes coke formation (chemical inertness)
- Minimizes coke deposition (anti-fouling)

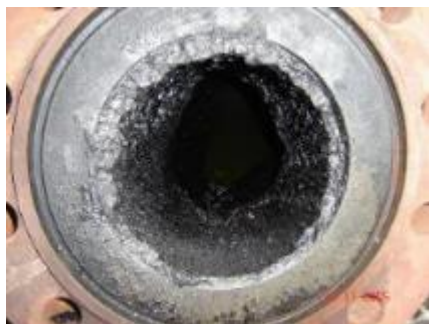
Coke deposition inside the tubes causing:

- **Fired heaters** frequent shutdown for pigging
→ **Huge loss of production cost**
- **Preheat exchangers** constantly taken out of service due to coke accumulation
→ **Tube deformation related to hot spots**
- Poor **Heat transfer efficiency** due to coke layer
→ **High fuel consumption in the furnace**

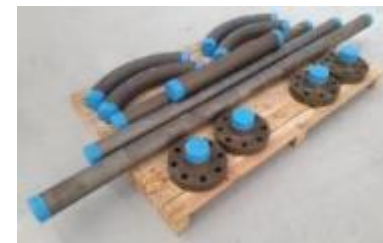
ID coated tubes, bends and flanges installed at the furnace outlet line to prove anti-fouling properties.

Dimensions: OD 4", Sch. 80 - 317L SS

- **Very thin coke layer** - not detected by Radiographic test - 75% reduction in coke deposition.
- **Coke was much easier to remove** - 3 times lower water pressure than before was enough to remove all the coke.
- **Decoking services** - may use softer pigs and cleaning will be less frequent

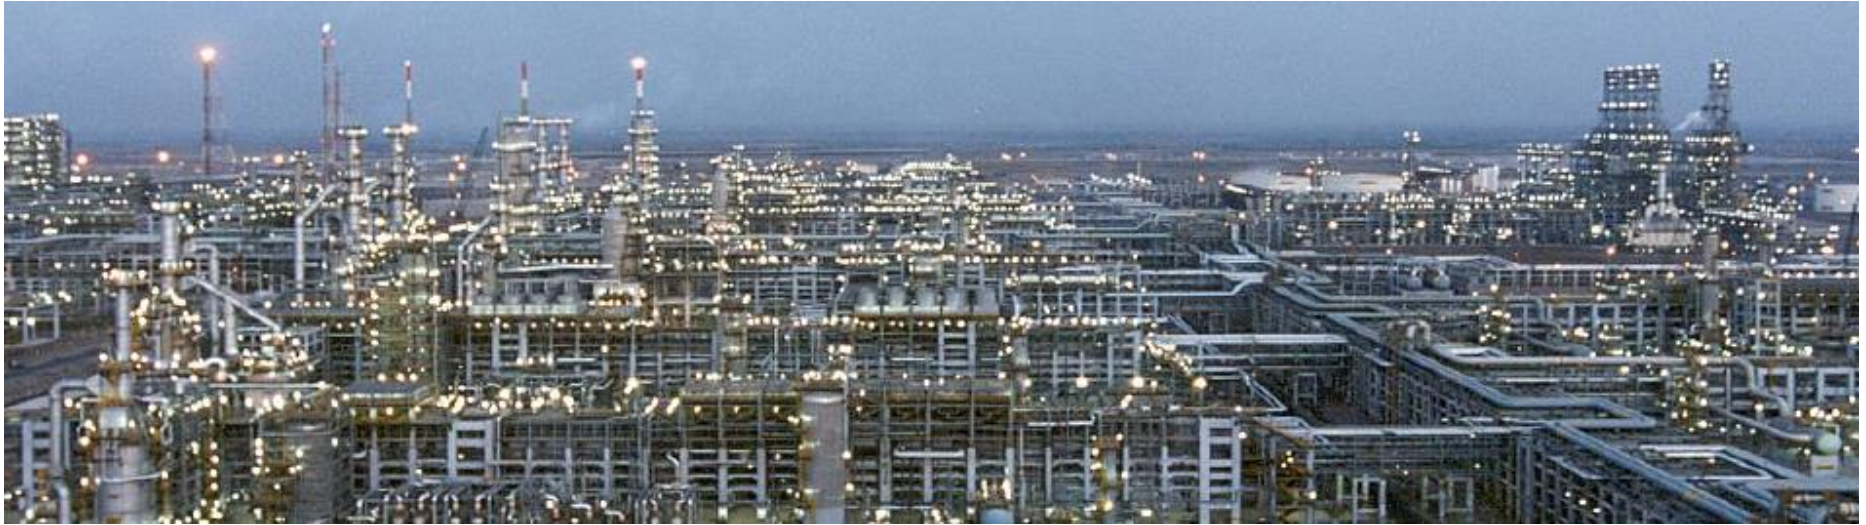
Delayed Coker Furnace

- Refinery operates 1 Delayed Coker, with normal capacity 124,000 barrel/day.
- Delayed Coker has 3 furnaces. Each furnace 6 passes. Each pass 30 radiant tubes
- Heater tube material: P9

- Frequent decoking is required due to coke layer build up leading to:
 - High **pressure drop**
 - Increase in **tube metal skin temperature**
- Each furnace requires **pigging every 3 months and online spalling every 30-45 days in 2 passes/furnace**
- During pigging, **one full furnace is out of service for 3-4 days → unit running at 70% capacity. During Online Spalling, reduced capacity to 93% for one day/pass.**

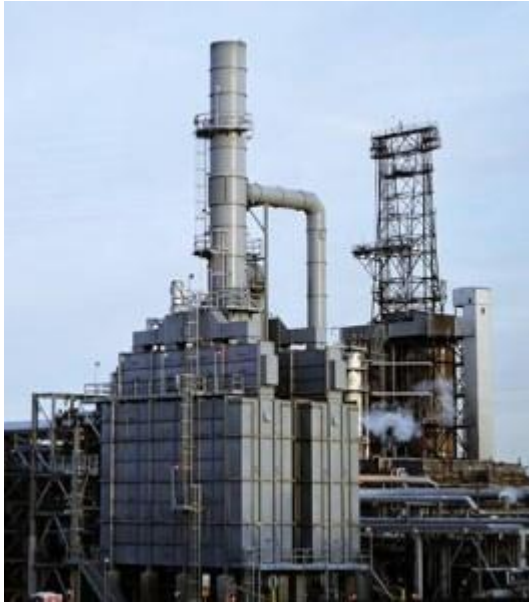
Delayed Coker Furnace

Example of Delayed coker furnace

- Heater tube material: 347H
- Heater requires online spalling every 2-3 months and also mechanical pigging once per year → 4 spalls per year and 1 mechanical pigging
- During spalling, one pass needs to be out of service, so overall throughput to the unit is reduced to 75%. Spalling time takes approximately 1 day per pass → 4 days per spall.
- Pigging requires full unit shutdown for 6 days

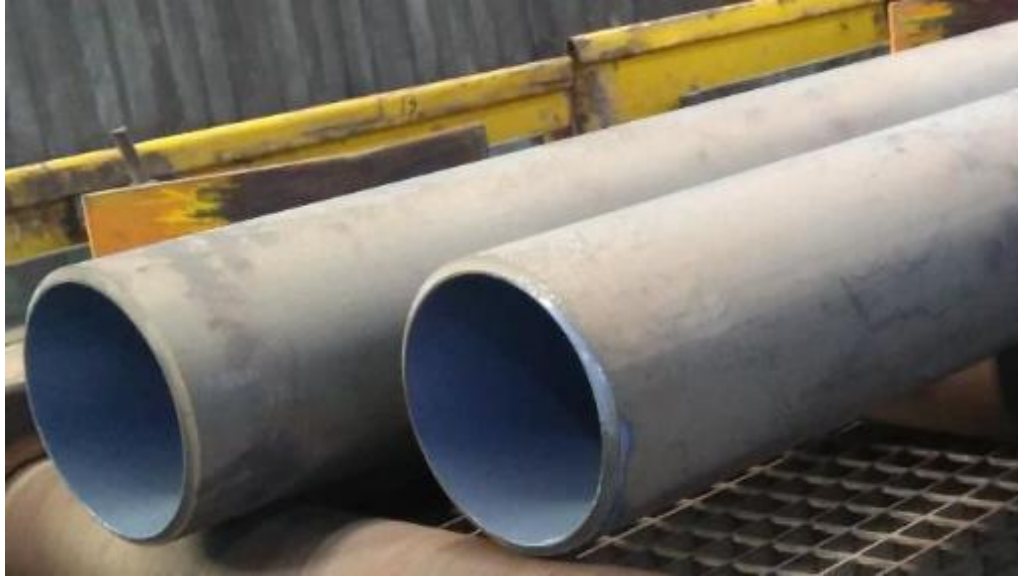
Tubes installed in VDU furnace

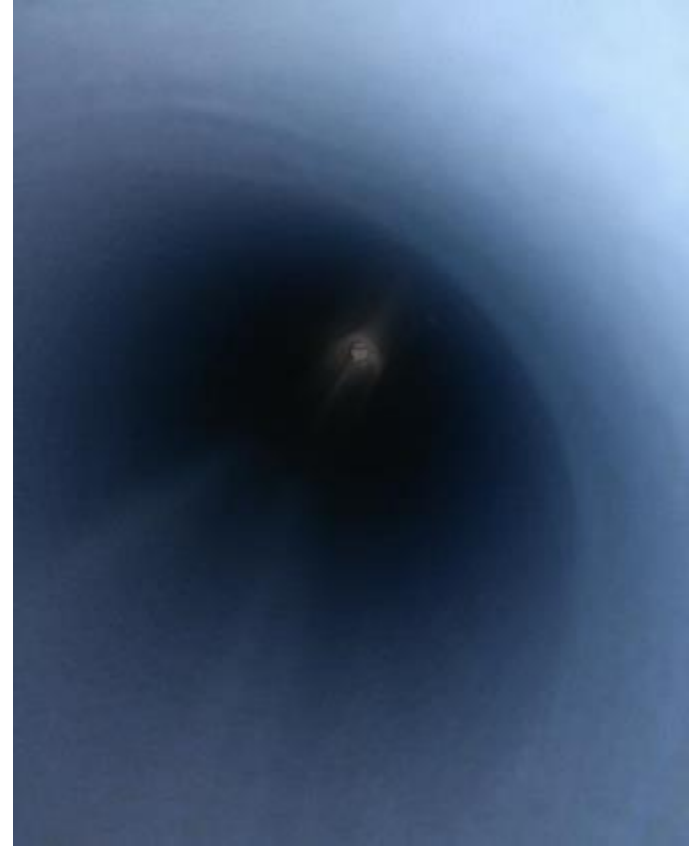
Inner surface view

Tubacoat **inner coated** tubes

Base material: 317 SS @ Dimensions: OD 5", Sch. 40

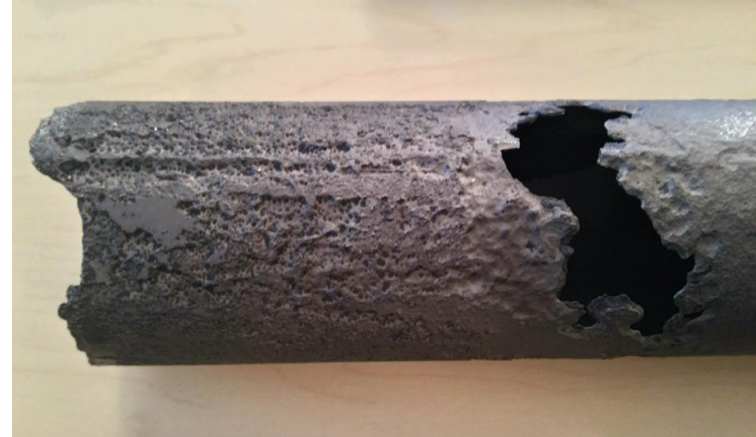
Substrate
Material
TP310 (bare)

Chemical corrosion

Efficiency loss

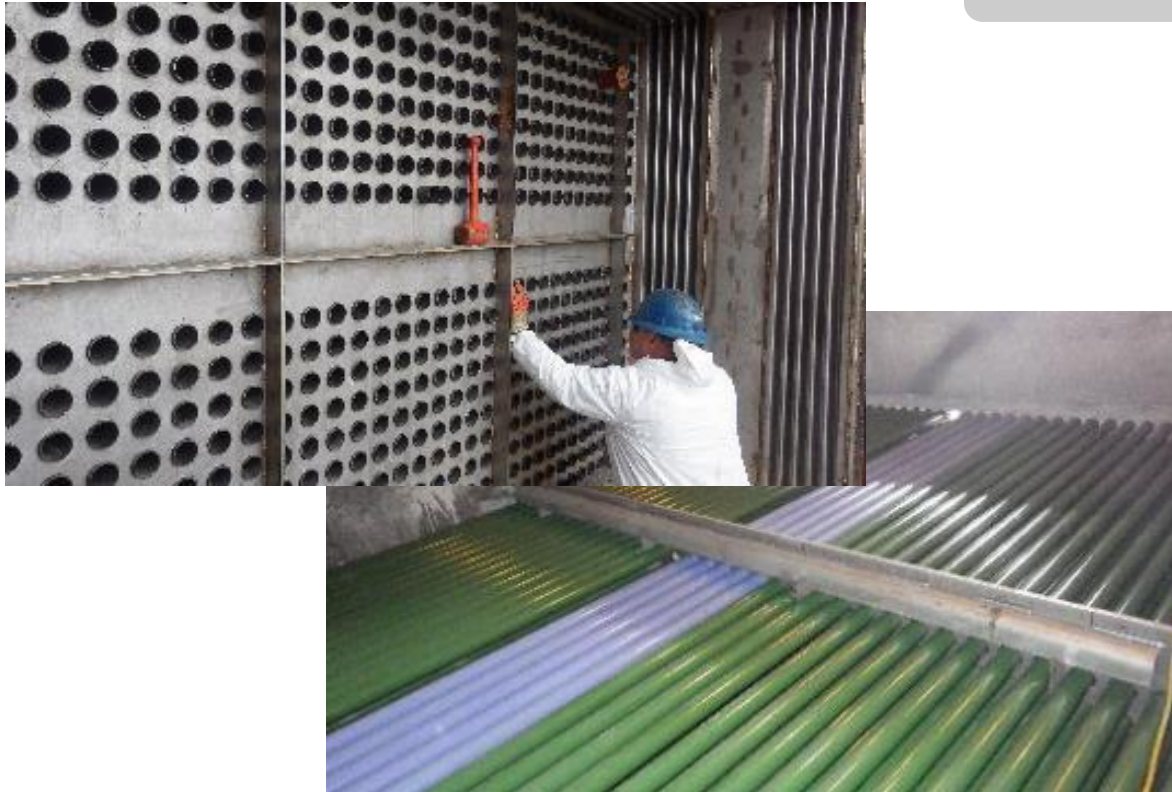
≈ 800 tubes (TP310 grade, OD63.5/WT2.41, outer coating), delivered to customer in Jan'2017 and installed in coke calciner in April 2017.

Status: facility in full operation (& continuous performance monitoring)

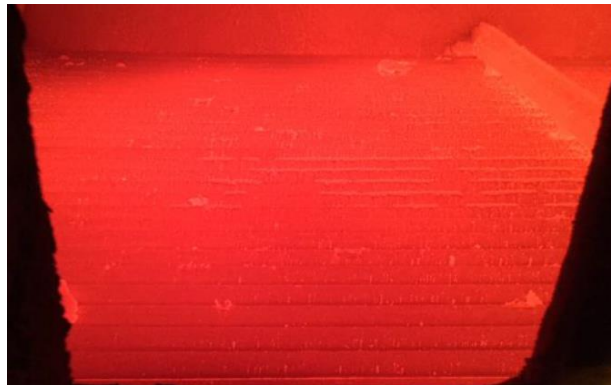
Operator received 3 times cycle length,
savings of US \$2 million/yr.

Real pictures of coated tubes in
coke calciner recuperator after
15 **months** running in full
operation
