WHY ARE DCUs SO HARD TO INSULATE?

PYROGEL HPS: ENGINEERED FOR DCU SERVICE

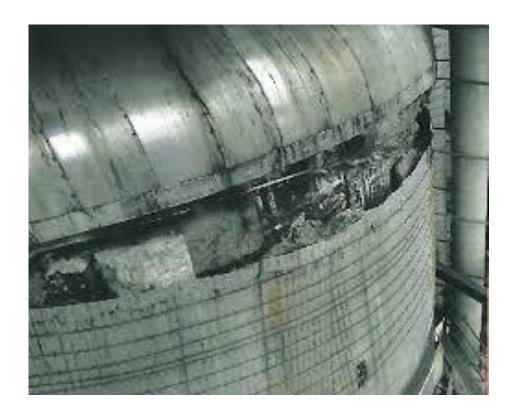
- As the insulation gets wet, it gets heavy, sags, and opens up seams
- Within 3-5 years, heat loss from the drums can increase by 2-4X

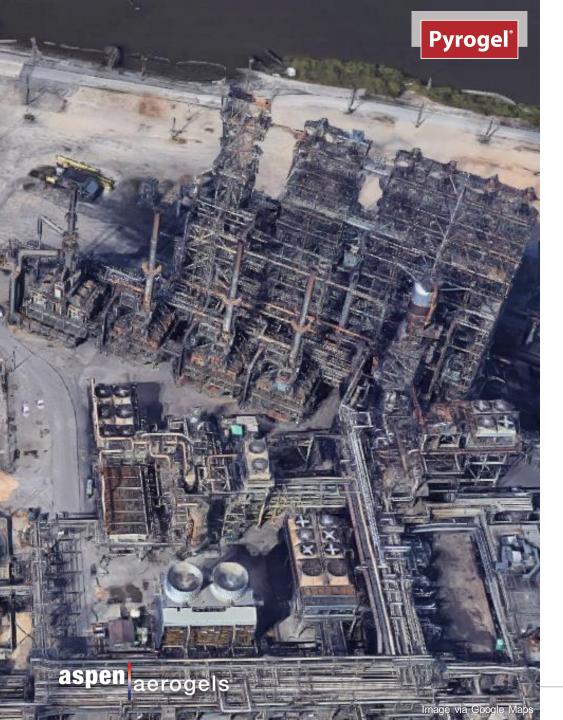
REFINERY ADDED TWO PYROGEL DRUMS NEXT TO SIX INSULATED WITH MINERAL WOOL

Facility added two new drums to their six-drum unit and insulated with 60mm of Pyrogel.

The team detected that the new drums were running 10°F warmer than the six older drums still insulated with aging mineral wool.

THE NEXT FOUR-DRUM SET WAS SUPER-INSULATED WITH 100MM OF PYROGEL

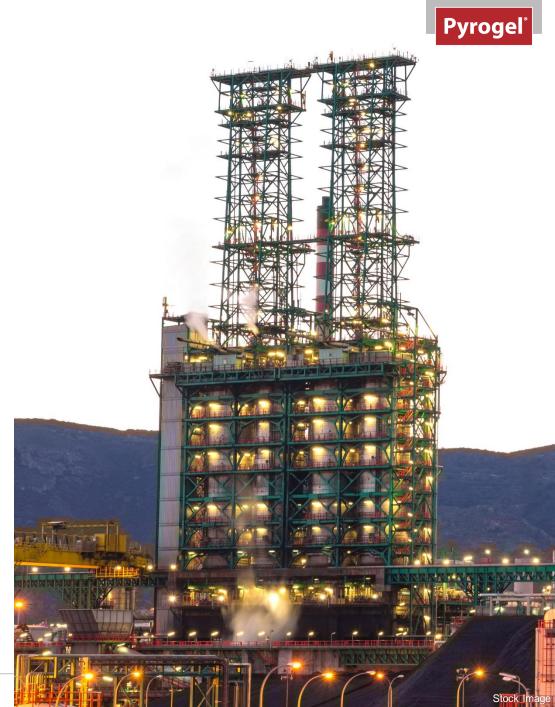
RE-INSULATE FOUR DRUMS WITHOUT DOWNTIME

Drum shells required re-insulation but the facility did not want to take unit offline. Pyrogel was installed on the shell while the unit was in service, during cutting operations. The top heads and bottom cones were completed during a subsequent turnaround.

Upon completion of the work, the unit engineer noted lower VOCs and harder coke, both indications of higher liquid yields to the fractionator. They now estimate Pyrogel had increased DCU profits by \$30-50K/month, and they expect even more once furnace temperatures and flow rates have been optimized.

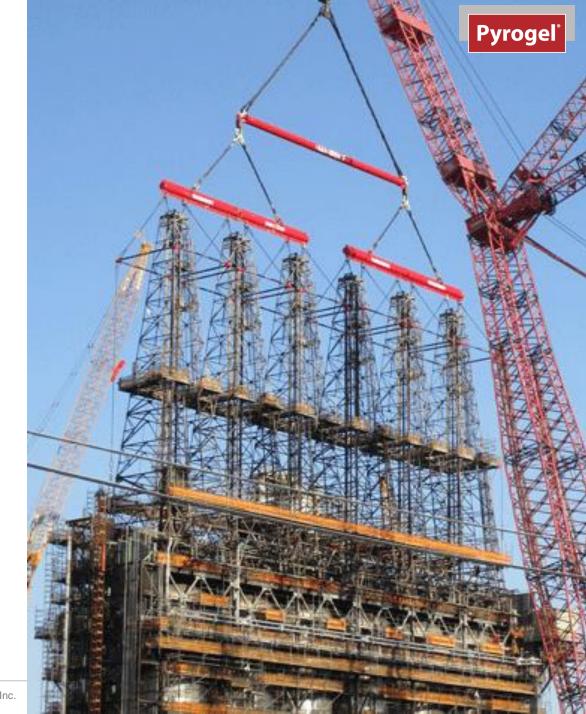
6-DRUM REPLACEMENT INTO EXISTING STRUCTURE

To accelerate the replacement of six coke drums, the constructor wanted to insulate them on the ground prior to lifting. The existing insulation design – 150mm (6") of mineral wool – was too thick to drop the drums through the existing structure.

Using Pyrogel shaved 75mm (3") off the outside diameter of the fully dressed drums, enabling a flawless installation and on-time commissioning.
