#### Index

#### Furnace Inspection Tools

#### Furnace Tube Inspection Reporting

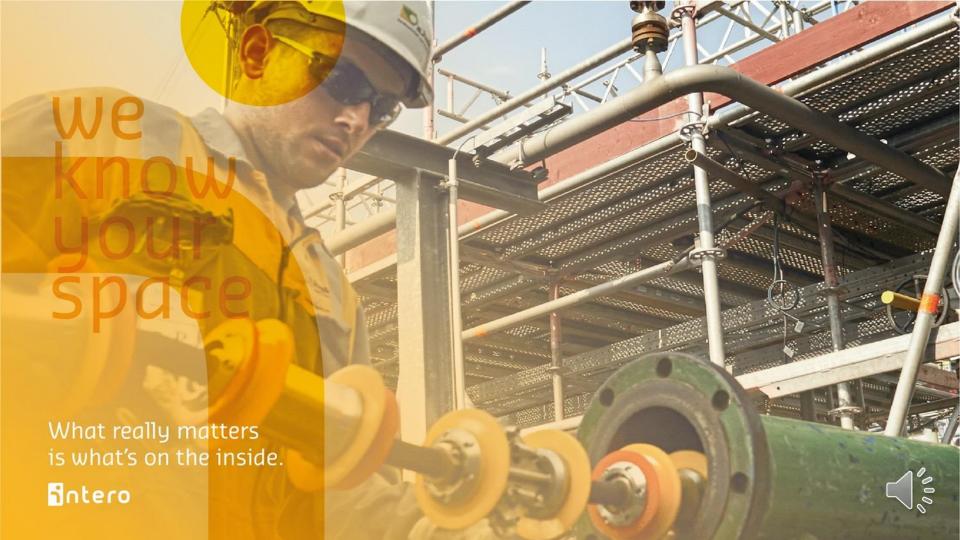
- Robust 2 unit, bi-directional
- Multiplex tools 3"-10" (12" available upon request)
- 1D 180° short radius return bends
- Onboard data storage of A-scan
- 3-5 feet per second inspection speed

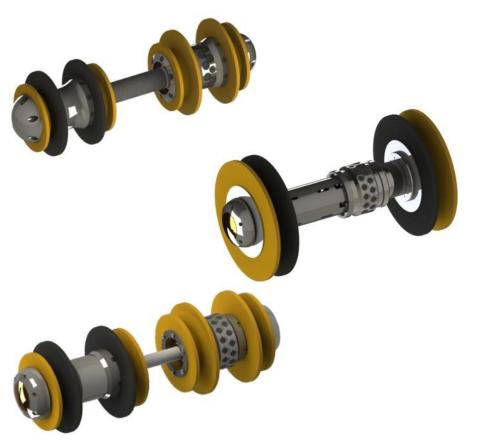
- On-site data check (field report)
- 48-hour final reporting
- General corrosion (minimum remaining wall thickness per tube)

Fretting, bulging, creep

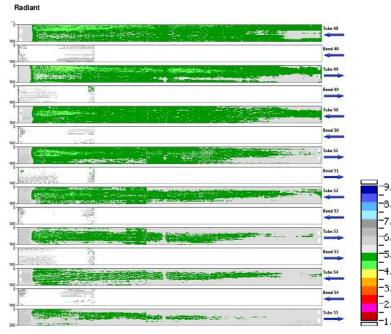
**Furnace Tube Inspection Reporting**

- Reporting
  - Tabular overview
  - C-scan per pass/tube/bend

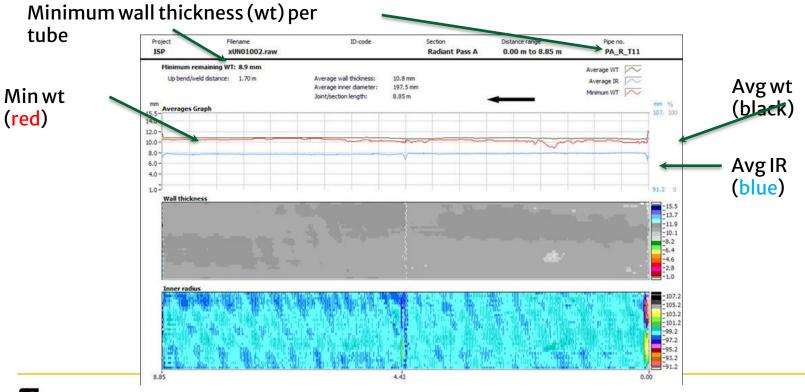
#### Furnace Tube Inspection 2.0

- Improved sampling rate
  - More measurements per foot

- IMU On-board
  - Tube mapping capabilities

- Selectable resolution
- Up to 360 measurements/rev

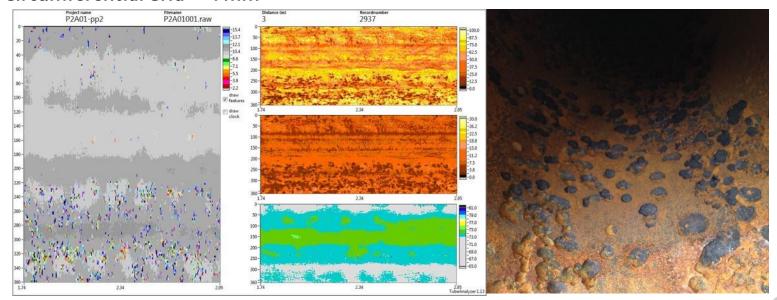
## Pitting Detection

- 6" Sch 40 tube
- Circumferential Grid < 4 mm</li>

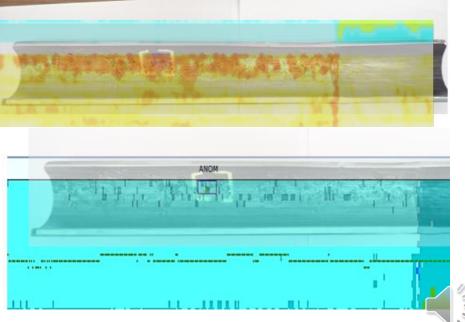
3" Sch 80

Pitting depth of 6.4 mm

Location of lowest manual UT

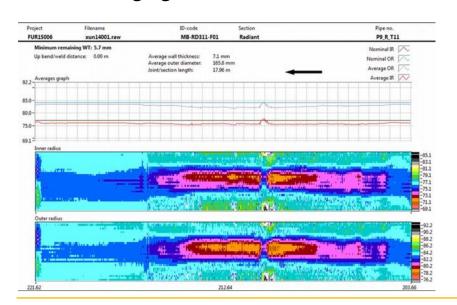
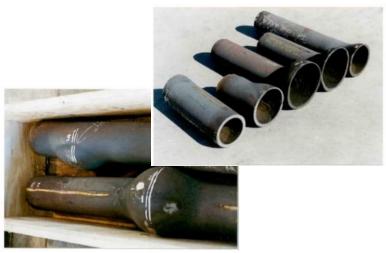
## Capabilities (Bulging)

- Tube size 6"
- Bulging detected >= 1% of ID

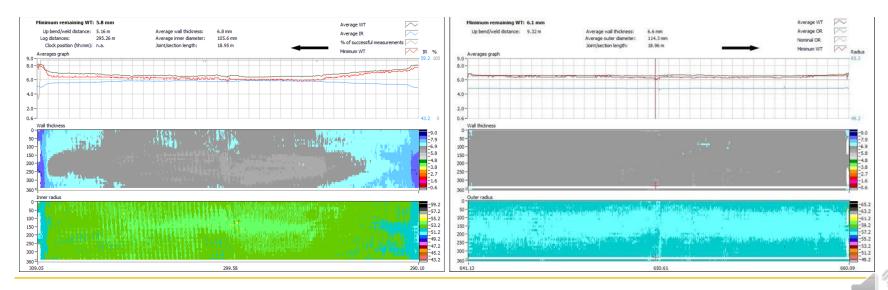
## Capabilities (Creep)

- Need comparison ID/OD
- Difficult to detect

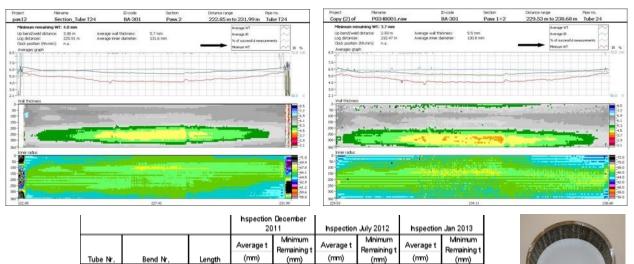
#### **Corrosion Monitoring**

Bend 1

Bend 2

Year 3 Year 2 Year 1

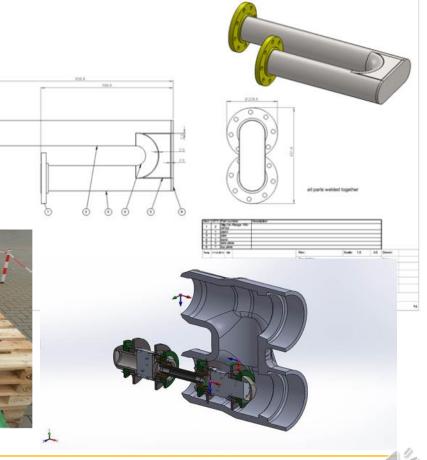
## Plug Headers (Mule Ears)

Inspect furnaces without removing and/or cutting out plug headers (mule ears)

Tool configured per the specific plug
