Delayed Coker Cutting Derrick Collapse

Presented by Mitch Moloney of **ExxonMobil**

@ Galveston TX coking.com May-2012

Delayed Coker **Partial Derrick Collapse**

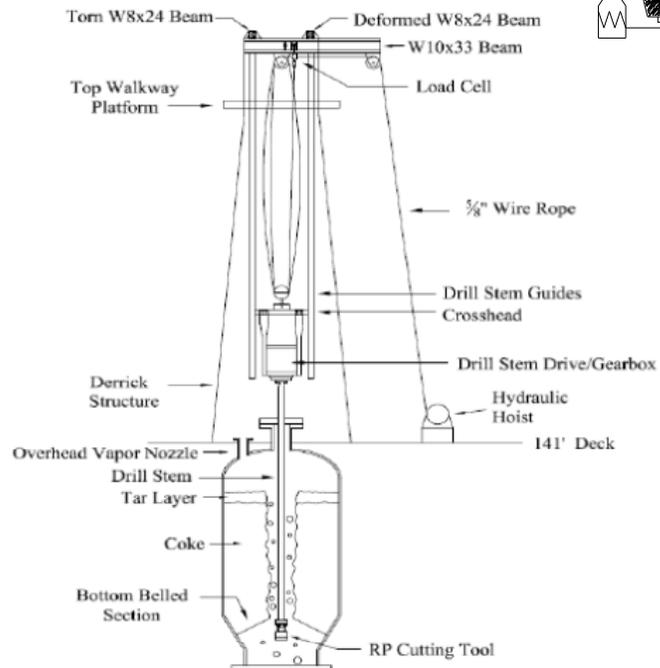
CoFlexip Cutting Hoses
 RuhrPumpen Manual Cutting Bit
 RuhrPumpen Pneumatic rotary joint
 Joy Winch 1970's version retrofit to hydraulics by Exxon

No Free-Fall Arrestor
 No Cable Tension Readout
 No Cutting Tool Elevation Readout

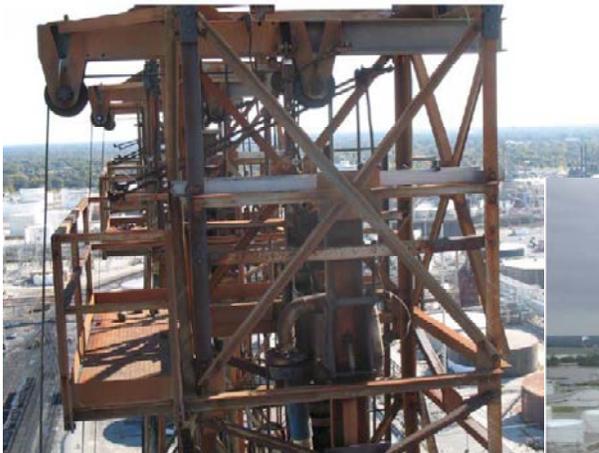
Before

- 07:30 A Contractor noticed that the derrick structure looked abnormal at the top of the derrick; this is when the damage was found.
