Coker Vessel Life Extension Repair Implementation

REFCOMM
BAHRAIN 2015

Delayed Coker Unit Karlsruhe Germany

Coke drum D-001 B

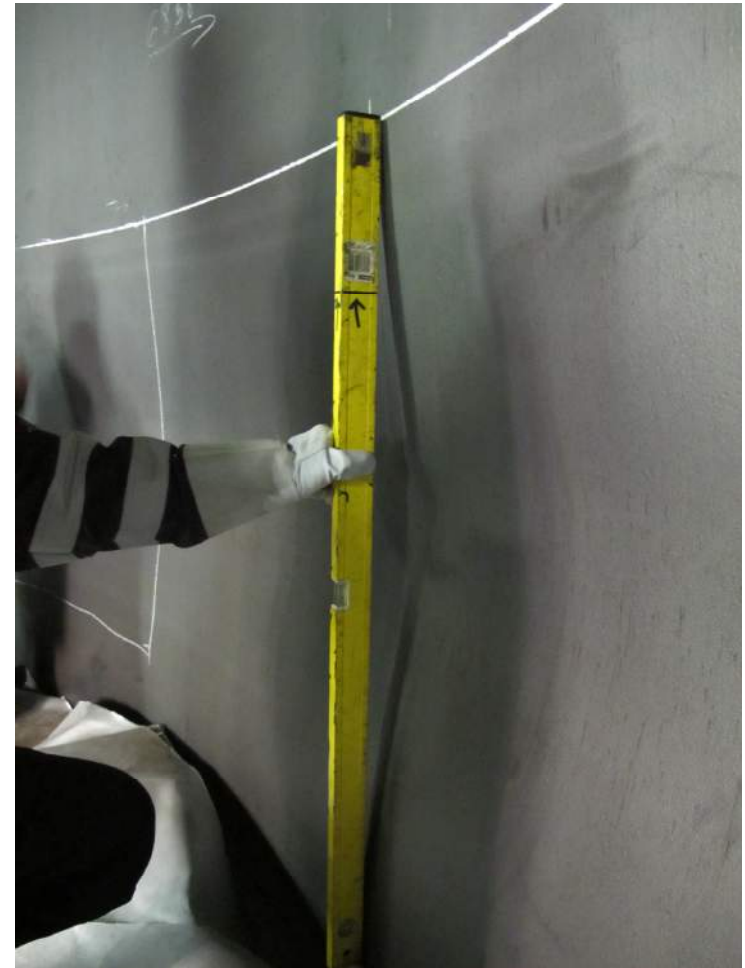
Shell Bulging Damage

- Planned T/A in 2012
- Bulges in delayed coking unit increased rapidly, so emergent repair had to be executed
- Analytical support and “Engineered Repair” developed
- Machine welding used to implement structural improvement repair
- Temperbead process eliminated requirement for PWHT

Repair Options Evaluated

Option	Implementation Schedule	Repair Complexity	Repair Integrity
Window Replacement	Long	High	Low
Section Replacement	Long	High	Medium-Low
Structural Overlay	Short	Low	High
