DCU FURNACE TROUBLESHOOTING: “HIGH TUBE METAL TEMPERATURE”

C K SINHA

Senior Manager Technical Services,
sinhack@indianoil.in

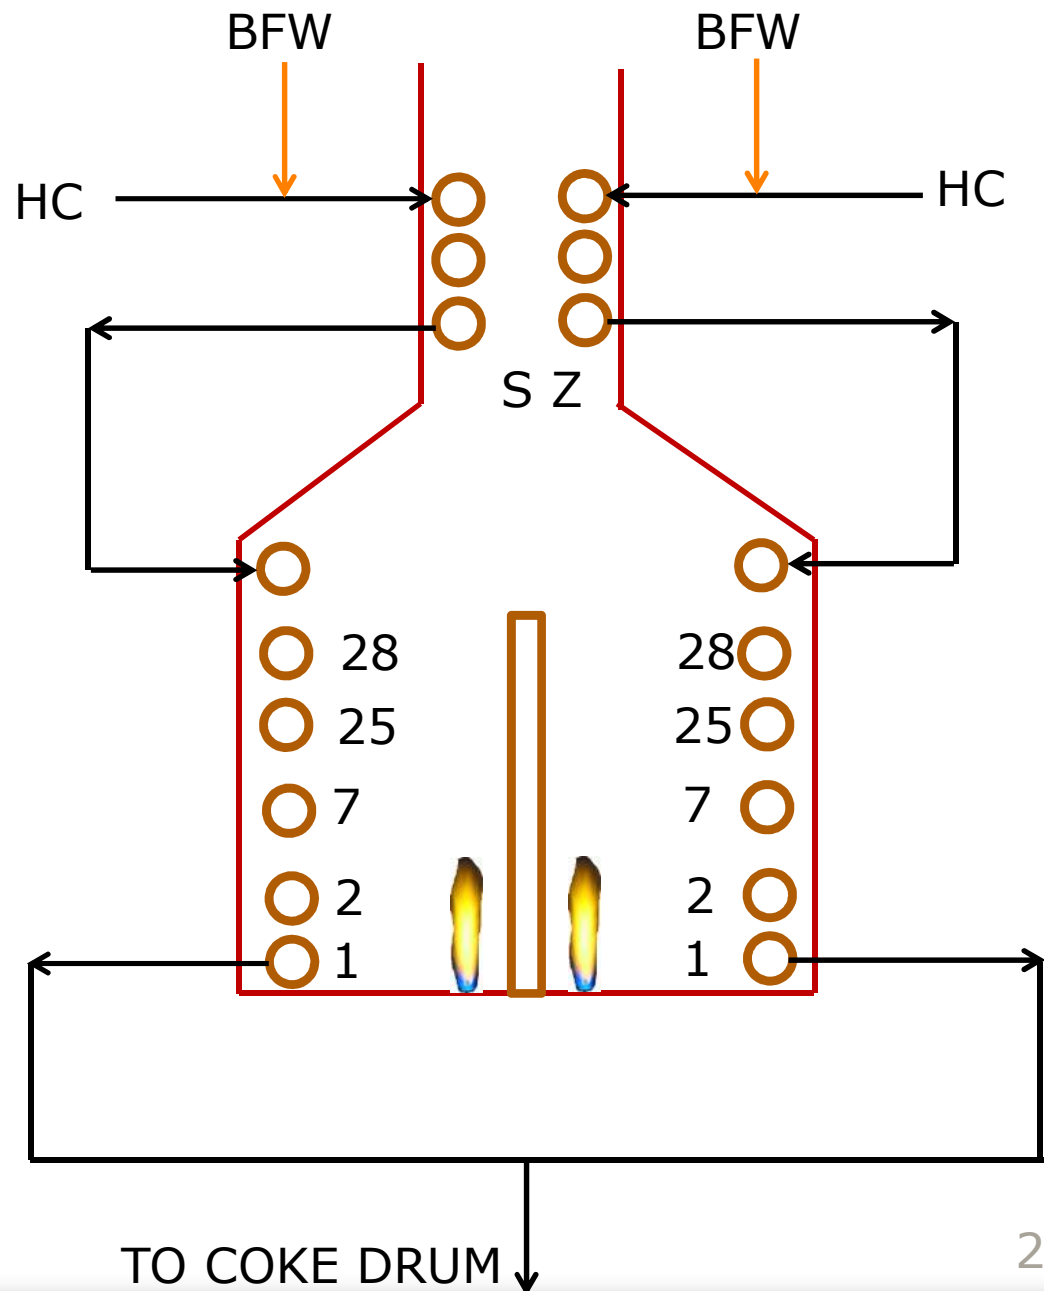
FURNACE OVERVIEW

- ❑ 2 - Pass Bottom Fired Natural draft Furnace
- ❑ Design Fired duty- 8.16 Gcal/hr
- ❑ Low Nox flat flame burner
- ❑ Total 36 no of tubes in radiation section
- ❑ Tube metal T t'couple on tube no 1,2,7,25,28 & shock zone (SZ) tube
