# Field Modification of DCU Support Skirt-to-Vessel Attachment Weld Geometry

By: Pedro E. Amador – VP Business Development & Technology Darren Barborak PhD. – Director of Materials & Welding Patrick Lester BSWE CWI – Senior Welding Engineer

Unique Implementation Case Study

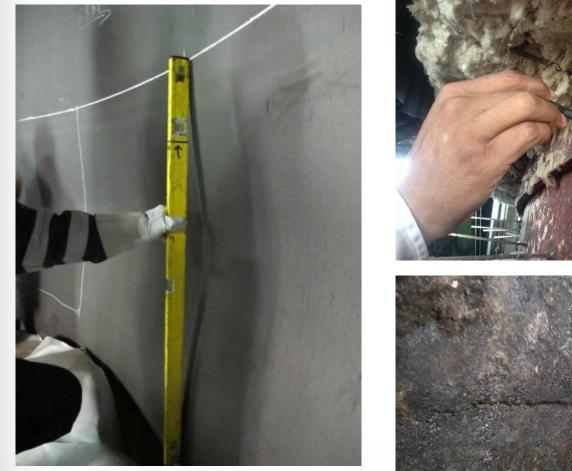
Bulging

Skirt Attachment Cracking

Pressure Boundary Cracking

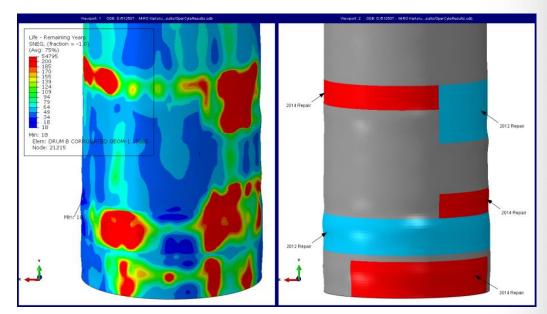
**Engineered Structural Overlays**

- Map vessel to collect deformation data
- Evaluate stress/strain intensities with analytical tools
- Characterize highly affected areas
- Design "Structural Overlays" to address critical regions

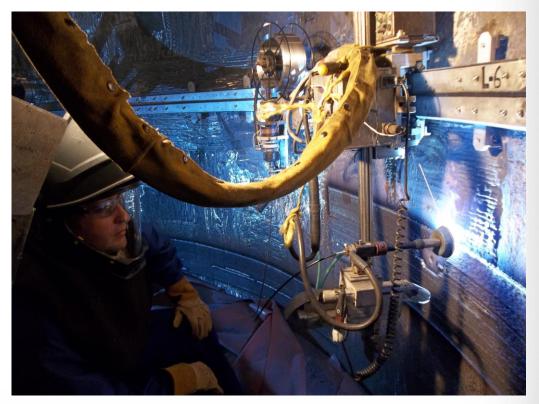
**Engineered Structural Overlays**

- Install structural overlay(s) in accordance with design criteria
- Utilize automated welding processes to provide homogeneous mechanical properties and minimize volumetric and surface imperfections
