aquilex welding services B.V.

Coke Drum Repair

October , 2011 Dusseldorf

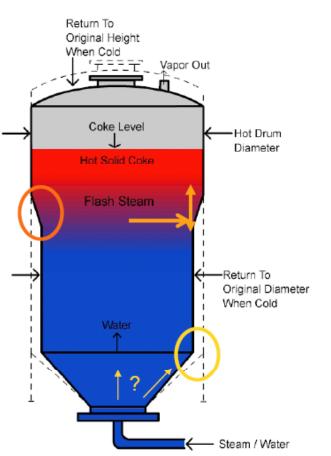
Hot oil (900F) fills the drum and hardens as it cools, cracks and releases vapor

Eventually water can form and fills the drum

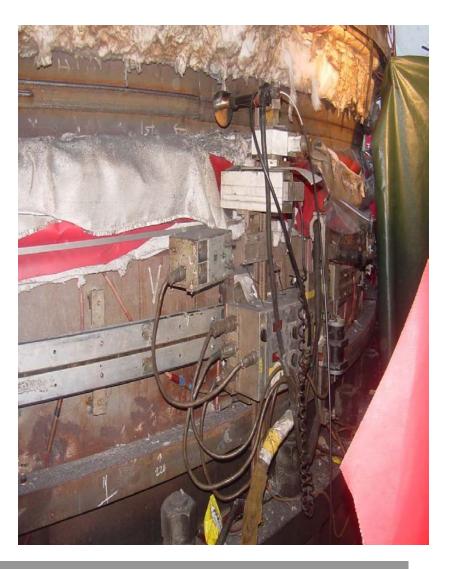
Client options:

- Stick Welding:
 - Already had contracted with local general contractor to gouge and reweld, and it was going to take 3 outages to complete.
 - 3 Outages x 5 days = 15 Days required
- Automated Welding :
 - Utilize Temper bead technique
 - Work on both Coke Drums simultaneously
 - Eliminate PWHT

Engineered Repair Design:

- Utilizing 8 Automated Weld Systems
- Machined and Re-Welded Circ Seam using Temperbead WPS
- Post Soak used, eliminated PWHT
- UT Shear Wave acceptable
- 5 day Schedule for the welding of both Coke Drums
- Savings \$\$\$
 - Customer avoided 10 days of Downtime
- Recently inspected after 1000 cycles no cracks reported
