# Delayed Coker Cutting Derrick Collapse

Presented by Mitch Moloney of **ExxonMobil**

@ Dusseldorf DL coking.com Oktober-2011

# Delayed Coker Partial Derrick Collapse

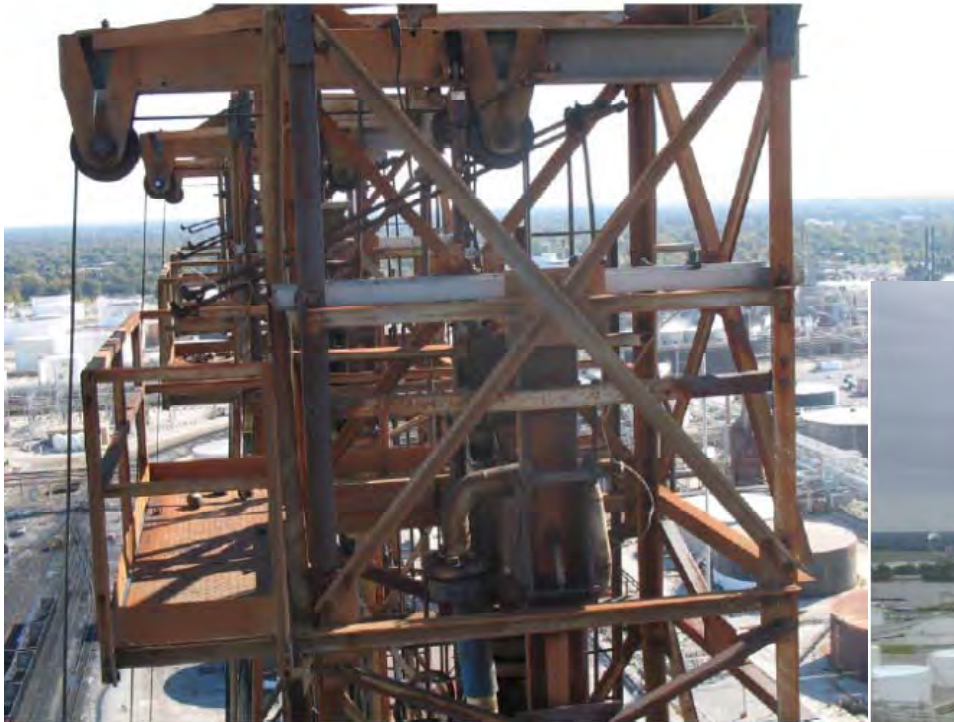
Before

- 07:30** A Contractor noticed that the derrick structure looked abnormal at the top of the derrick; this is when the damage was found.

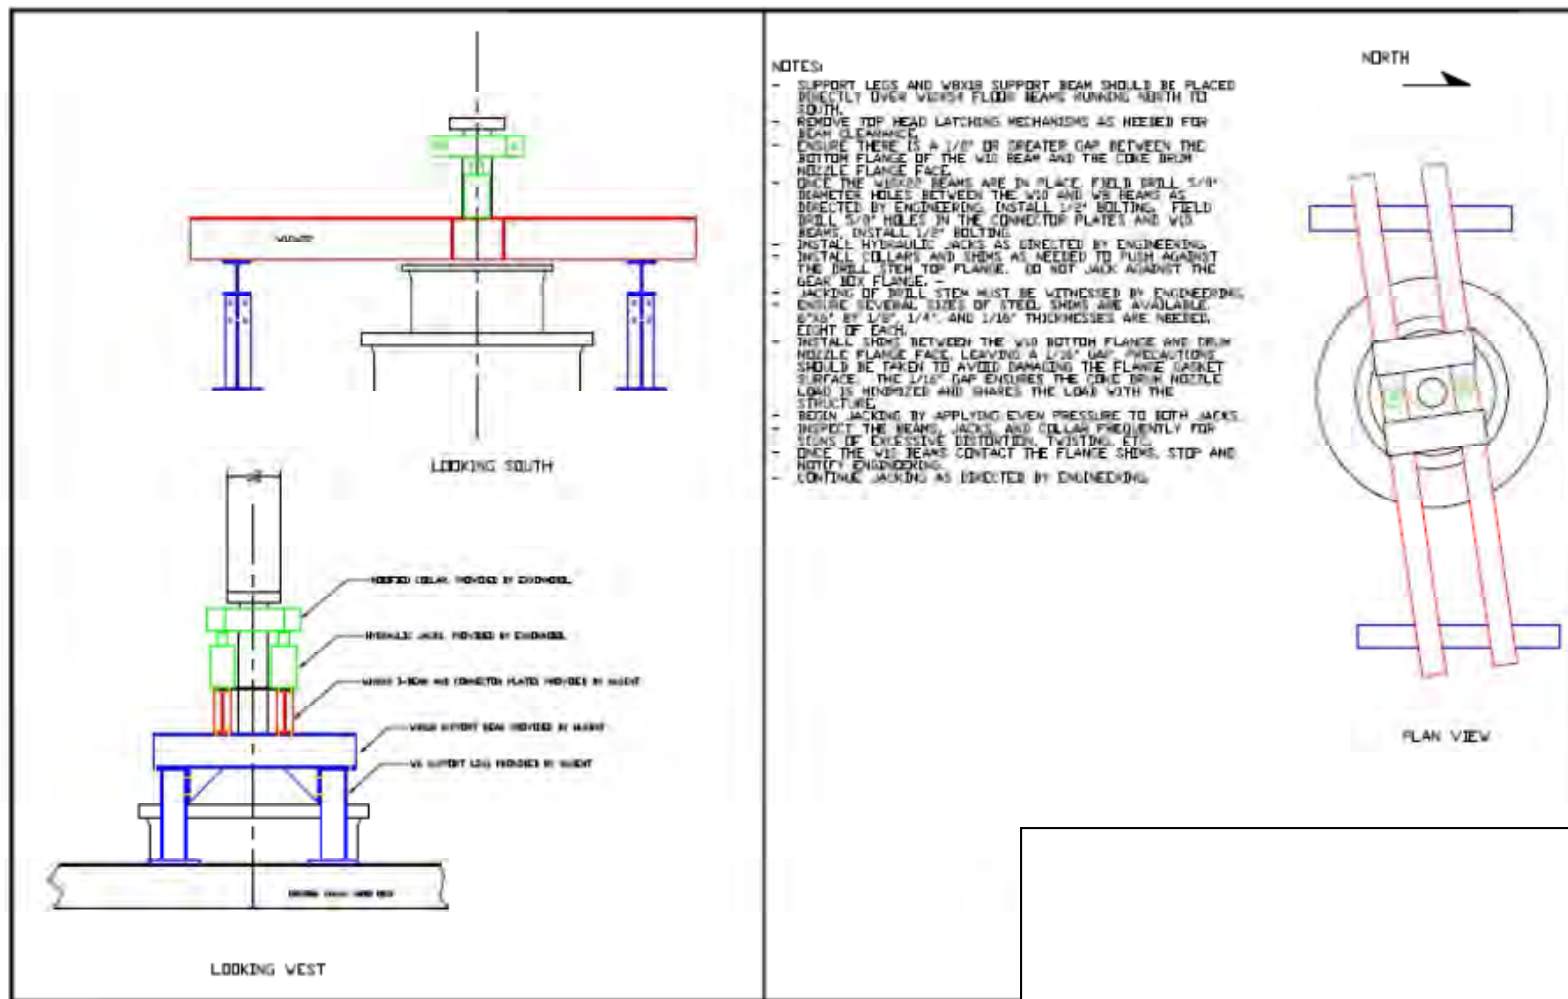
## Hydraulic Jacks Arrangement (Unsuccessful):

This coker (Site-1) found that 60,000 lbs (27,000 kg) was maximum load the coke drum structure beams could support. And they did detect beam deflection on the structure when that force was applied.
