Coke Drum Dual Feed Issues

David Gibson – ExxonMobil Manufacturing Principle Engineer

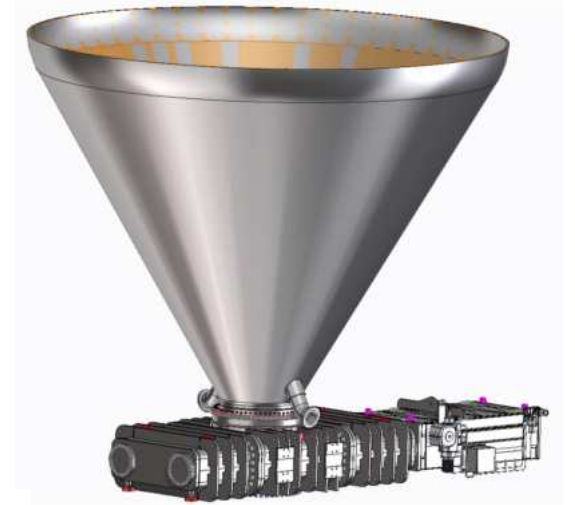
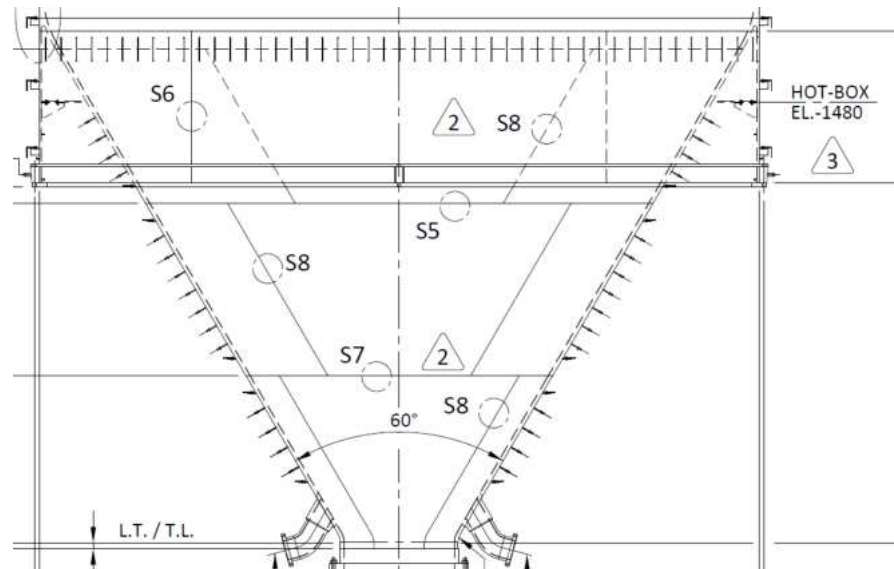
Drum Design

- 32' diameter drums
- Forged Y ring
- Skirt with keyhole slots
- 2" thick C-1/2 Mo base metal, 410 cladding
- Cone angle of 30° from vertical
- 10" dual feed inlet nozzles, nozzle angle matches cone angle
- 5" thick drum bottom flange
- Z&J un-heading valve
- Startup 4Q2018
- ~23 hour cycle time
- ~450F warm up

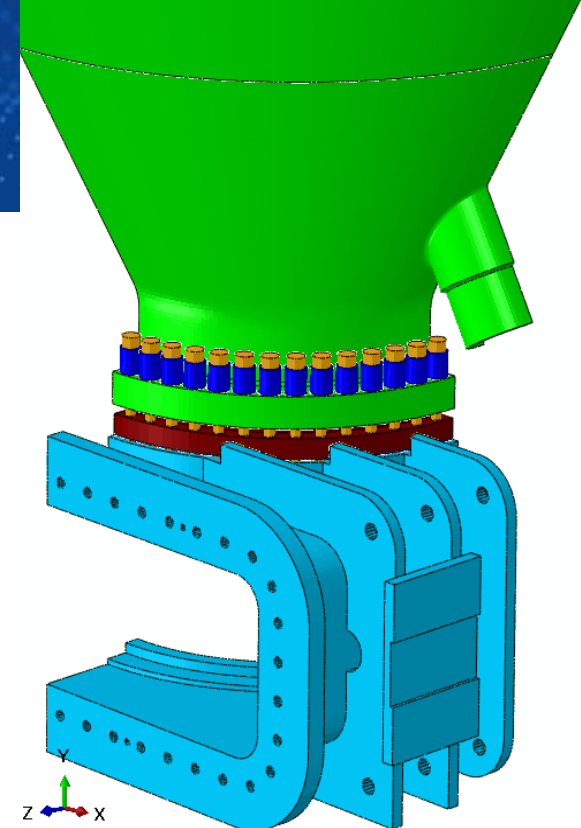
Approach and set up of FEA

- Analysis Objective
 - Determine if flange deformation and leakage is caused primarily by nonuniform circumferential temperature distribution or asymmetric radial stiffness of the BUD valve.
- Finite element analysis performed through Integrity Engineering
 - 3D model of BUD valve obtained from Z&J.
 - Process data and external temperature measurements used for boundary conditions model calibration.
 - ¼-symmetric, transient, coupled temperature-displacement model.
 - All flange attachment components included in model
 - Bolts including contact between flange bolt holes
 - Belleville washers
 - Gaskets (including non-linear material behavior)

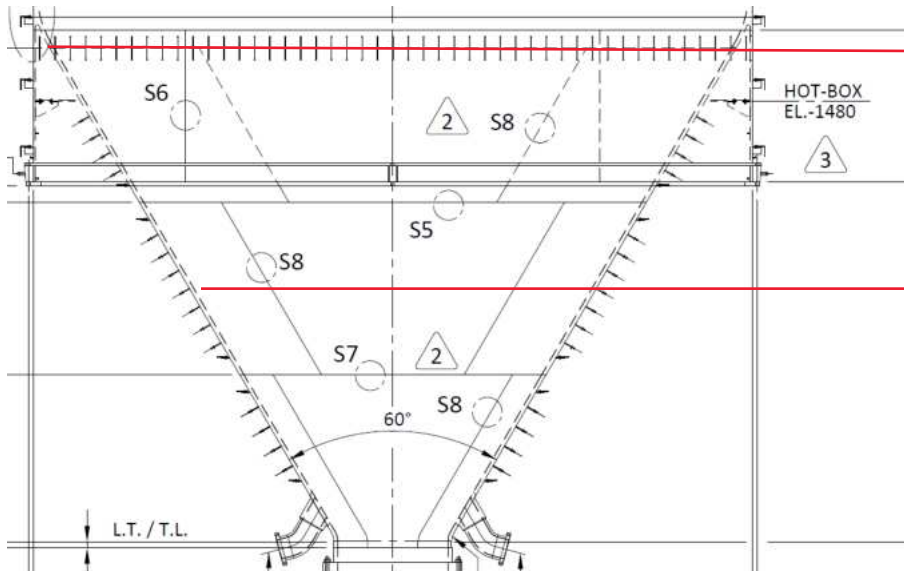
Cone Laser Scans

- Severe flange distortion – ovalization
 - In plane of dual feed nozzles
 - 1.3” diametrical flange distortion, varies across 4 drum set
 - Worsening over time
 - May 2022 (~650 cycles) → 1.1” deformation
 - October 2023 (~750 cycles) → 1.38” deformation
 - Joint leakage
 - Gasket failure
 - BUD tapped hole thread damage
- Severe cone distortion
 - Generally ovalized, >4” difference in diameter
 - Localized areas of wrinkles
- Beginning to see anchor bolt failure

- **Install Center Feed Devices (CFD) on all 4 drums** to eliminate temperature gradients.
 - Requires lower cone replacement
 - Challenging fit-up due to cone distortion
- **Flange replacement** is an interim repair, but **not recommended**.
 - Cone distortion and fatigue life consumption will continue leading to pressure boundary cracking.
 - Fitting the new cone later will become more challenging. Poor fit-up will result in future cracking
 - Flange leakage and anchor bolt issues will continue

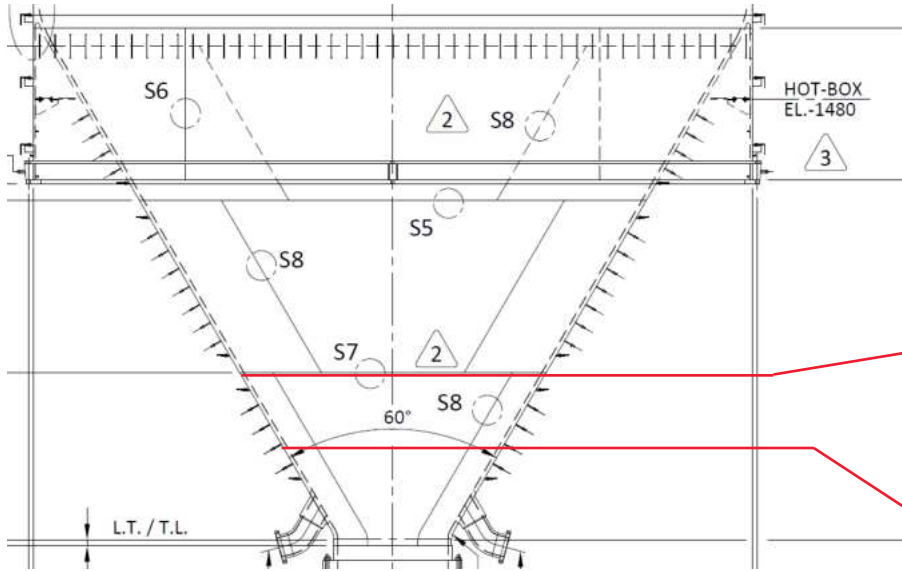
Cone Laser Scans – cont'd

All Four (4) Drum Polar Plots:
Elevation -6000mm

Drum	Min	Max	Diff	Change
D401-22	-3326	-3242	+84	+1
D501-22	-3331	-3248	+83	+22
D701-22	-3307	-3245	+62	-15
D601-22	-3325	-3248	+77	-
