# 2017 CHEVRON COKER SAFETY & RELIABILITY

- Presentation for REFCOM Conference – DELAYED COKER
- May 2017

- Bottom unheading injury
- Furnace transfer line loss of containment
- Furnace transfer line cleaning – coke ignition
- Furnace tube thinning investigation

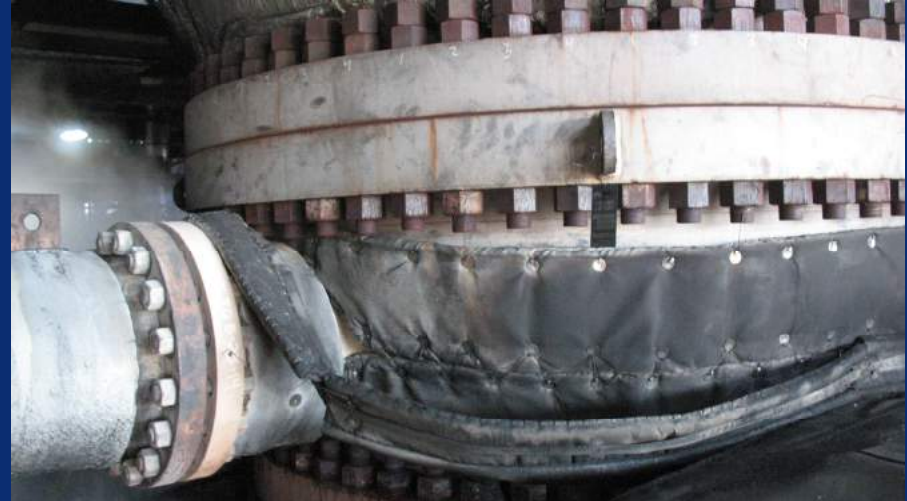
- 6/1/2016 Coke Drum Sequence
- Feed
- Switch
- Steam strip to main fractionator
- Depressure to blowdown
- Quench - 157,000 gallons, good  
(V-510 condensed steam 33,000 gal, normal)
- Vent below 2.0 psig (normal)
- **Drain - poor, did not drain much water**
- Unhead – Opened BUD from remote location
- Normally water rushes out from 60" BUD opening if the drain has been poor.
- In this instance, coke bridged and held water and coke in the drum until....

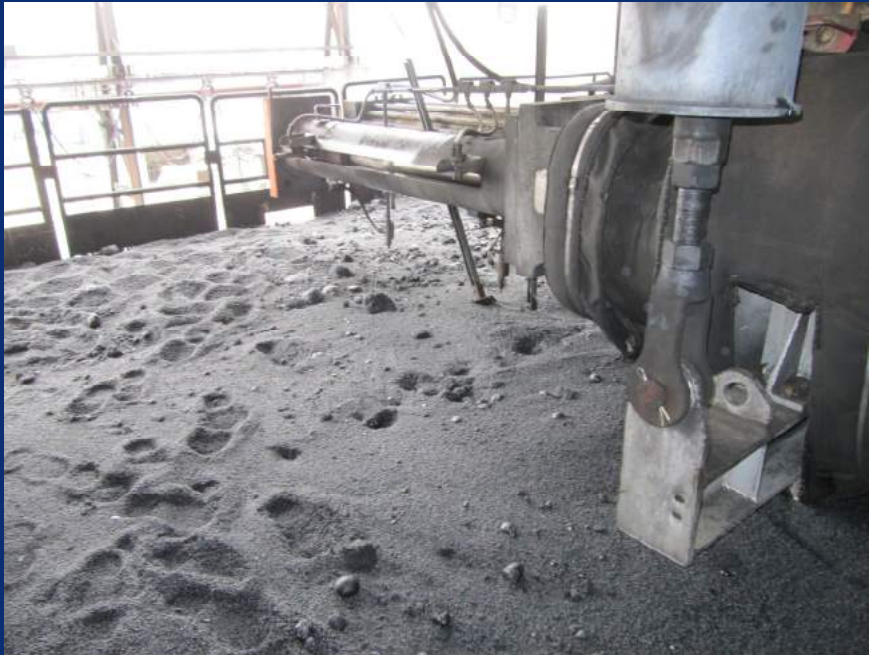
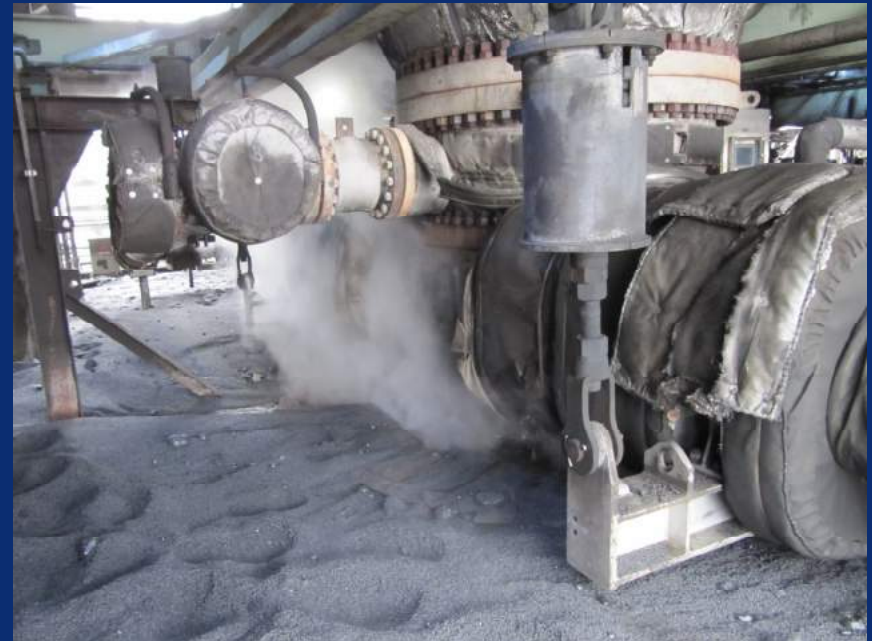
... structure operator came down from blowdown (middle) deck to feed / unheading (bottom) deck to insert locking pin into the “valve open” position. (About 10 minutes after opening BUD).

The fall-out of coke and water occurred at that point in time. Coke and water overwhelmed the stationary chute into the pit, backed up and came out the ~ 6” gap between fixed chute and stationary chute.

1. IMMEDIATELY STOP Re-INSERTING locking pin after opening BUD until after the energy source (coke & water) has been removed from coke drum. Recommend inserting after coke has been cut to verify that the BUD limit switch is in correct position, fully opening the gate. Verifies an edge of the gate will not be in path of falling coke and experience erosion during coke drilling operation.
2. Continue and complete the fixed chute replacement. Monitor new design performance; has it stopped coke back-up onto bottom unheading deck?

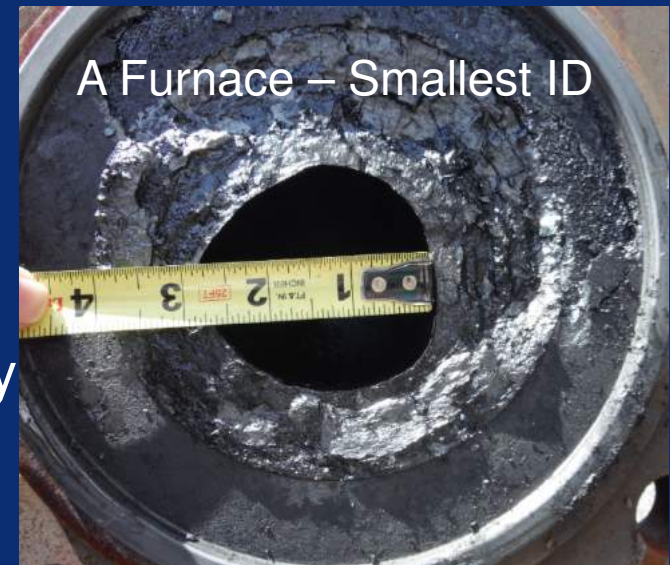
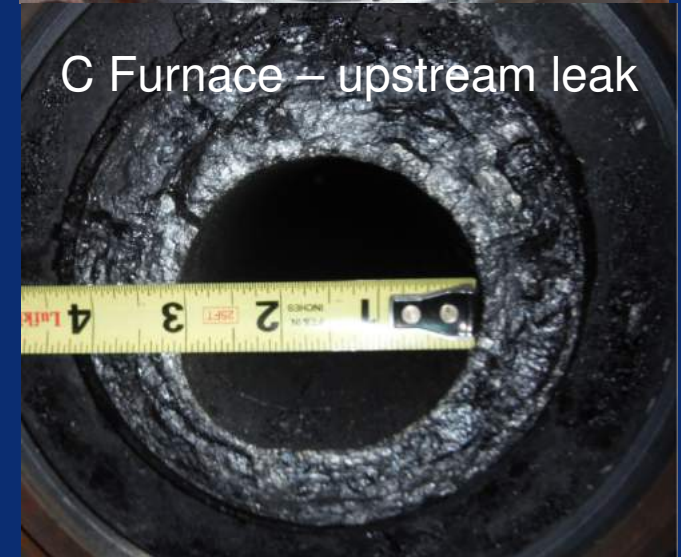
- Elevated coke build up in the transfer piping increased velocity of spalling steam/coke fines, accelerating erosion.
- Condensate rates in the Spall Procedure were set at a previously inspected ID of 3.9".
- ID in C Furnace 6" piping ranged from 3-3.5".
- Spall velocity ranged from 500-600ft/s.

- Lower the condensate rate during spalls in the procedure, which lowers the velocity and erosion.
  - Spalls have been equally effective.

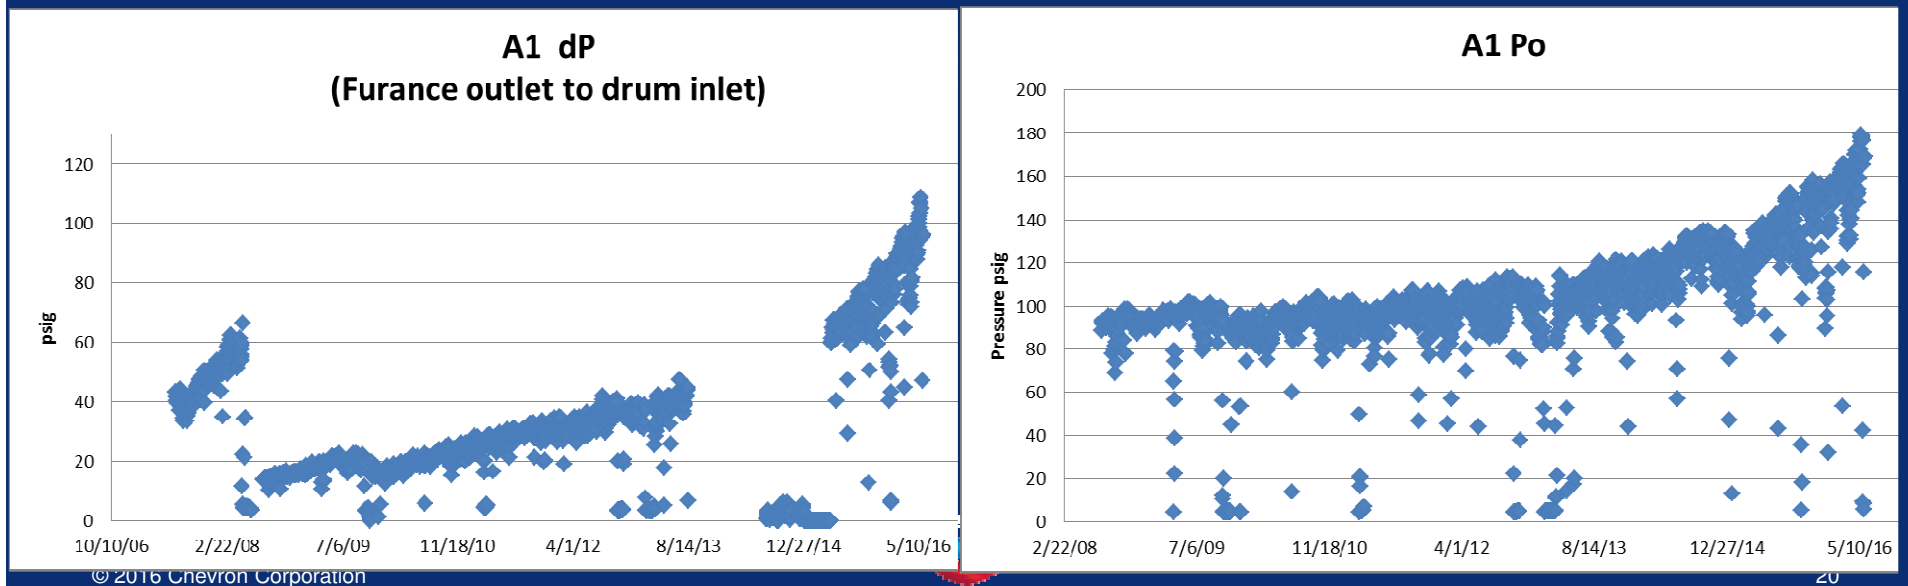
- dP in the furnace outlet piping has increased since the line has been replaced and/or hydroblasted.
- Increase is evident in all 3 furnaces (highest in A).
- Increases exponentially over time as would expect with dP correlated to  $\text{diameter}^5$ . Also no step change indicating it was not from a single event.
- Increase in pressure indicates increased coke formation.

- Set a limit on furnace transfer line dP which will trigger Operations to open, clean, and inspect the transfer line.
- Develop and implement an asset strategy plan on the Furnace transfer line.
- Eliminate and/or minimize the affect of quench steam in order to reduce channeling.
  - Install Cushion Tee's which avoid the 90 degree mixing point and impingement of coke fines during spall on first elbow.
  - Consider increasing transfer line temperature limit during spalls in order to eliminate quench steam.

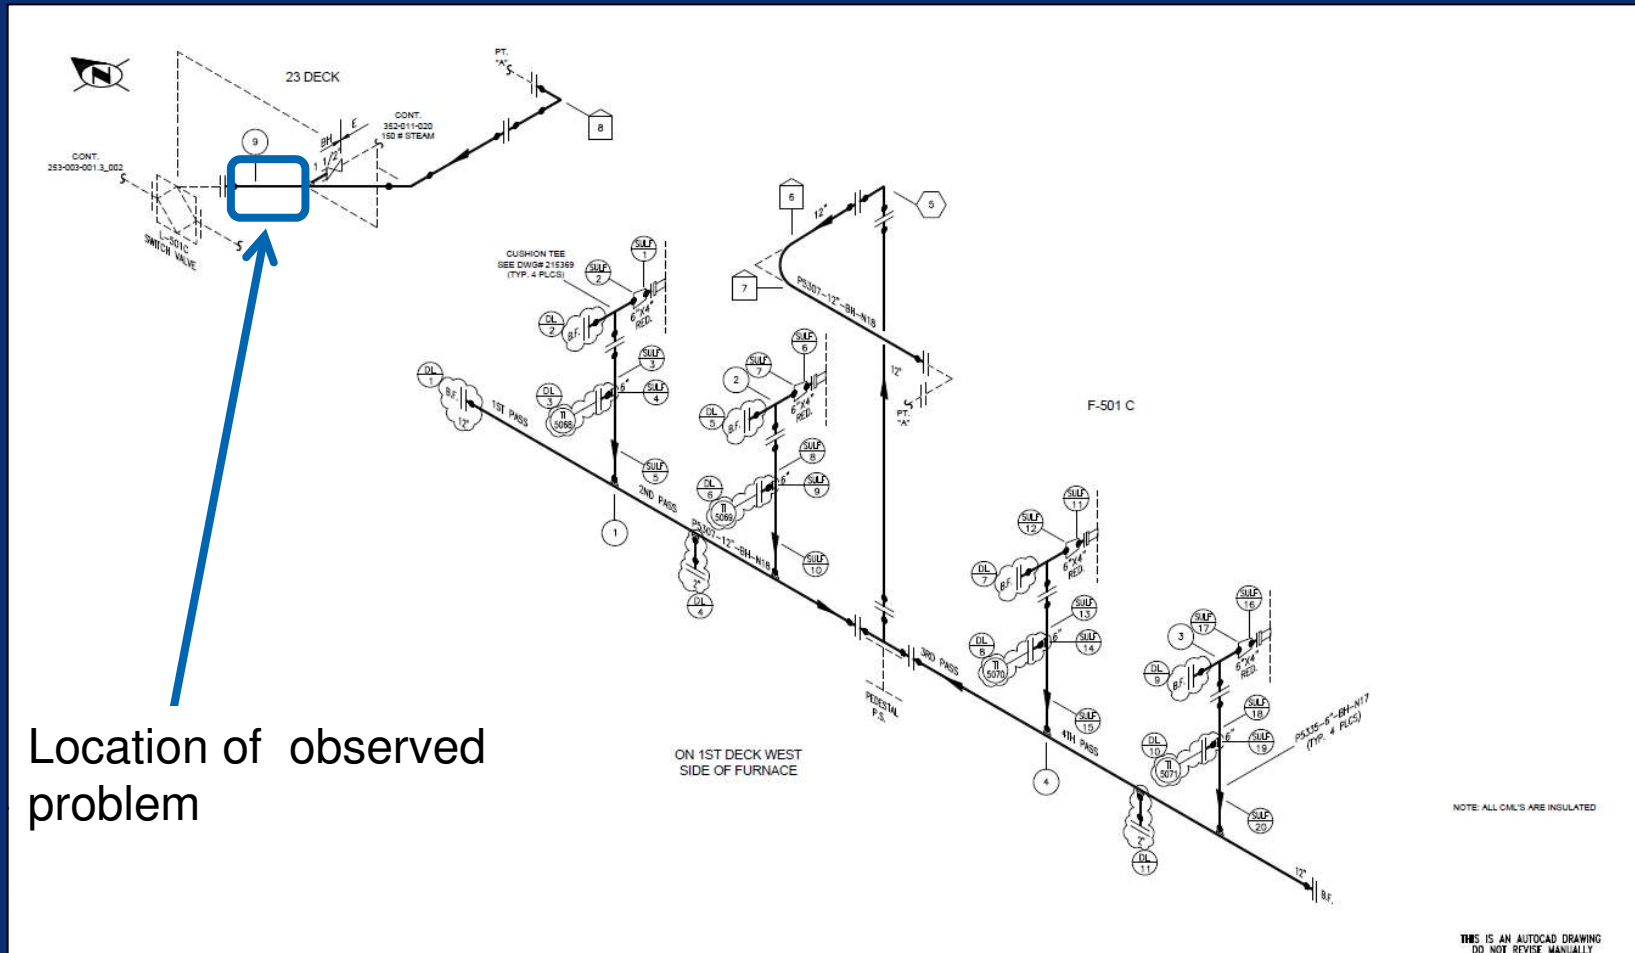
Location of observed problem

Observed sagging elbow.

- Performed hardness testing
  - Showed tensile strength slightly above 60-85 ksi (ASTM A387 spec for 5Cr class 1 plate)
  - Concluded no considerable damage re: mechanical properties. Line deemed fit for service.
- Stress Calcs:
  - Caesar modeling showed 2-3 ksi max stress.
  - API 579 calcs - exposure temp was ~1500-1600F to yield/creep at 2-4 ksi
  - Recommended a new pipe support to eliminate potential for future damage due to creep/yield.

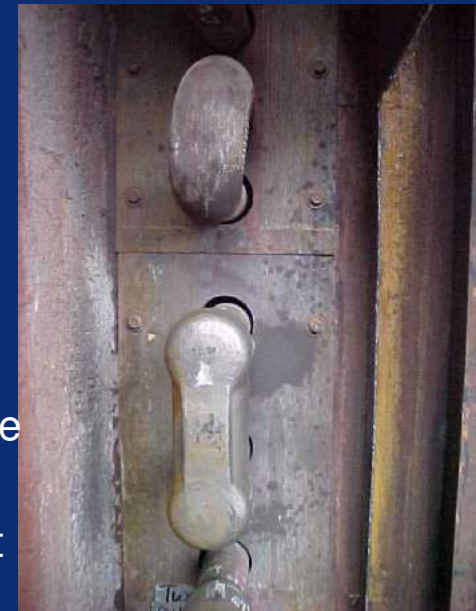
U-bend  
hole

- Raise radiant roof tubes to eliminate “suspended brick” design.
- Initial rounded U-bend replacement with flatback.

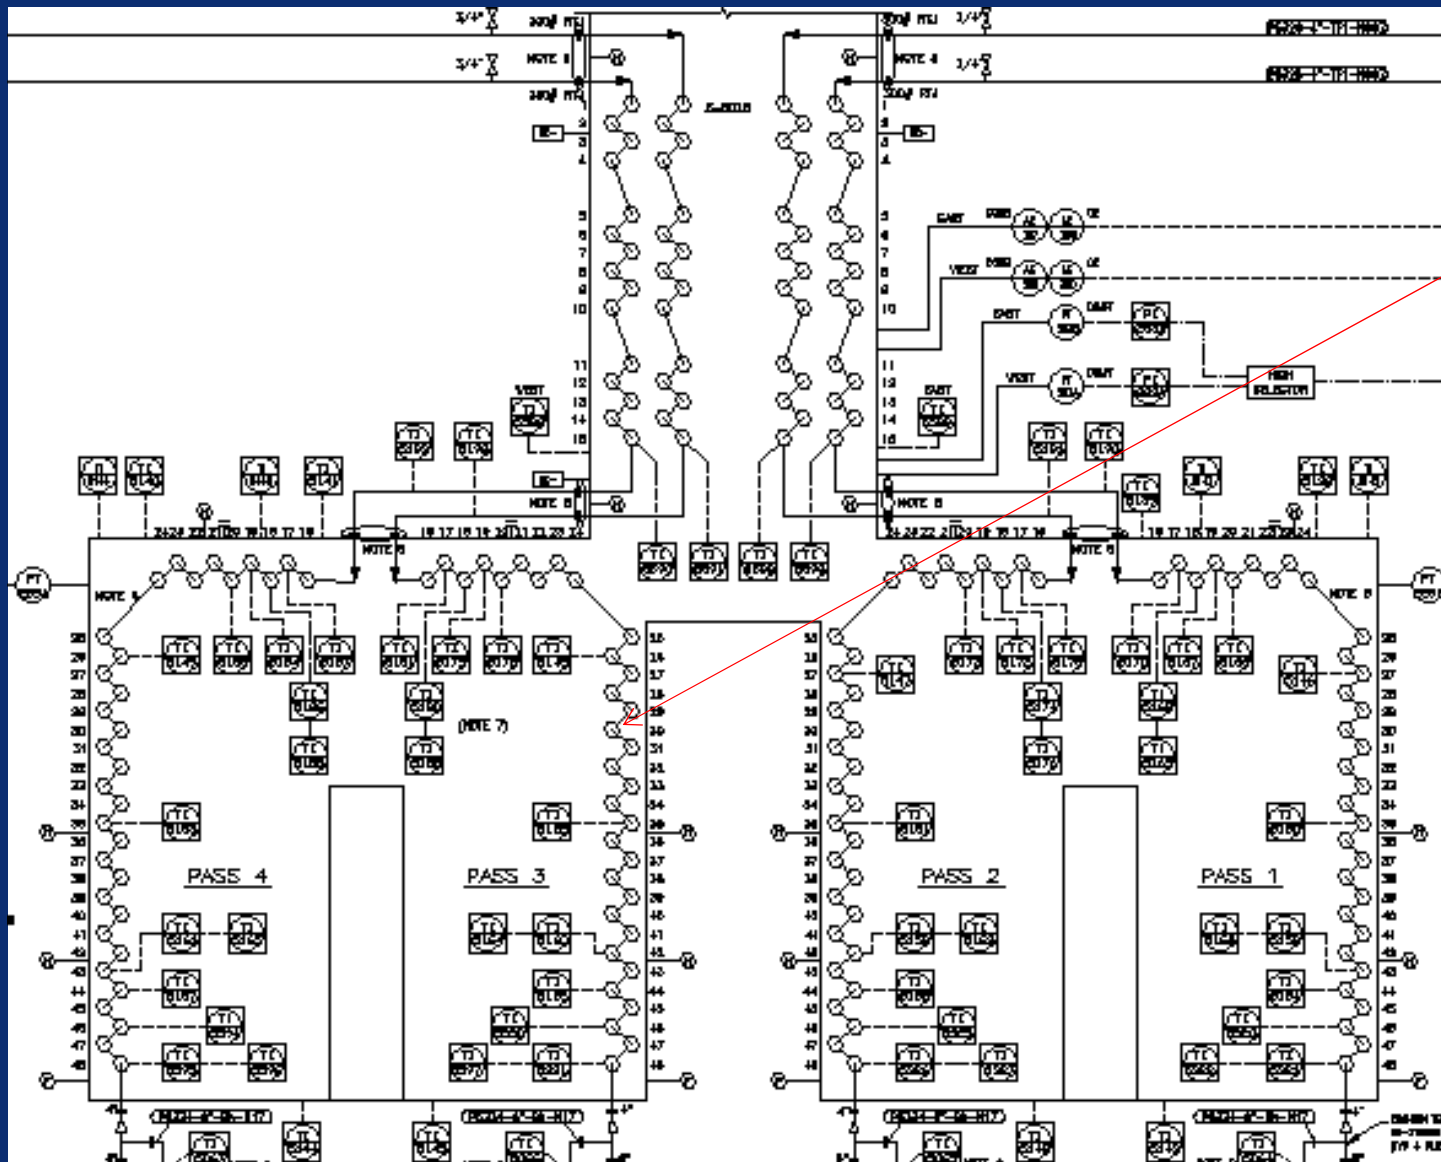
Tube 30  
Pass 3  
F-501B

Circumferentially, damage is only 4:00 – 7:00, the tube side that “sees flame reflected from wall”. Back side of tube is nominal, 0.226".

- Confirmed 347 SS tubes.
- The H for high carbon grade was not confirmed.
- Dark spots indicate higher presence of carbides.
- Carbides forming within individual grains towards the inner surface.
- CARBURIZATION damage is occurring toward the inner surface during normal operation.
- THINNING occurs by spalling off carburized metal during temperature cycling in coke removal process.

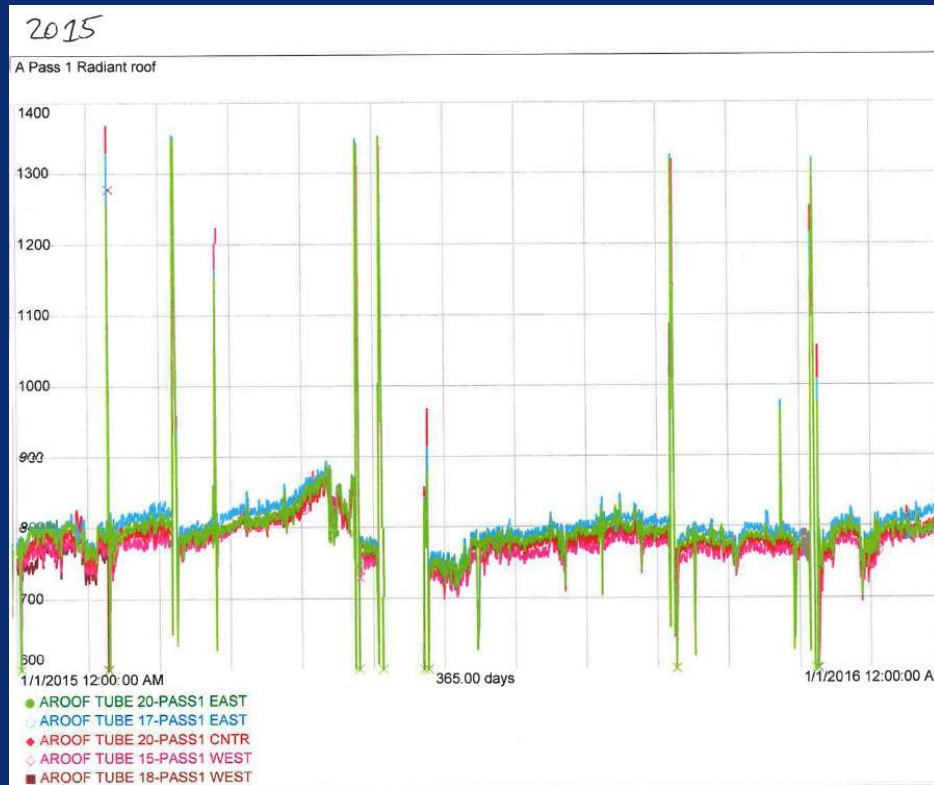
# F-501A Pass 1 Radiant Roof Tubes

Short duration spikes are during coke removal.

F-501A/B/C roof tubes have maximum TMT under 1000 F. No convection section TI excursions. Tube wall loss is similar for radiant roof and radiant wall, which runs at much higher skin temperatures. Radiant roof temperature is well below temperature where CARBURIZATION is expected.

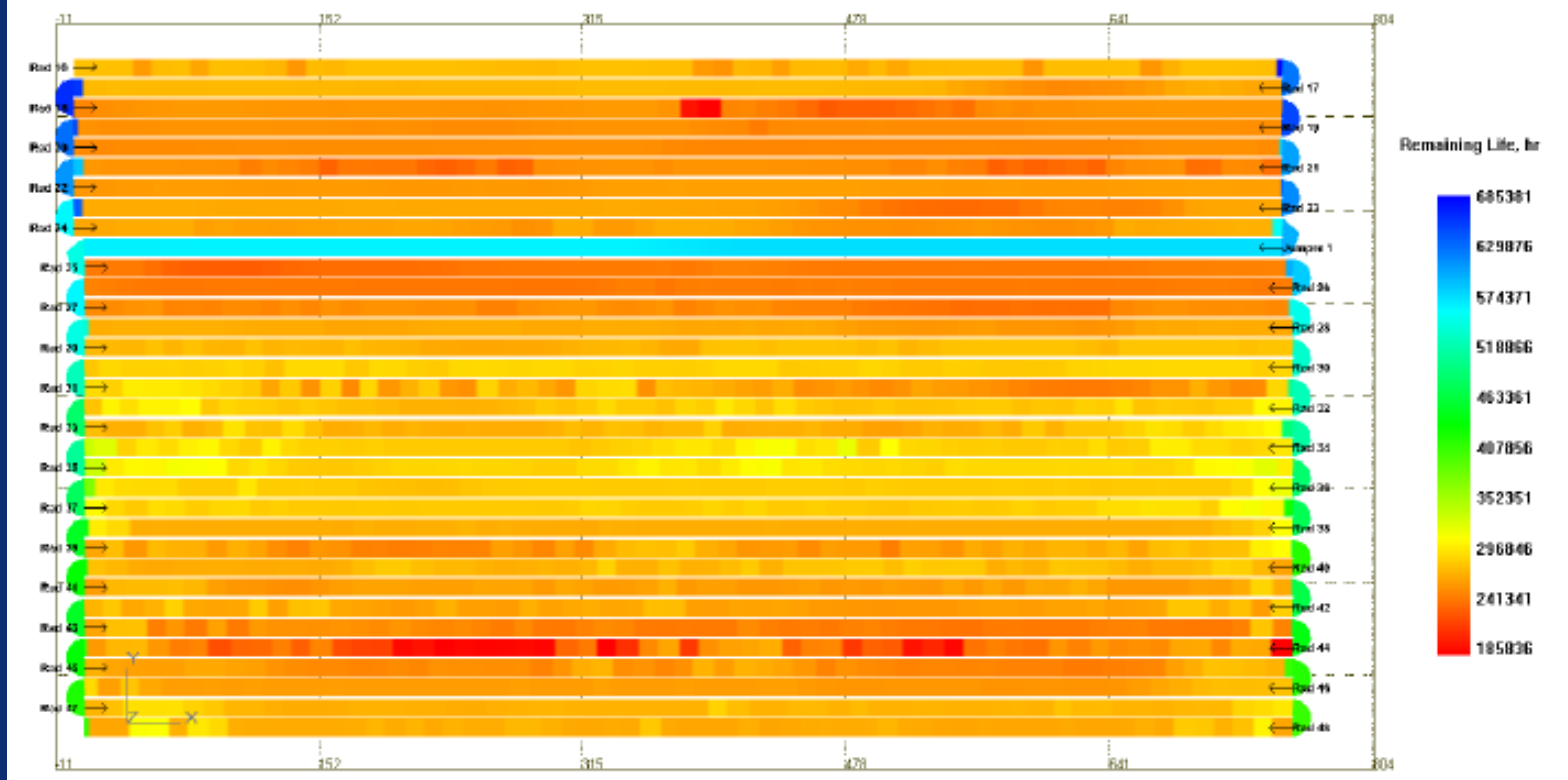
Figure 1. Failure Remaining Life for Pass 3 Radiant Tubes

DWW: Furnace tube remaining life pretty uniform; not longer for roof radiant tubes which have not seen high temperature. Furnace tube thinning seems to be independent of skin temperature??

The Radiant tube metal loss rate was significantly higher than expected based upon the material (347H stainless steel) and the sulfur content of the feed. Chevron had reported the elevated metal loss rate was due to carburization damage, but the Quest Integrity metallurgical evaluation and the operating TMT assessment did not support this conclusion. The metal loss rate is most likely the result of the high temperature sulfidation mechanism. The elevated rates could be due to various reasons, such as naphthenic acid content of the feed, frequency of descaling operations, etc. It is also possible that localized hot spots may contribute to the metal loss damage rate, although these hot zones have not been reported in the infrared monitoring. Chevron should further investigate the Radiant metal loss damage rates and take appropriate actions to reduce or manage the damage rates.

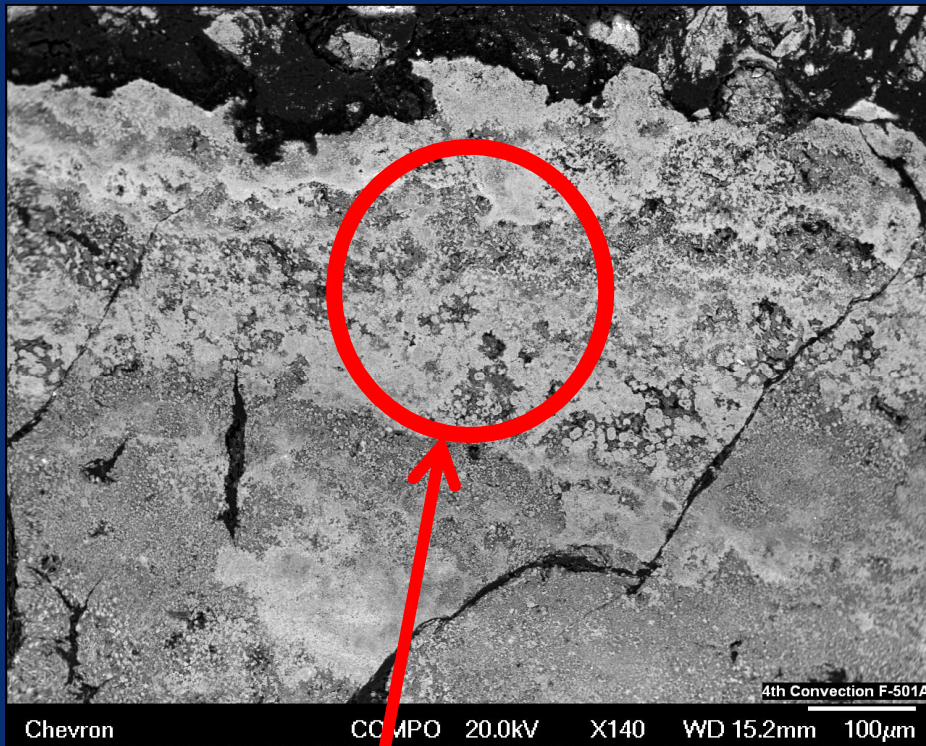
Lighter areas have  
high calcium content

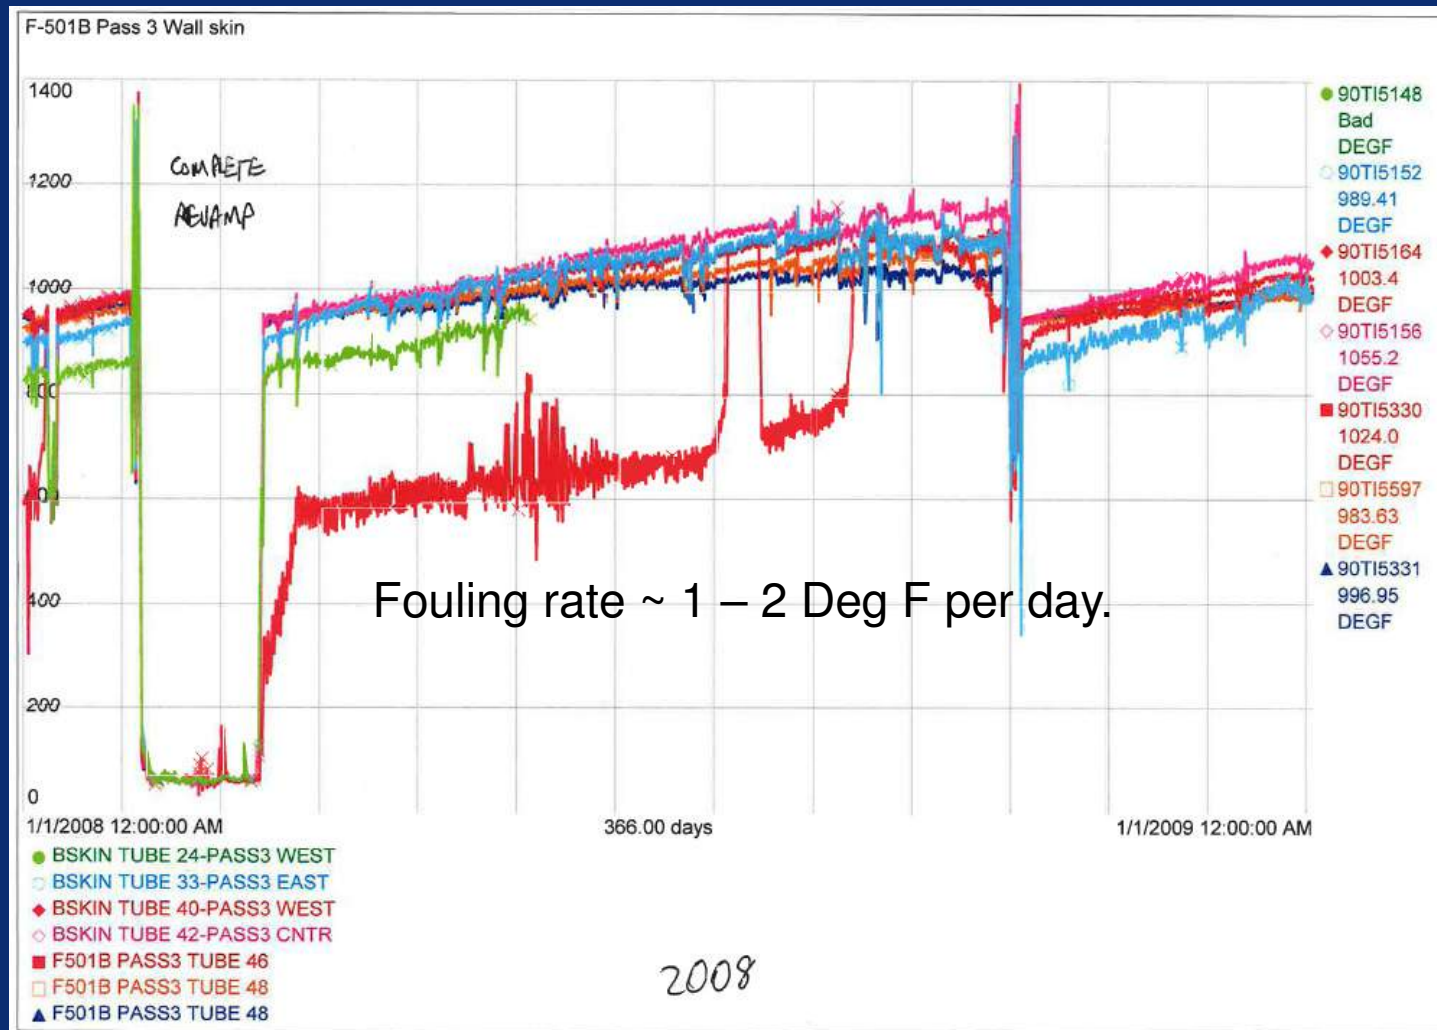
# Furnace Fouling Rate: F-501B in 2008

- Key process monitoring by Engineering / Operations is the increase in Coker furnace tube skin temperatures.
- Many factors can affect furnace fouling rate, especially with a balanced draft design.
- There has been a marked increase in coke removal frequency from 2014-2017 compared to 2008 – 2011.
- After coke drum replacement in 2014, Coker feed rate & operating factor increased – no drum cracks. Annual furnace rate has increased but operating day rate has not changed significantly.
