Coke Drum Repair

Coker Weld Overlay Project

Bulge Repair of Coke Drum Utilizing Temperbead

Skirt to Shell Weld Repair with Temperbead Process

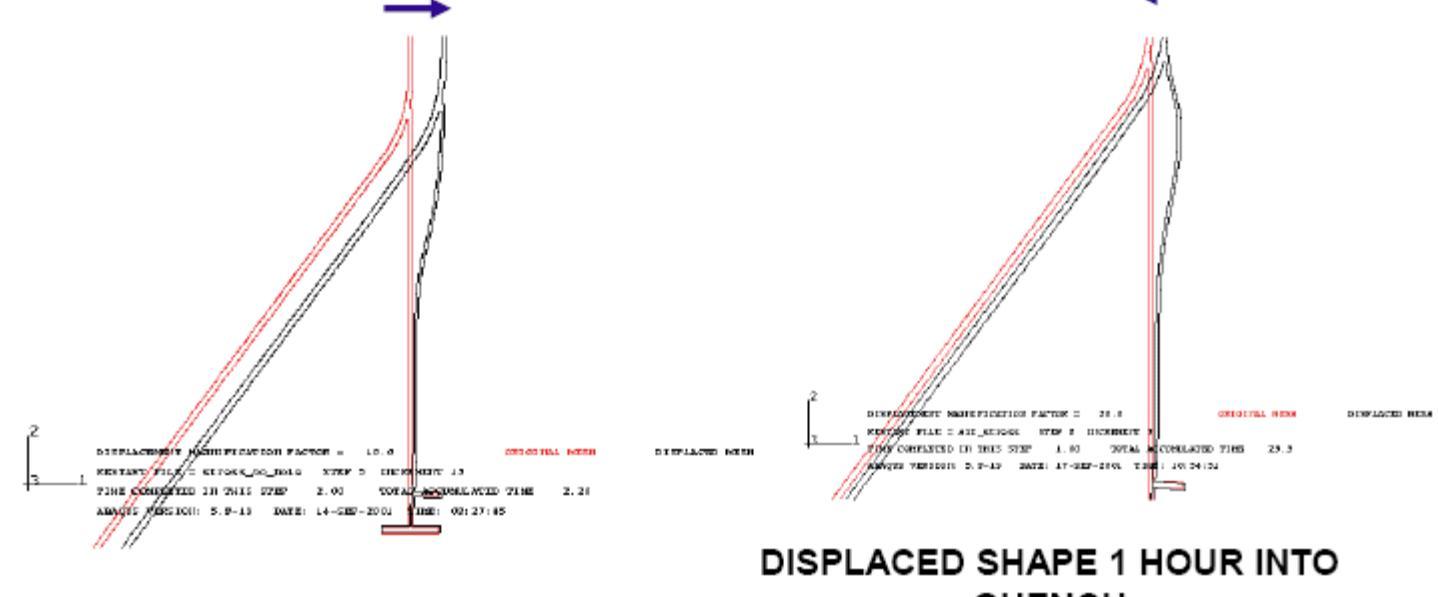
Skirt Cracking During Quench - Skirt is Pushed and then gets Pulled by Knuckle DISPLACED SHAPE AT THE END OF FILL

QUENCH

(MAXIMUM STRESS DURING QUENCH OCCURS HERE)

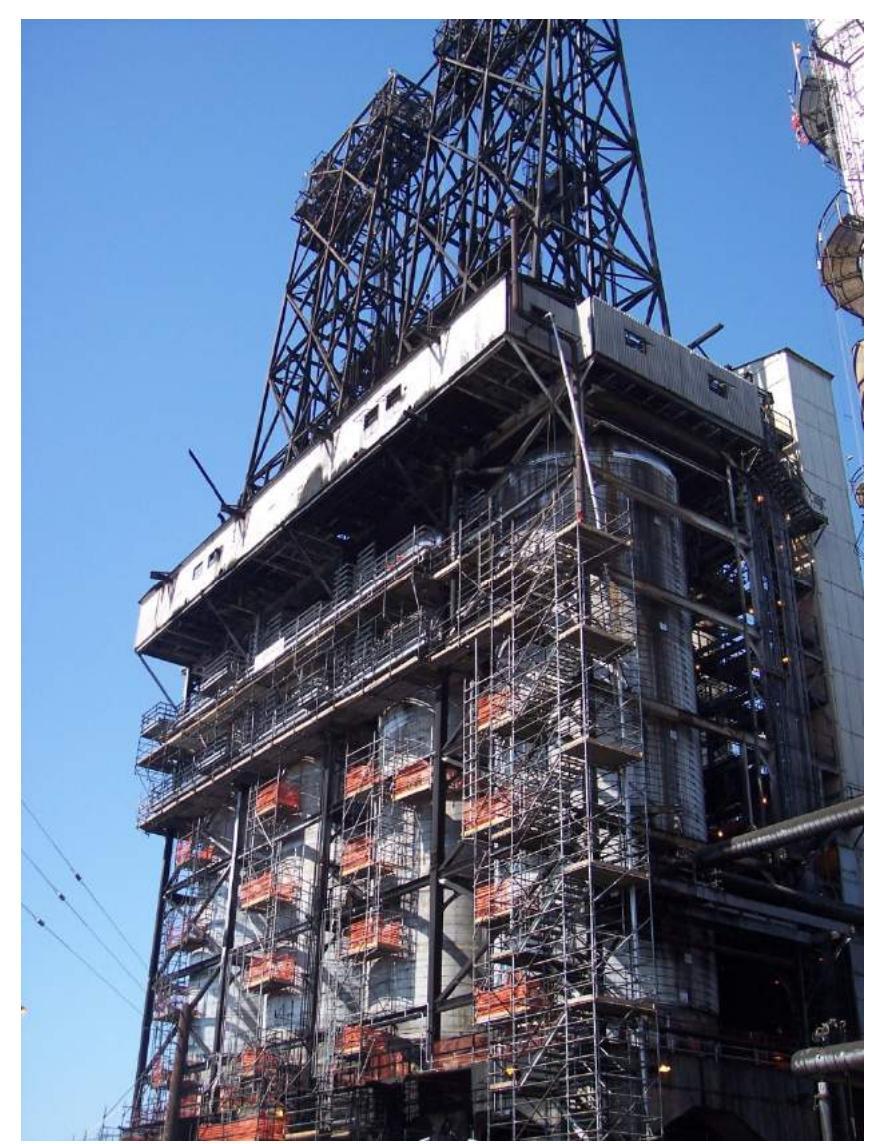
- T/A to Retro fit (4) four Coke
 Drums to accept new Delta Valves
- Coke Drum Material: SA387, Grade C, 1 ¼ Cr ½ Mo, 25mm thick
- Perform repairs to existing 410 explosion bonded cladding by applying over 115sq.m. of Inconel 82 Overlay in cone section above bottom nozzle
- Schedule: 10 days for all four drums total completion

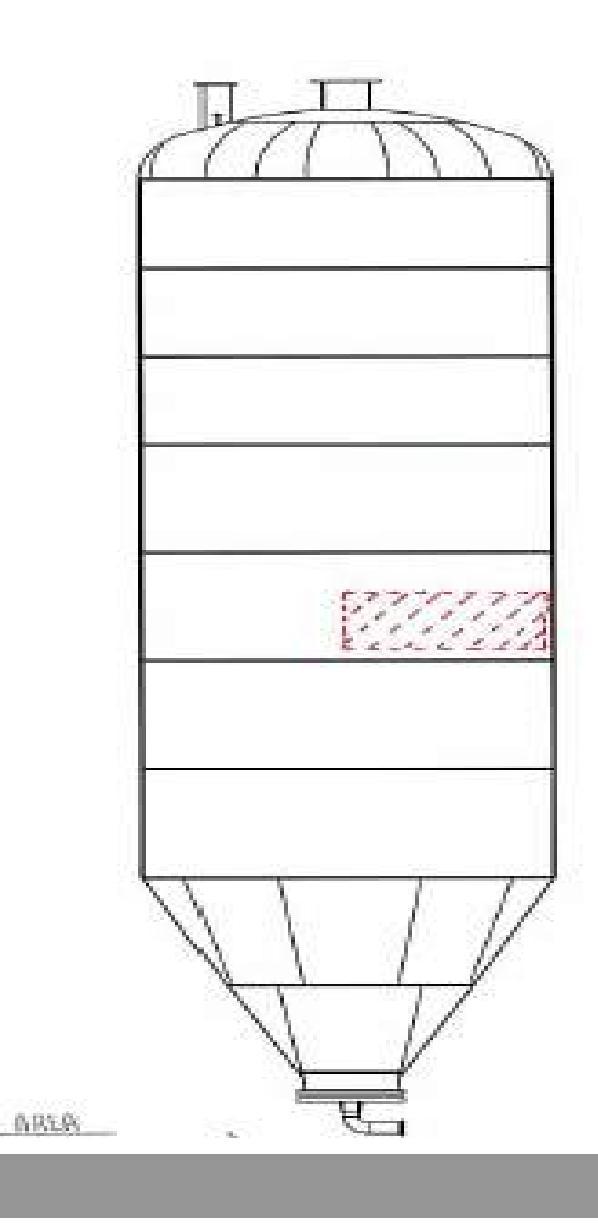
Bulging Coke Drum

- 8 Coke Drums
- Material: SA 263 Grade C
- Wall Thickness: 22.3mm
- Diameter: Ranging from 7925mm to 9755mm.
- Size: Ranging from 20m to 29m.
- One of the Cokers was experiencing bulging due to fire in drum

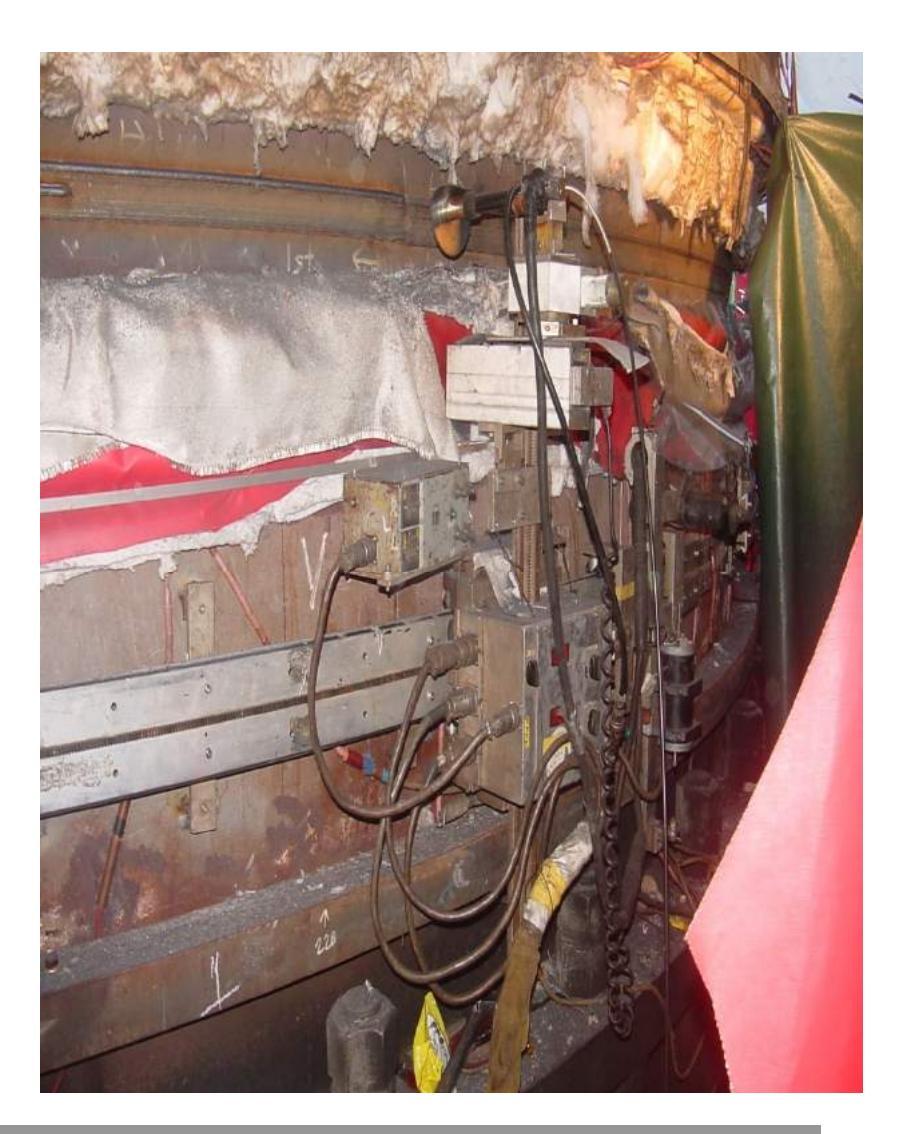
- 2 Coke Drums
- Tower details:
 - SA-387-Grade 11 material
 - 31.7m tall
 - 8m ID
 - Original wall thickness 31.75mm
- Turnaround inspection:
 - 2003 T/A repaired weld seams in Coker # 2
 - May 2006 found many indications approximately 5mm deep, 25mm long, throughout the entire circumference of the weld seam in both drums

- Stick Welding:
 - Already had contracted with local general contractor to gouge and reweld, and it was going to take 3 outages to complete.
 - 3 Outages x 5 days = 15 Days required
- Automated Welding :
 - Utilize Temper bead technique
 - Work on both Coke Drums simultaneously
 - Eliminate PWHT

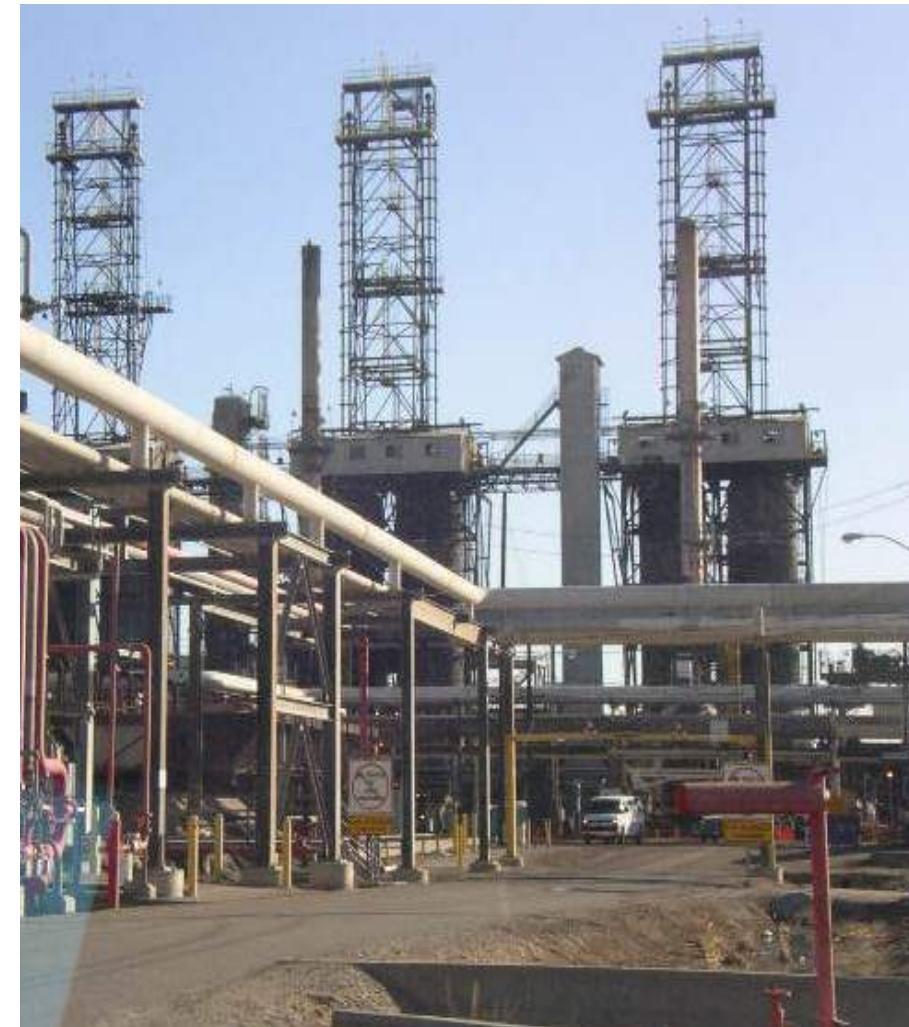
- 12 Drums
- Material: SA 387-12-CL2
- Drum Thickness: 1.377"
- Height: 90' Tan Tan
- Diameter:18'5" ID
- Customer was experiencing cracking below skirt to shell weld. Changed the skirt design (key hole slot) to reduce stress on skirt to shell weld.
