## Innovative Coke Drum Repairs

Coking.Com Workshop  
Galveston, TX  
03/24/2009

Welding Services Inc.

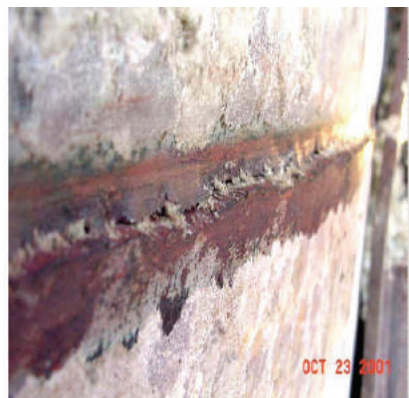
- Cracking
  - Circumferential seam
  - Skirt to Shell welds
  - Shell cracks
- Bulging
  - Circumferential Seams
  - Shell Course
- ID Corrosion
  - Delamination/wear of I.D.

**Many skirts are cracking within 5 years of operation**

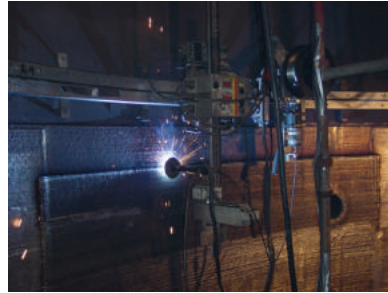
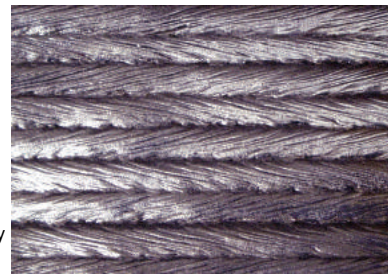
- (2) Large projects occurring in Coker (Installing Delta Valve's and Overlay work)
- Schedule: 10 days
- Reducing Cost
- Improving Quality
- Reducing Safety Instances

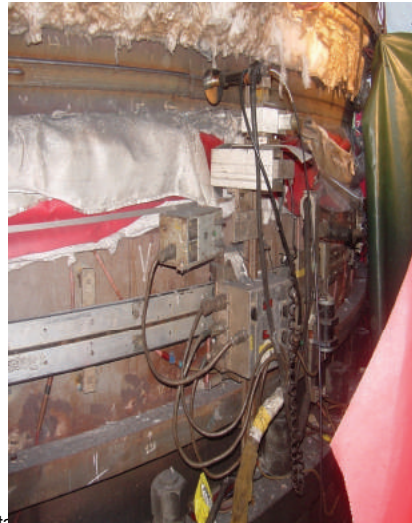
- 2 - Coke Drums
- Tower details:
  - SA-387-Grade 11 material
  - 31.7m tall
  - 8m ID
  - Original wall thickness 31.75mm
- Turnaround inspection:
  - 2003 T/A repaired weld seams in Coker # 2
  - May 2006 found many indications approximately 5mm deep, 25mm long, throughout the entire circumference of the weld seam in both drums

- Stick Welding:
  - Already had contracted with local general contractor to gouge and re-weld, and it was going to take 3 outages to complete.
  - 3 Outages x 5 days = 15 Days required
- Automated Welding :
  - Utilize Temper bead technique
  - Work on both Coke Drums simultaneously
  - Eliminate PWHT
