A DIFFERENT APPROACH TO ARREST THROUGH WALL CRACKS ON A COKE DRUM USING WELD OVERLAY

YURIK LEON
APPLICATION ENGINEER
WELD O LATINOAMÉRICA

REFCOMM[®]
BUDAPEST
2-5 Oct 2017

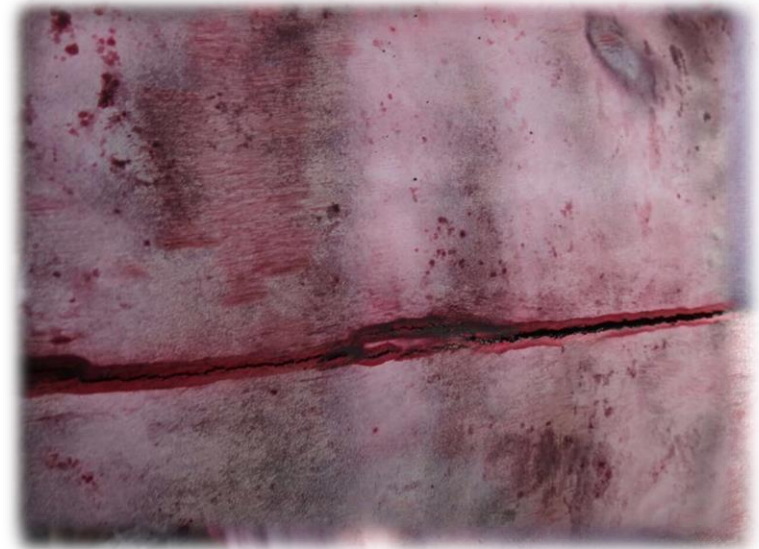
DRUM 2

UT Phased Array Re-Inspection C4 Drum 4

Lenght = 500 mm / 19.69 in
Depth = 27 mm / 1.06 in
