Coker Vessel Life Extension Repair Implementation

Structural Overlay Life Extension & Skirt Cracking Repair of Delayed Coking Unit Vessels

Refinery Located in Minas Gerais, Brasil 24,000 bpd coking unit (4 coke drums designated as A,B,C & D)

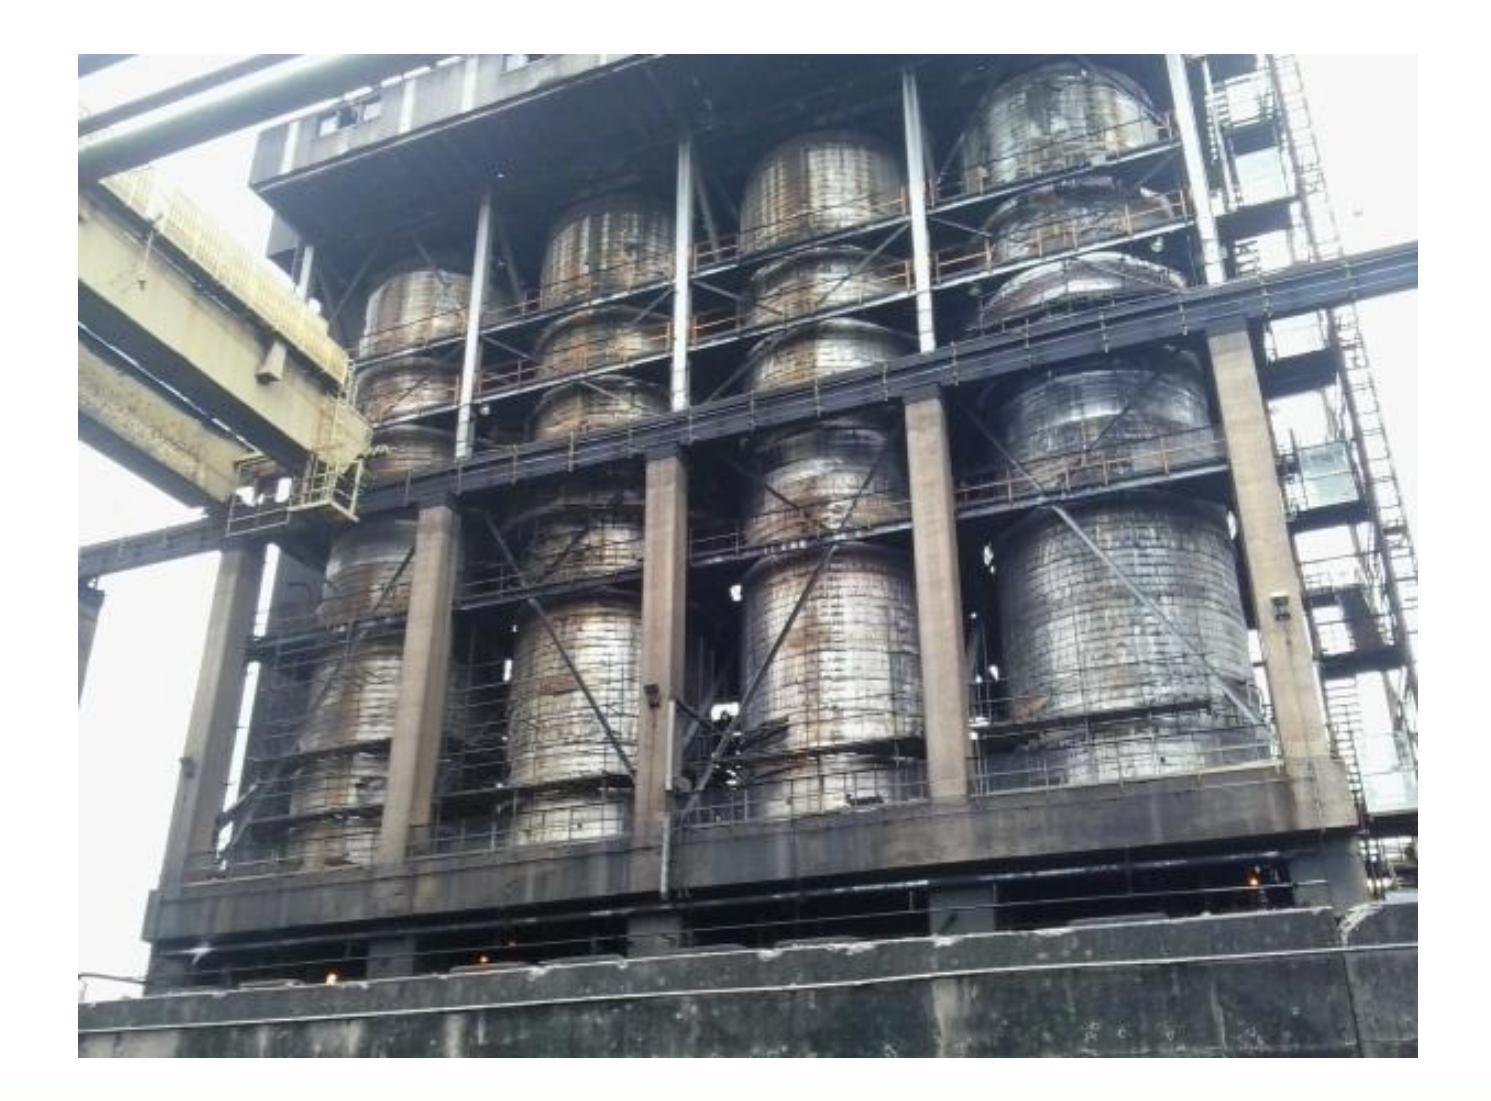
As-found Conditions of the Vessels

- Skirt to Vessel Cracking at the attachment weld location
- Shell Bulging in drums C&D which will lead to crack formation

Engineered Structural Overlay selected. New technology application for Petrobras. Significant Research and development performed with CENPES to evaluate and qualify this repair process.
