Managing Weld Stresses for Advantage in
Coker Engineered Repairs
Pedro Amador (VP&Chief Technology Officer WSI)

Coking and Cat Cracking Conference ←

Bulge Repair of Delayed Coker Unit
Karlsruhe Germany, March 2012

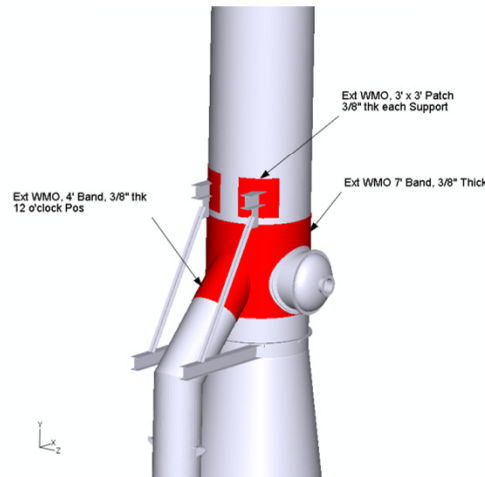
Engineered structural overlay

Post overlay stress gradients

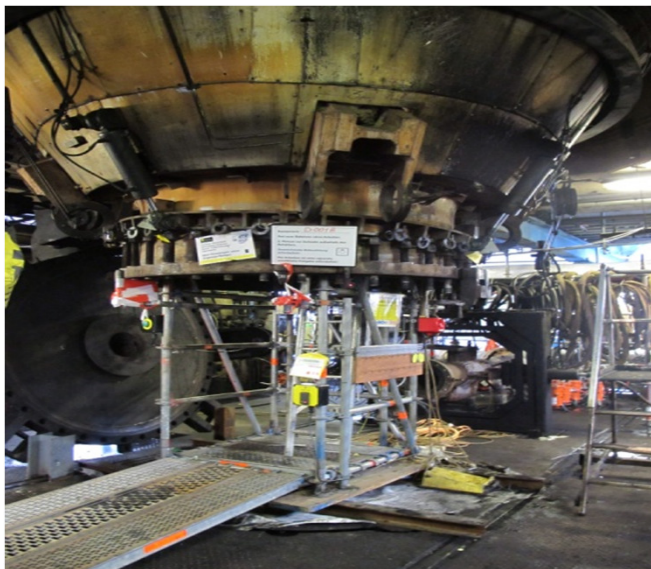
Coke Drum 001-B

Coke Drum D-001B	Coke Drum D-001B
Base Material	1,25Cr, ½Mo / 13CrMo44
Estimated remaining thickness of existing clad	2mm
Nominal thickness	40.5mm + 2mm SS410
Diameter	7315mm ID

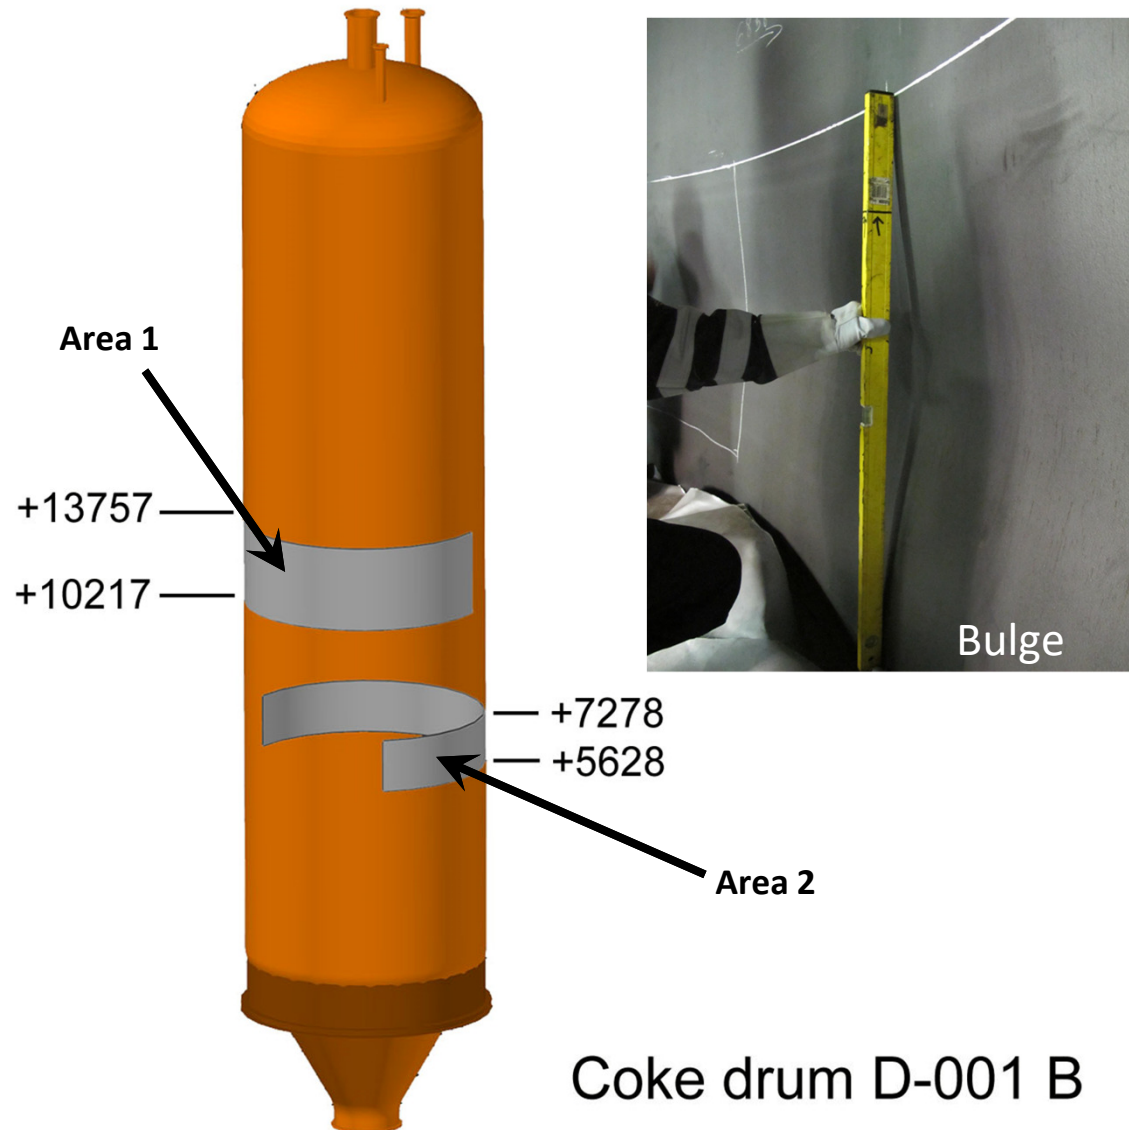
Bulge repair Area 1 (includes taper zone)	27.7m ² per layer
Bulge repair Area 2 (includes taper zone)	30.6m ² per layer
Filler material	Alloy 625
Overlay thickness per layer	3/16" (5mm)
Total Overlay one layer	58.3m²
Overlay three layers	174.9m²

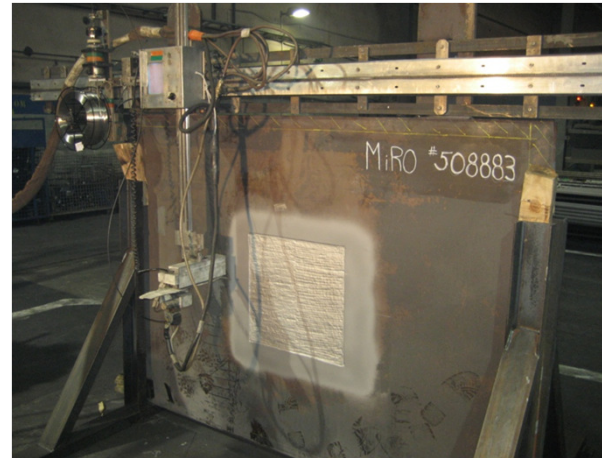
Removal of bonded cladding
