# MATERIAL TESTING AND CORROSION EXPERIENCE IN CRUDE UPGRADER ATMOSPHERIC DISTILLATION UNIT

Tore Arnesen<sup>1</sup>, María Specht<sup>2</sup>, Henry Tovar<sup>2</sup>, Erik Rodriguez<sup>2</sup>  
Statoil, Research Center, Norway<sup>1</sup>  
PDVSA Intevep, Research Center and Technical Assistance, Venezuela<sup>2</sup>

**REFCOMM**  
RIO DE JANEIRO

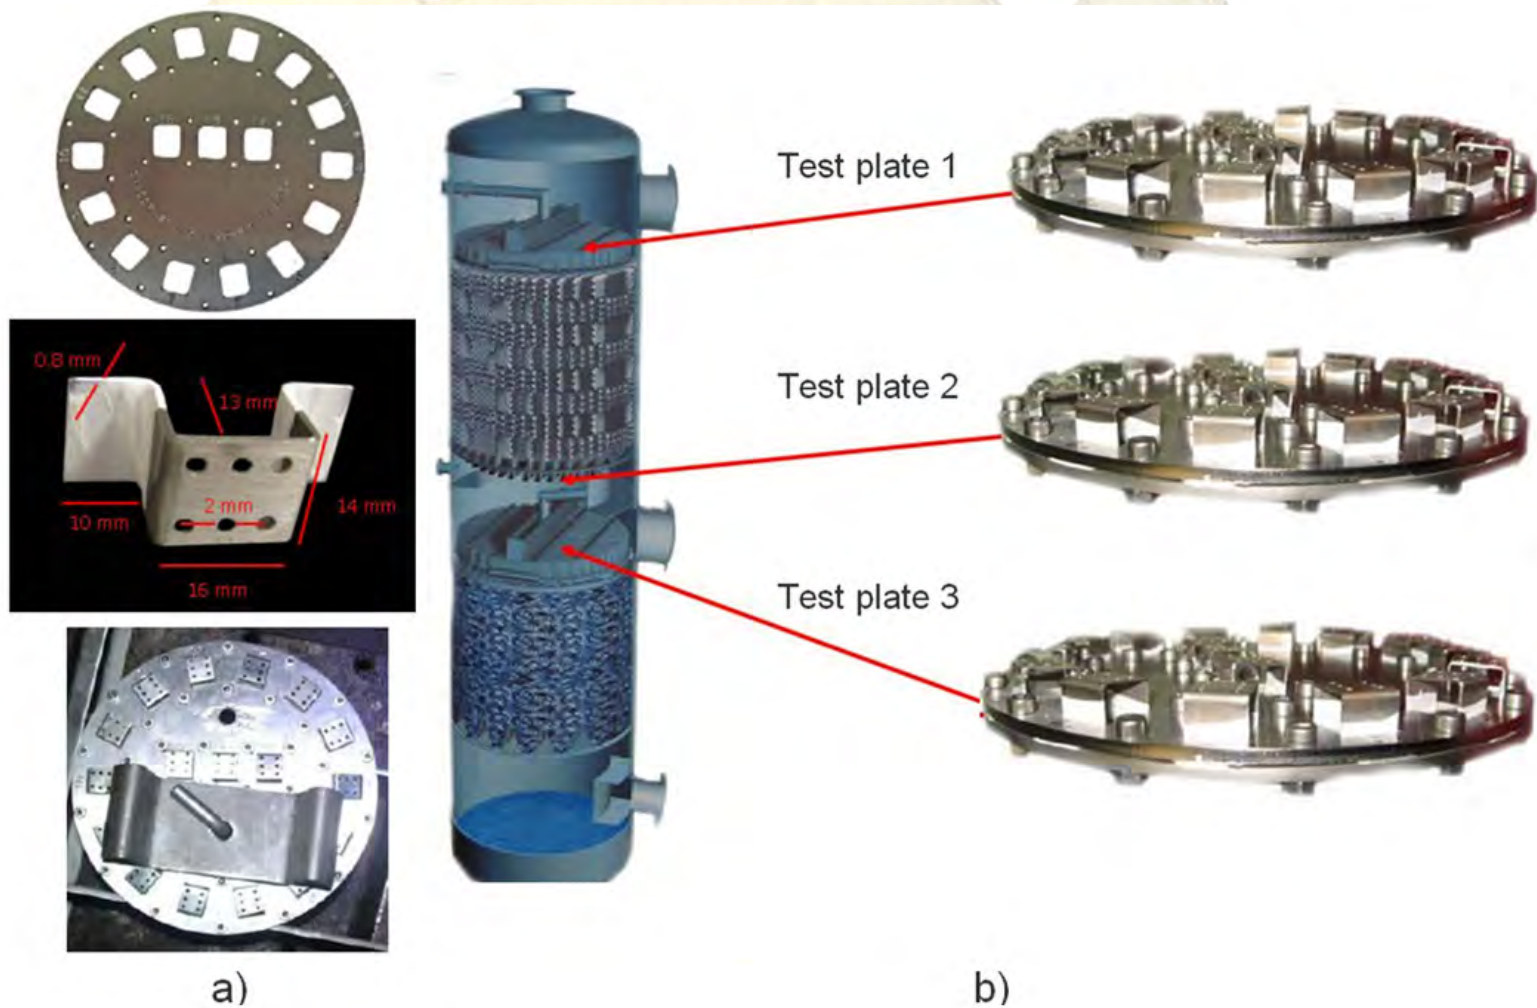
Test plates were designed containing 17 different materials. They were installed with the tower internals. The data collected after analysis would be useful for material selection process in crude distillation units of extra heavy crude oils Upgraders.

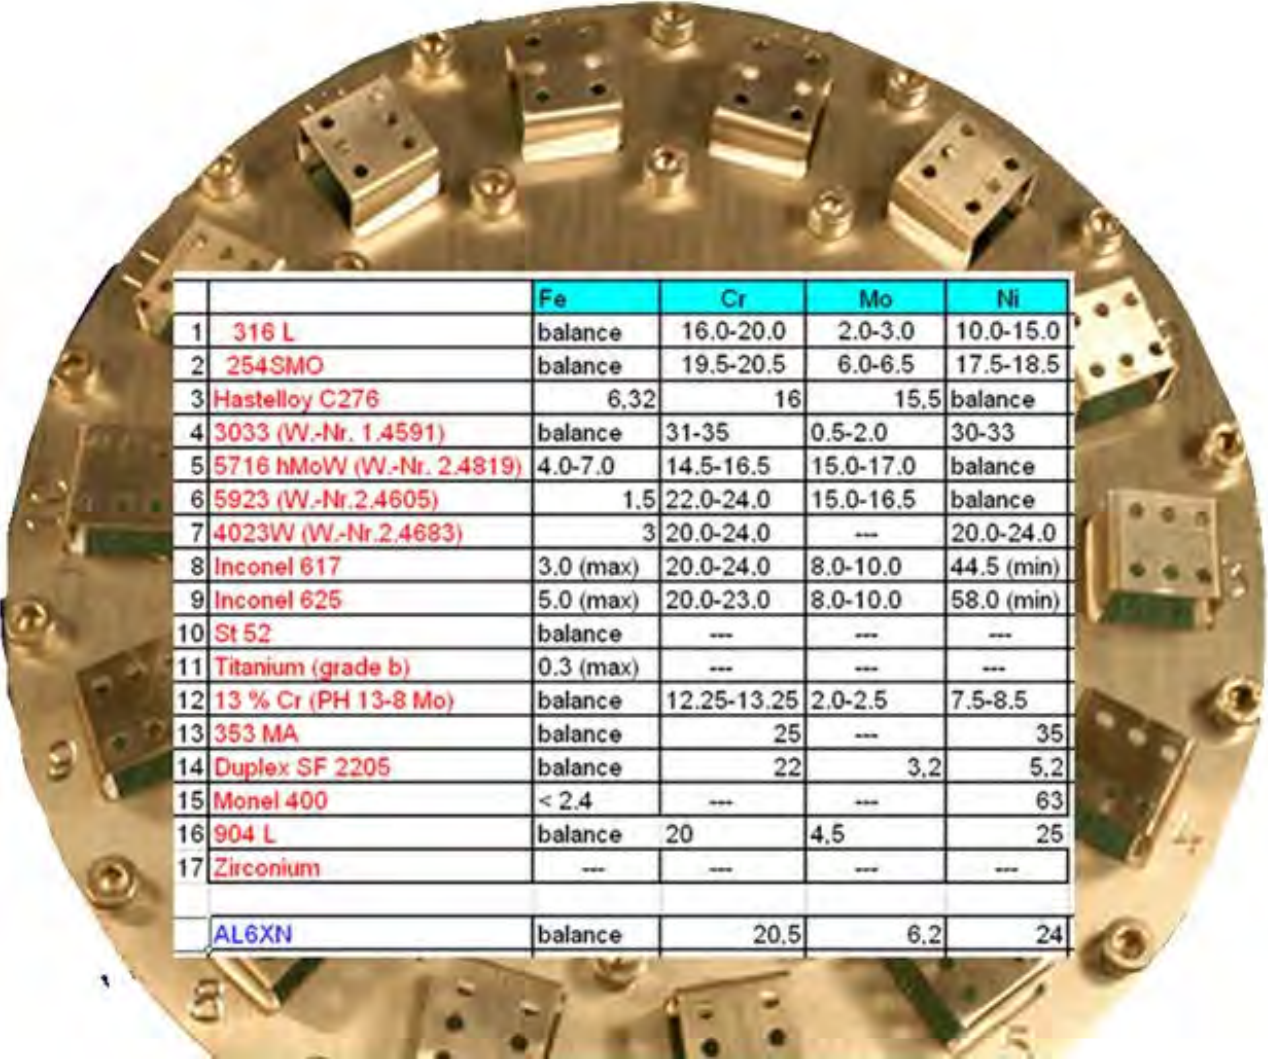
Most of the coupons were austenitic stainless steel (with a considerable high content of molybdenum) and nickel alloys. Carbon steel, zirconium and titanium were also included.
