# Repair and Retrofit of a Coke Drum Skirt Attachment Weld

Coking.com Meeting Fort McMurray, Alberta, Canada October 2012

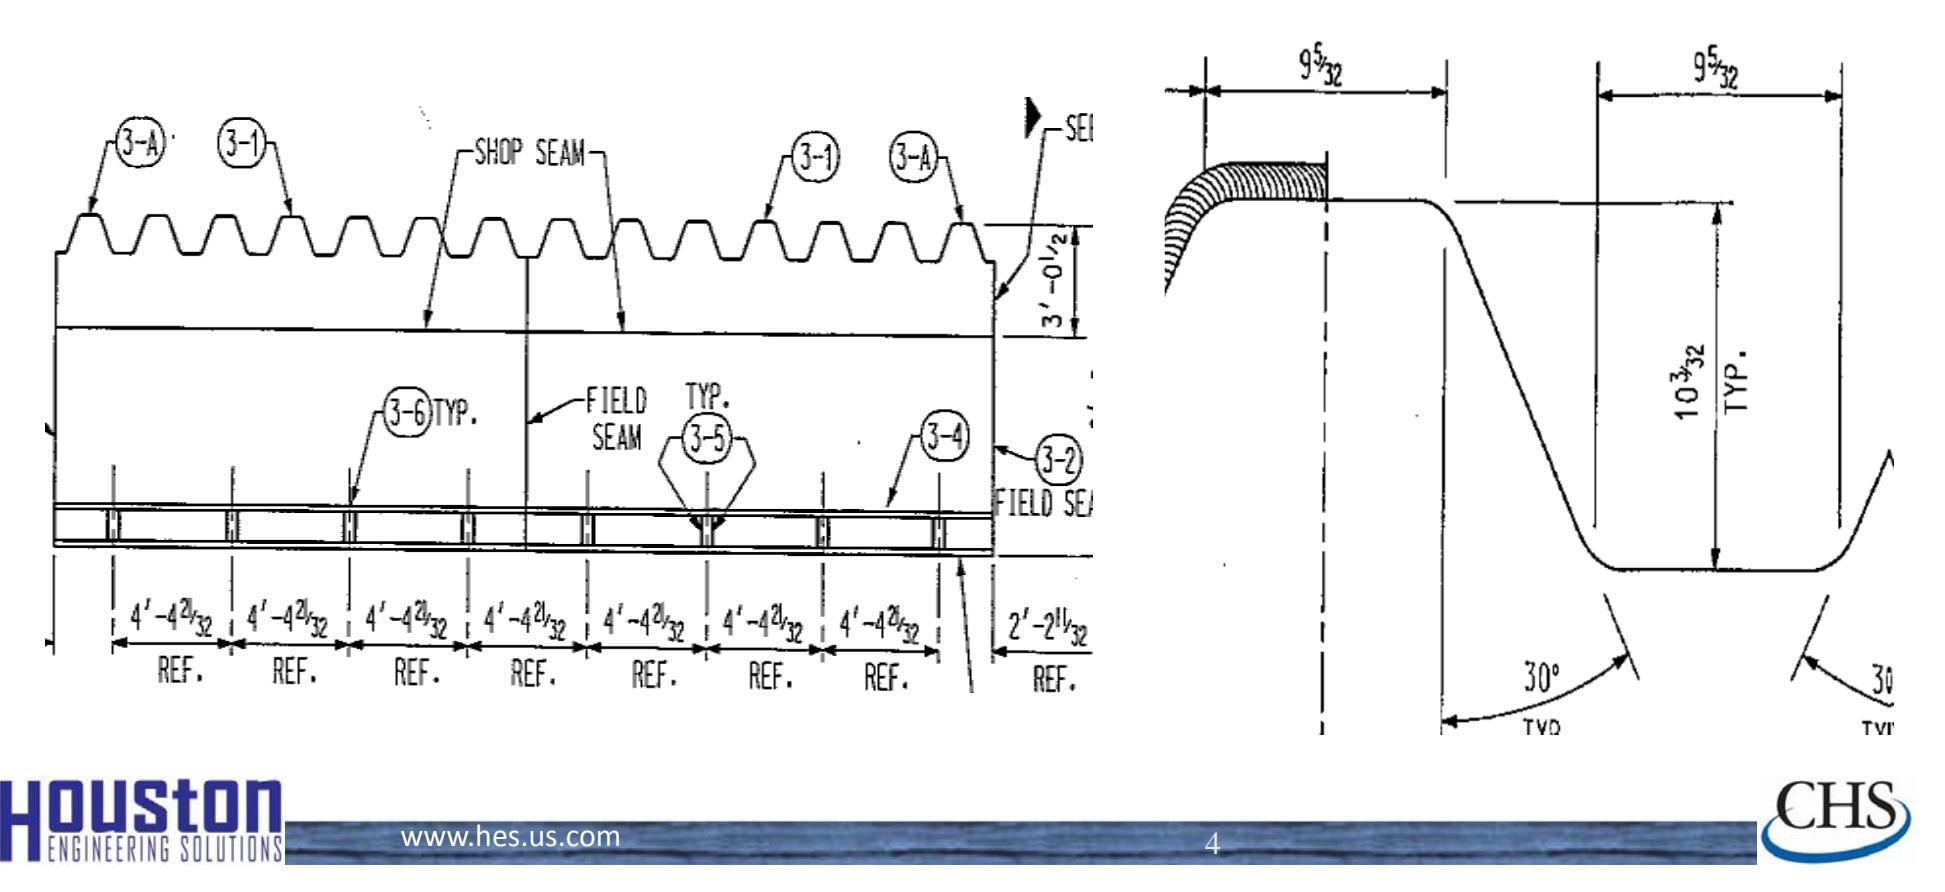
- 1-1/4 Cr  $-\frac{1}{2}$  Mo drums installed in 2007
- Drums Dimensions: 22' 0" ID x 72' 4" TT
- The skirt-to-shell attachment incorporates a scallop type lapjoint design with a continuous full leg fillet weld

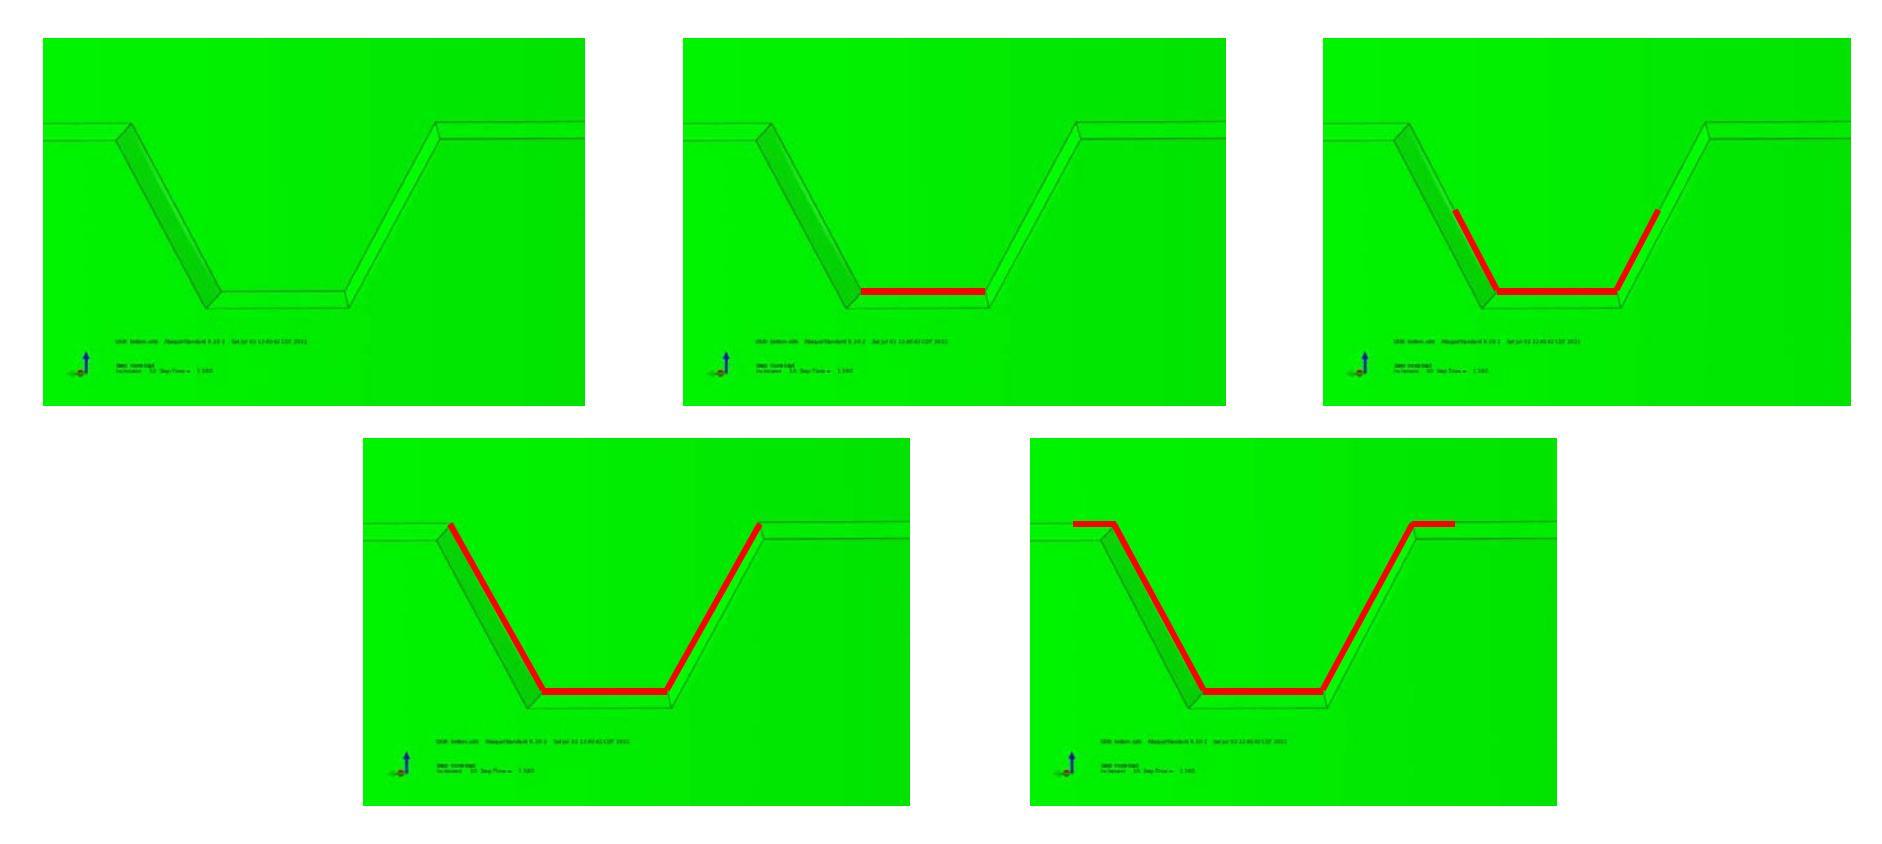
Model Case 1 : Fill, ASME Load Combination 5 , No Weld Crack. Model Case 2 : Fill, ASME Load Combination 5 , Crack Size of 9.16 " Model Case 3 : Fill, ASME Load Combination 5 , Crack Size of 20.81 " Model Case 4 : Fill, ASME Load Combination 5 , Crack Size of 32.47 " Model Case 5 : Fill, ASME Load Combination 5 , Crack Size of 37.05 " Model Case 6 : Fill, ASME Load Combination 1, Crack Size of 37.05 " Model Case 7 : Quench, ASME Load Combination 1, Crack Size of 37.05 "

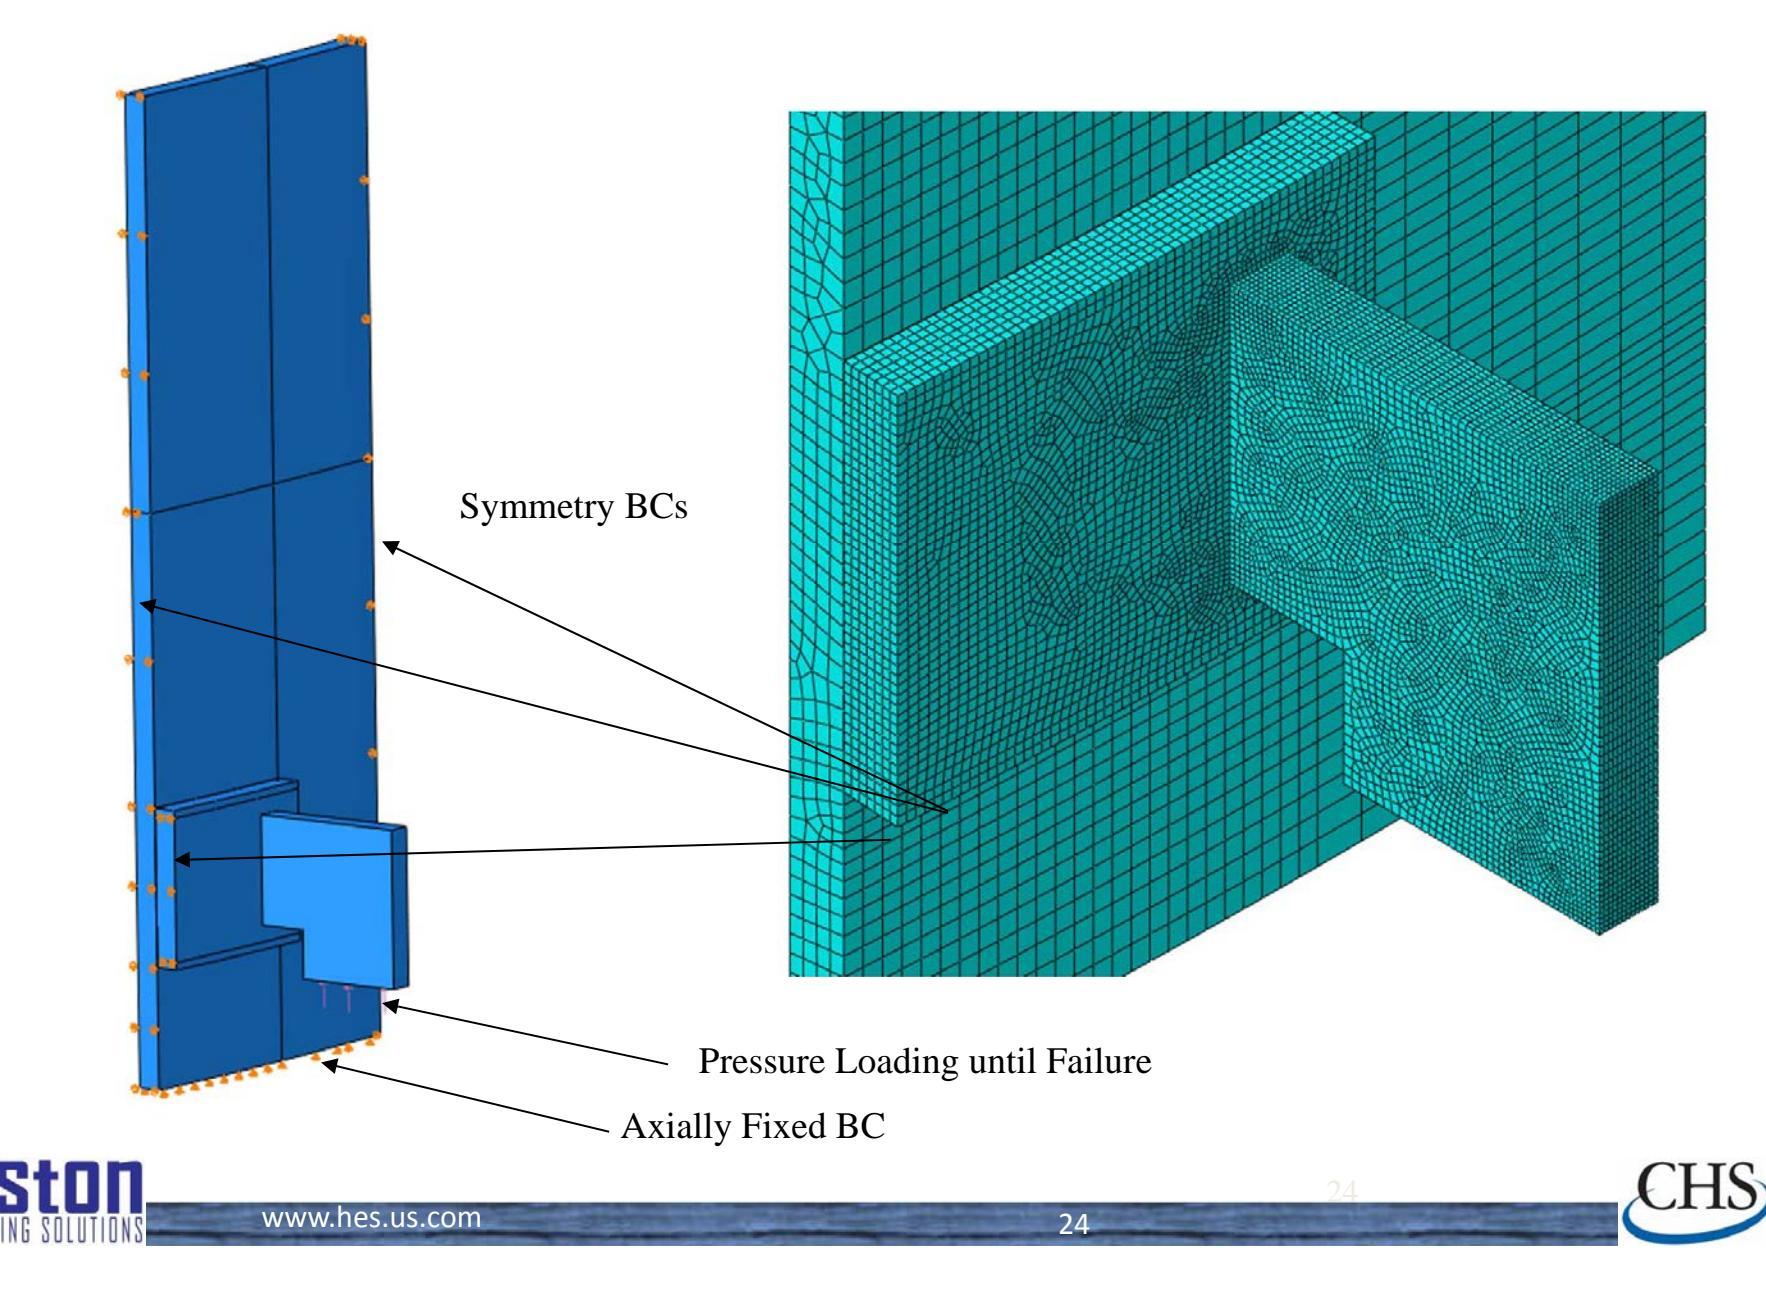
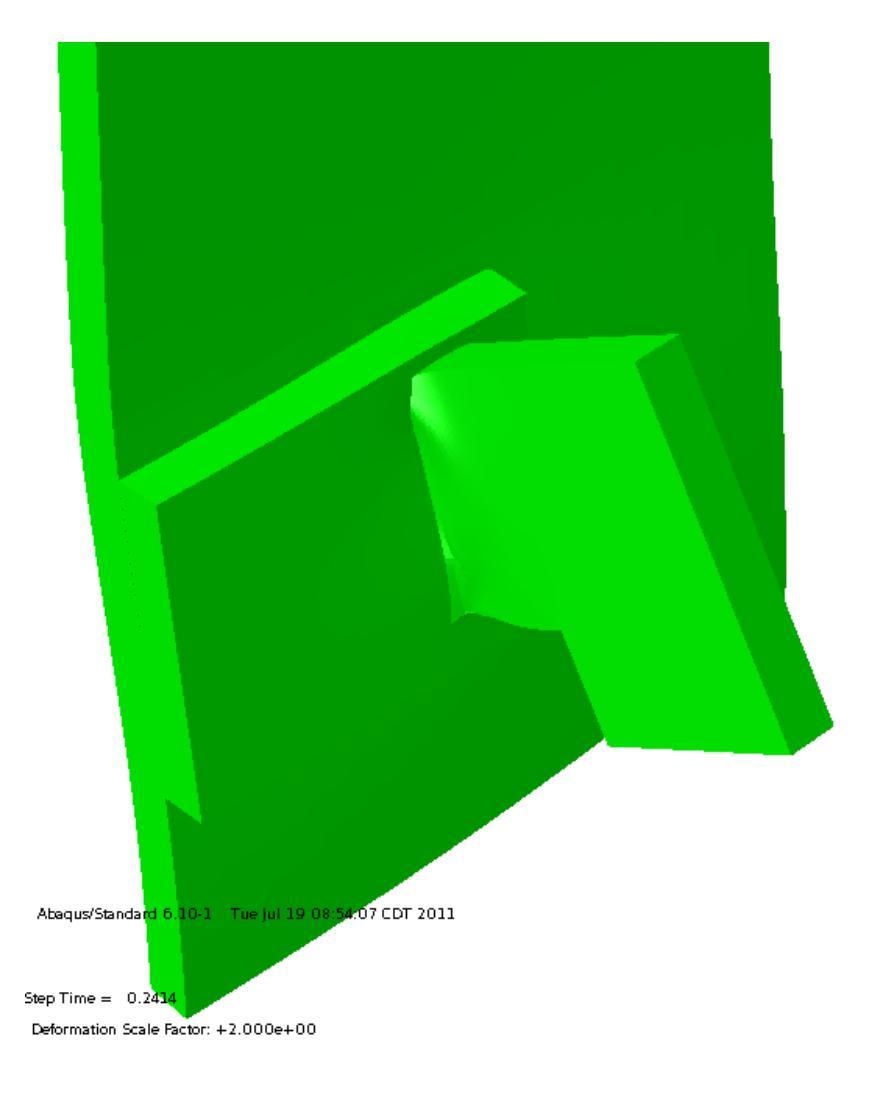
#### Deformed Shape @ Collapse Scale Factor of 1

- Retrofit replacement model plastically collapsed at 3.667 times the operating weight of the drum.
- Using API-579/ ASME-FFS Standard of 2007 which requires a factor of 3.15, this bracket has adequate strength to resist nominal loads
- The repad (or filler plate) is an option that can potentially improve the logistics of field implementation. Its inclusion does not materially impact the safety margin of the retrofit which is controlled by the bending capacity of the bracket plate.
