Repair and Retrofit of a Coke Drum Skirt Attachment Weld

CHS Inc

Houston Engineering Solutions

Coking.com Conference

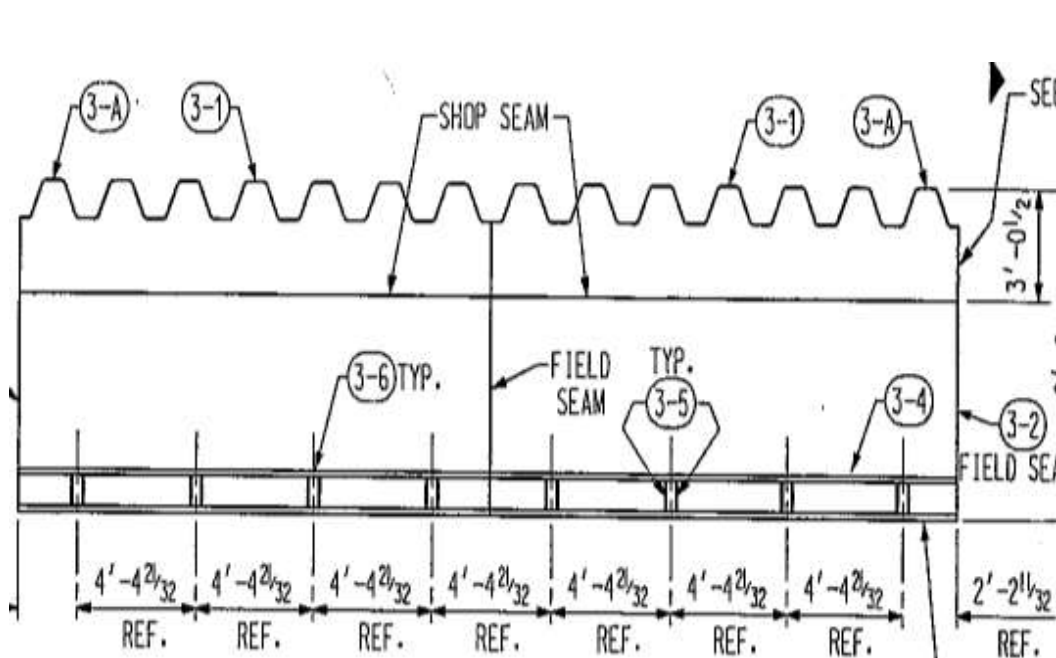
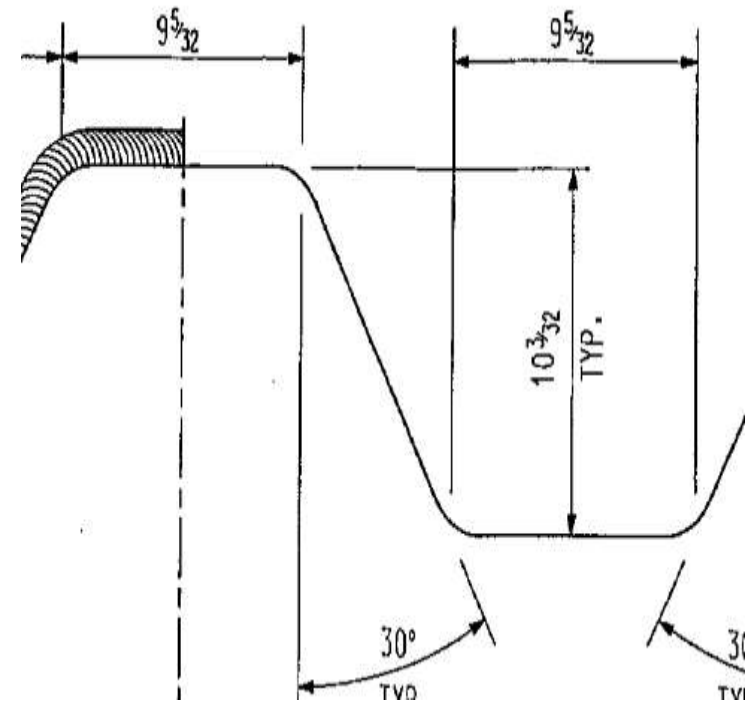
- 1-1/4 Cr – 1/2 Mo drums installed in 2007
- Drums Dimensions: 22' – 0" ID x 72' – 4" TT
- The skirt-to-shell attachment incorporates a scallop type lap-joint design with a continuous full leg fillet weld

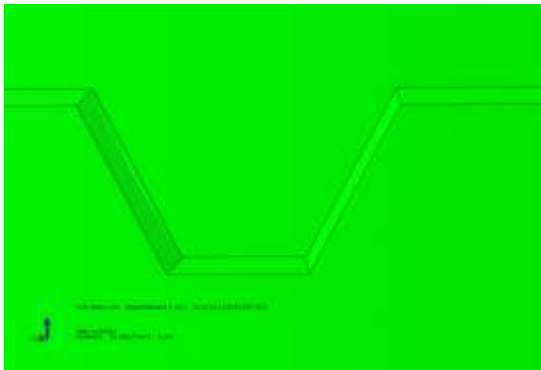
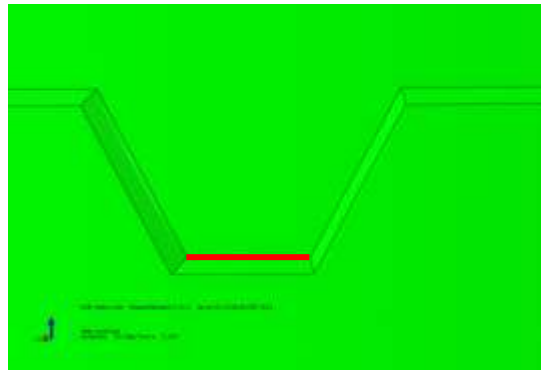
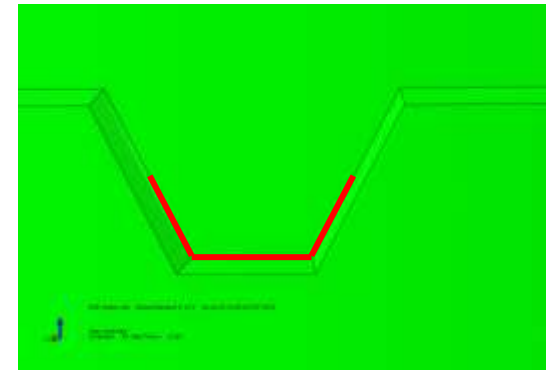
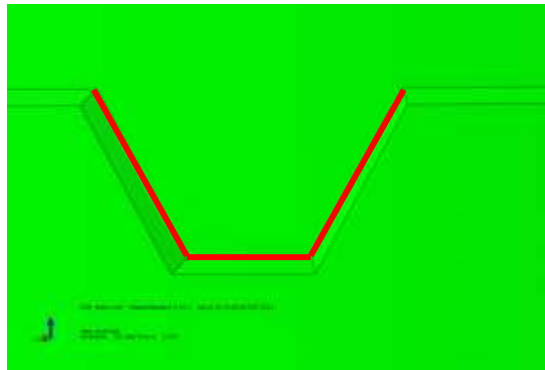
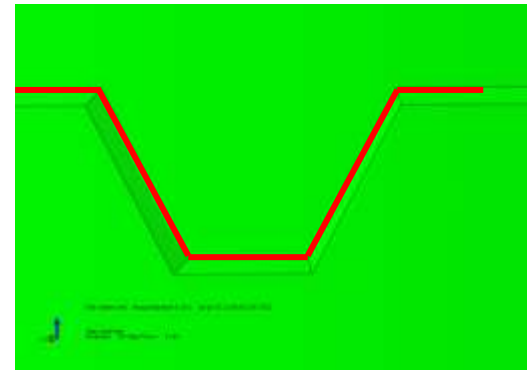
Model Cases 1 to 7

- Model Case 1 : Fill, ASME Load Combination 5 , No Weld Crack.
- Model Case 2 : Fill, ASME Load Combination 5 , Crack Size of 9.16 "
- Model Case 3 : Fill, ASME Load Combination 5 , Crack Size of 20.81 "
- Model Case 4 : Fill, ASME Load Combination 5 , Crack Size of 32.47 "
- Model Case 5 : Fill, ASME Load Combination 5 , Crack Size of 37.05 "
- Model Case 6 : Fill, ASME Load Combination 1, Crack Size of 37.05 "
- Model Case 7 : Quench, ASME Load Combination 1, Crack Size of 37.05 "

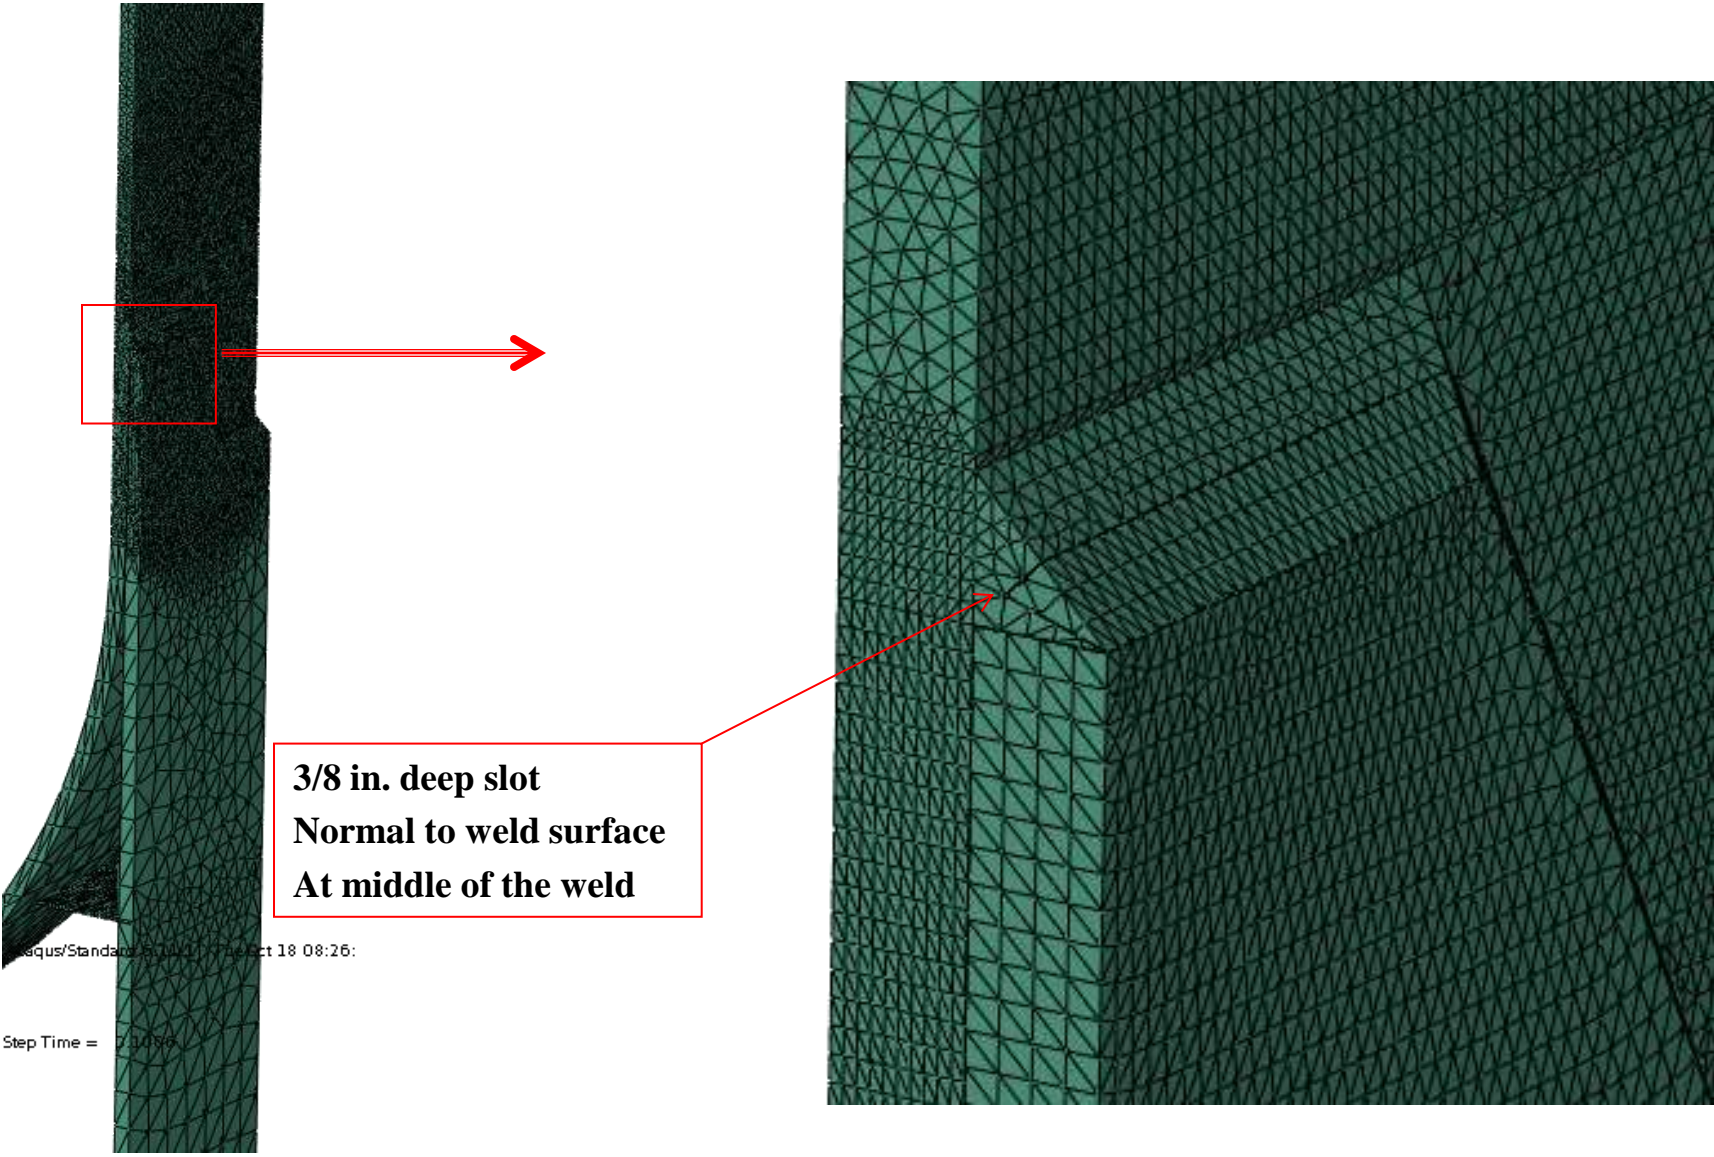
Finite Element Model

**3/8 in. deep slot
Normal to weld surface
At middle of the weld**

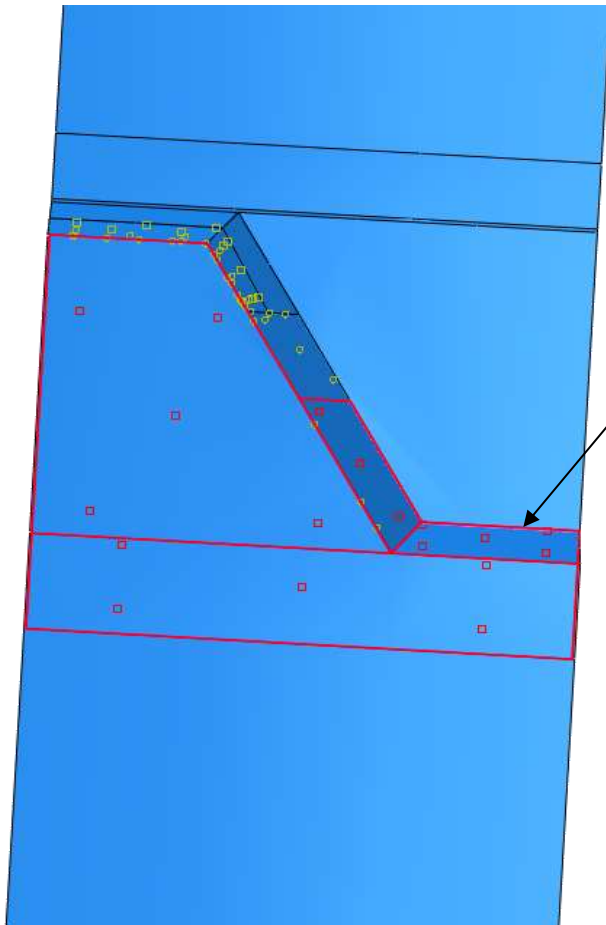
Base Model

no slot

Crack Size of 10.4"

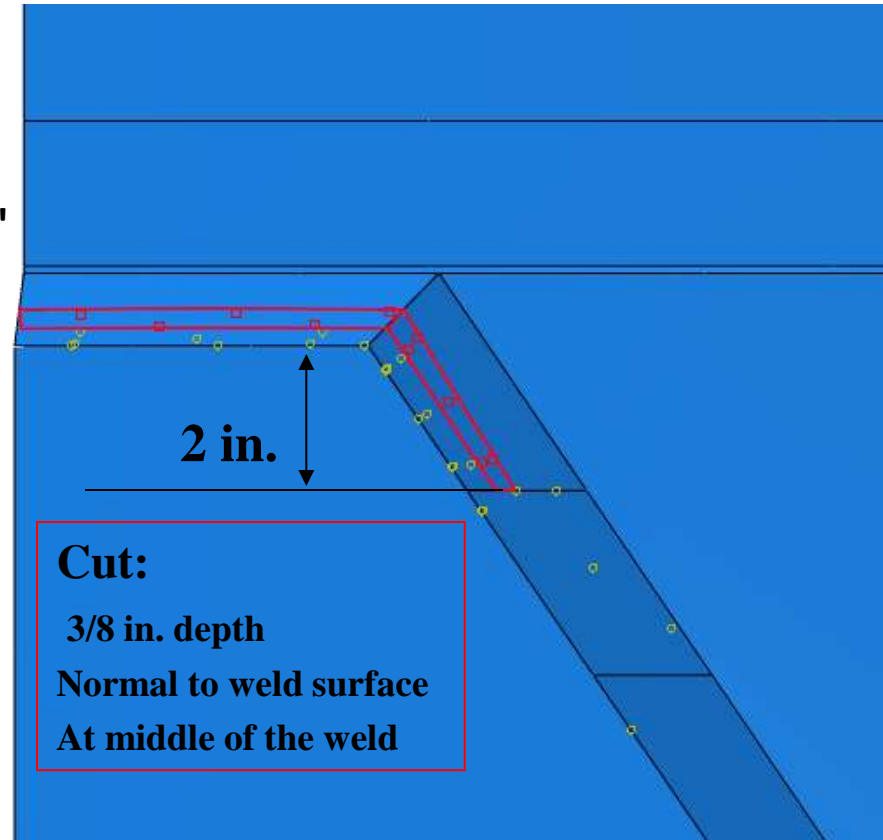
Slot Model

Same as Base Model + a slot cut across the peak of the scallop weld

3/8 in. depth

Normal to weld surface

At middle of the weld

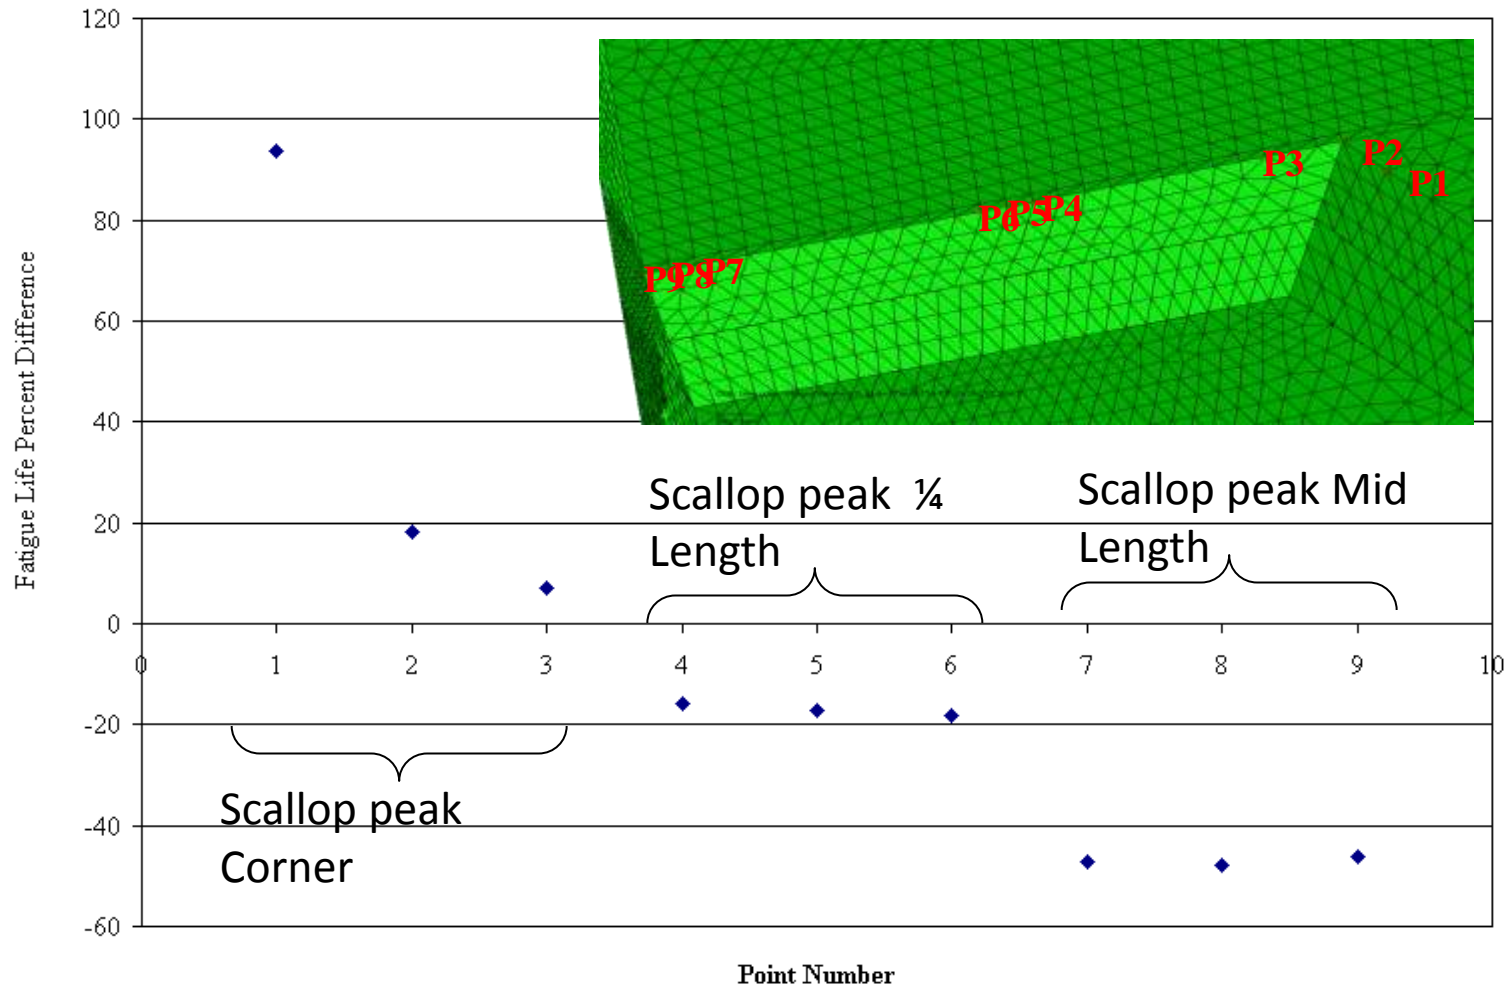
Fatigue Life % Difference at Weld Toe

- The simulated slots cause fatigue life to increase at the scallop corner and decrease along the middle of the scallop peak. Therefore, fatigue life increases where it matters most (i.e. where life is shortest at the corner).
- For a life that is over 100,000 cycles which is an order of magnitude longer than the life of a typical drum, the peaks of cracked scallop welds in the skirt-to-drum attachment weld are expected to have a long fatigue life with and without specified slots.
- The slots are expected to direct a crack that starts at the root of the scallop peak weld to propagate along the throat and away from the pressure boundary.
