Root cause analysis and successful modifications to eliminate hot spots in SRU at MOL's Danube Refinery

Ákos Németh
Residue Processing Area
Danube Refinery, MOL

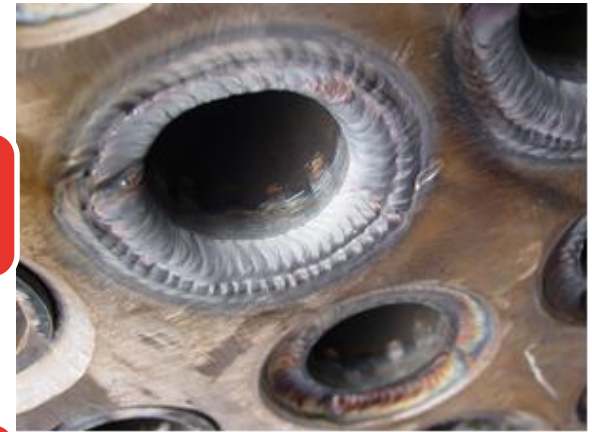
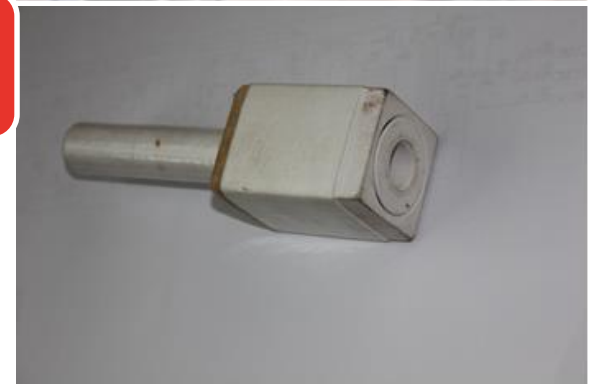
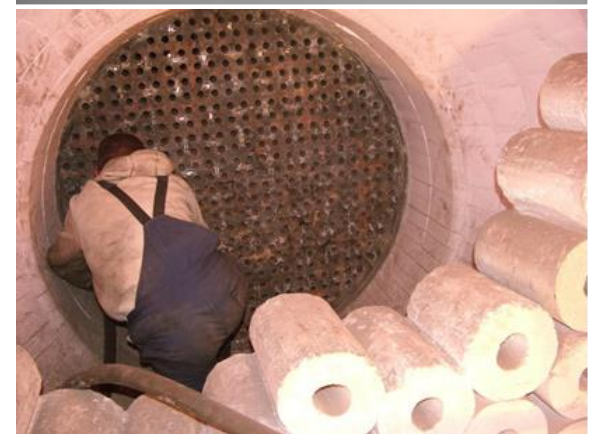
Damage mechanism:

- High temperature S-corrosion at hot parts of the inlet side tube endings

Suggestions:

- Thin bundle wall
- Corner of half V welds at tube endings
- Block type ferrules instead of tubular ferrule+refractory wall
- Fibre insulation coated ferrules
- Heat distributor wall (optional)
