May 1, 2019

ExxonMobil Baton Rouge Refinery Coke Bed Combustion Incident

Sarah Whitaker – Resid Conversion Specialist
David Gibson – Fixed Equipment Specialist

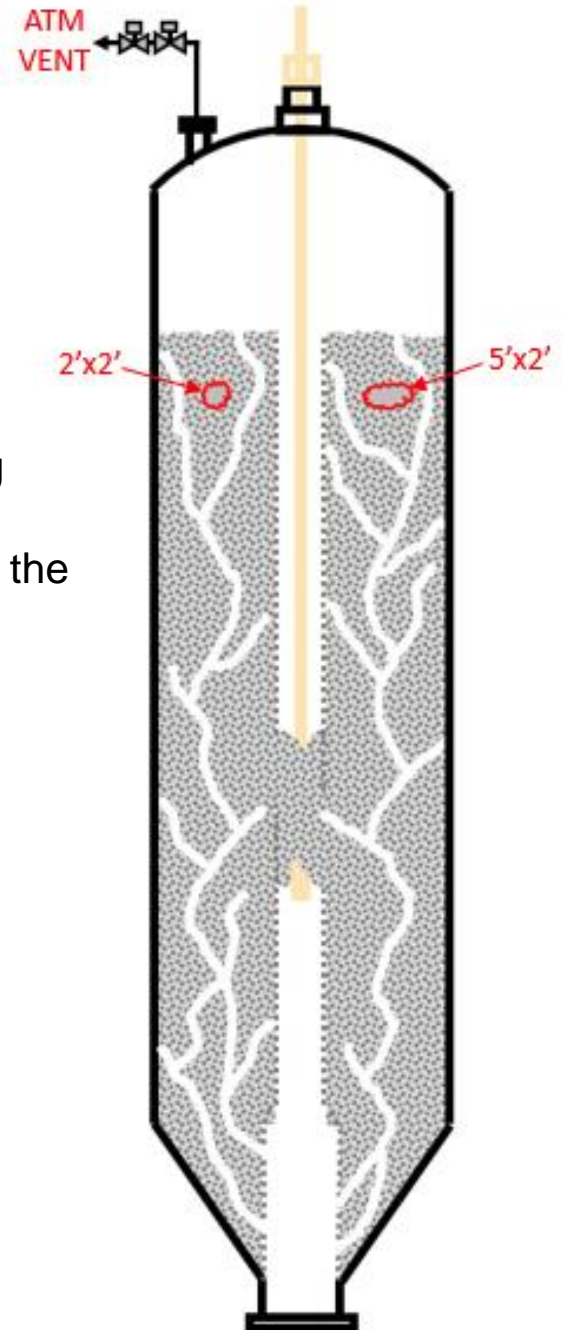
- Circulated out of coke drum
- Quench, vent, and dehead drum without issue
- Pilot hole complete, drill stem becomes stuck while raising
- Coke drum temperature increases
- Drum integrity compromised, sparks observed falling from the drum – Emergency Response includes:
 - Top water
 - Rehead bottom and add quench water
 - Steam purge into top head space
- Drum decoke complete

- No personnel injured or exposed
- Two through-wall holes formed near outage level
- Damage localized to drum
- Extended downtime to repair
