Addressing Increased Fouling Rates in Delayed Coker Heaters – A Case Study Identifying the Factors Behind the Increased Fouling Rates

Michael R. Kimbrell, P.E. 2019 Refcomm Galveston

Delayed Coker Heater fouling

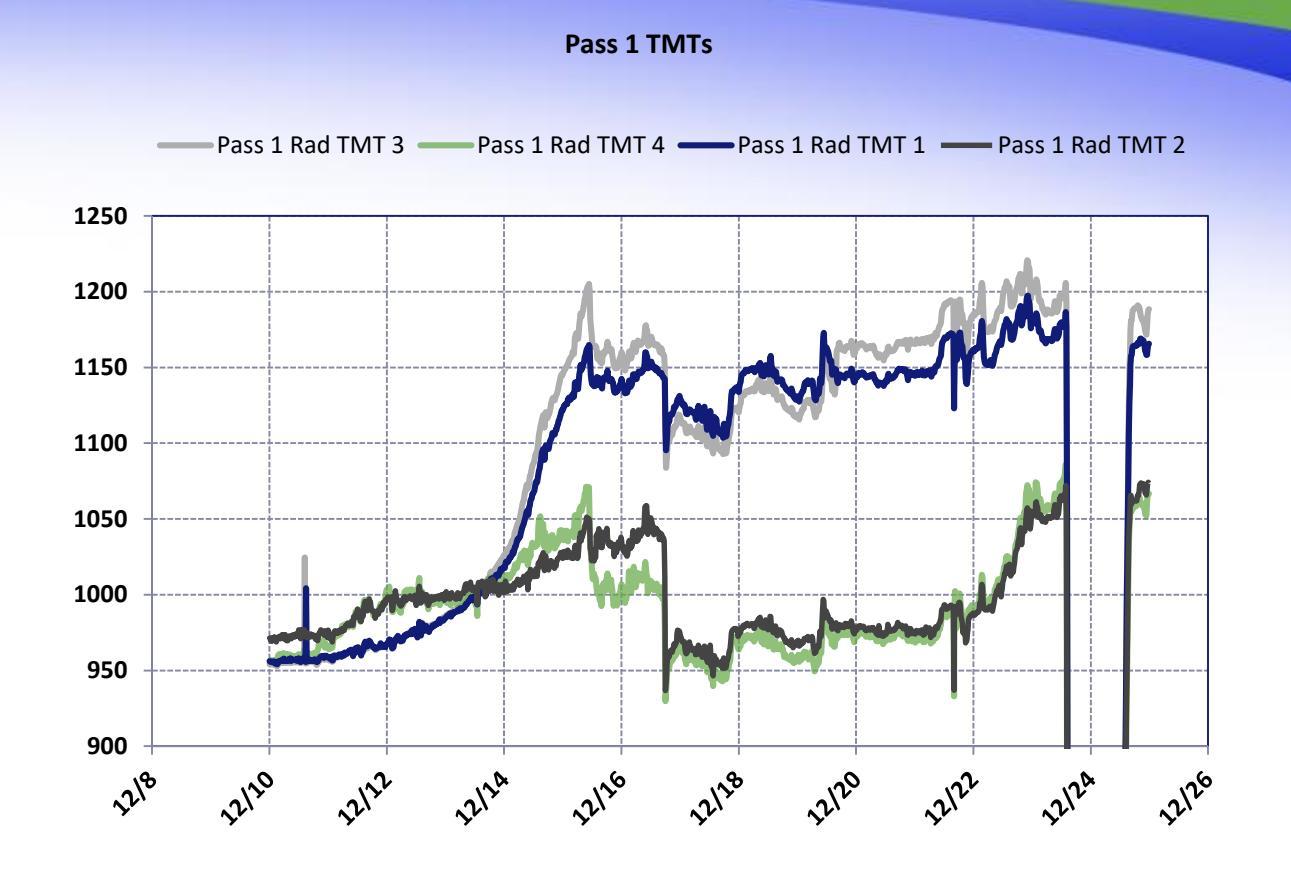
- Recent very high fouling rate was coincident with receipt of "heavy" crude into overall crude slate at a relatively low percentage
- Desalter performance showed evidence of increased emulsion layer thickness
- Coker heater fouling started shortly after this event

- The very rapid fouling in the last run and shorter prior runs was the result of asphaltene precipitation in the Coker feed
- Coker feed is very paraffinic with Watson K-factor of 12.0 and higher
- Any crude with higher than average asphaltene content will have the asphaltenes precipitate due to the paraffinicity of the feed.
 - The separated asphaltenes coke very rapidly
 - The coke formed from asphaltenes is very hard and non-porous, similar to what was found.
- Asphaltene precipitation from uncontrolled crude oil blending coupled with low velocities in Coker heater are the cause of these very short runs.

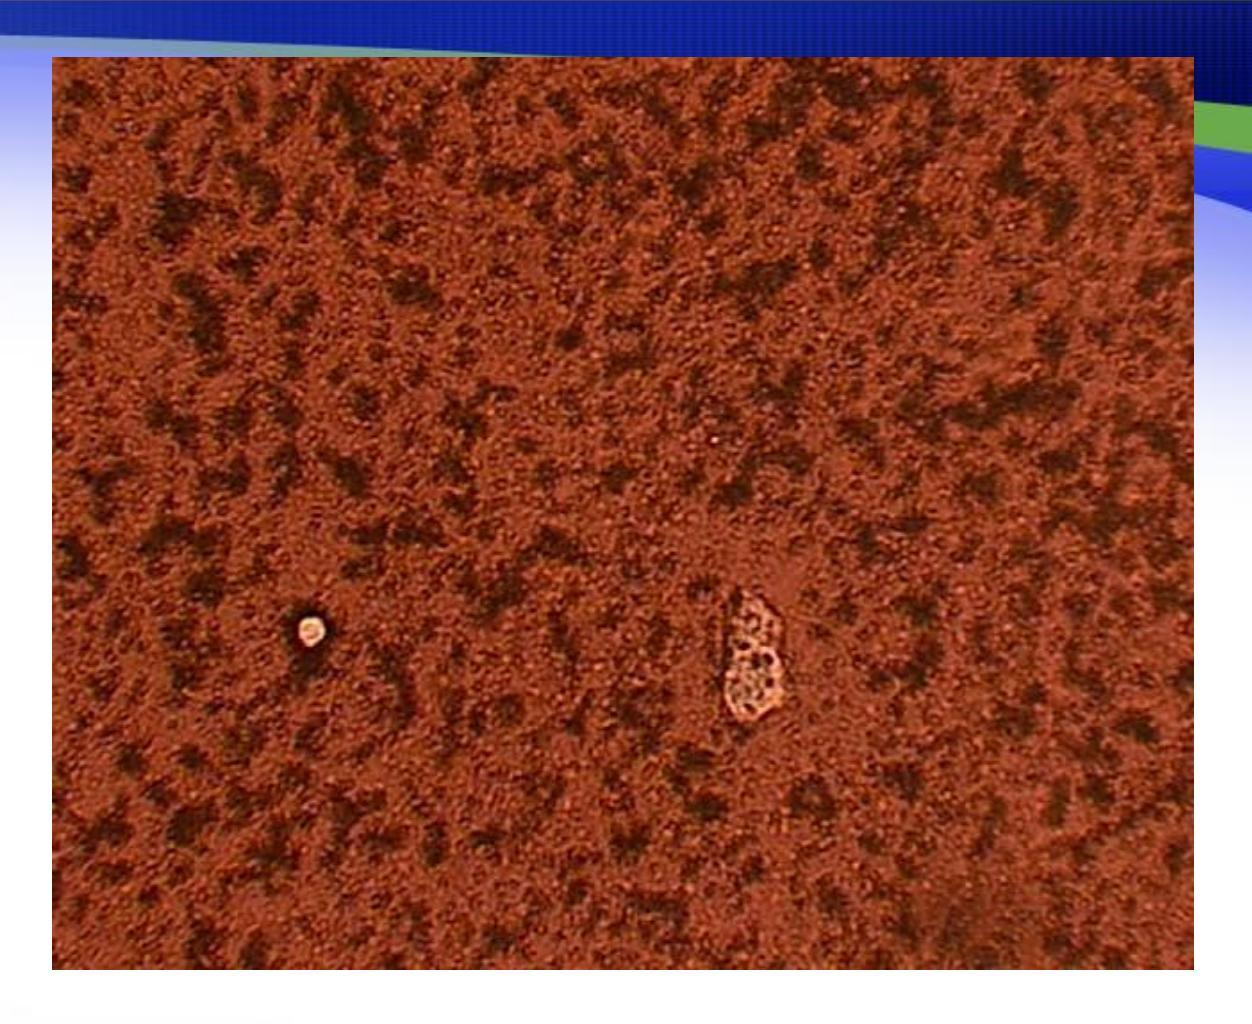
Visual inspection for Asphaltene precipitation

- Visual inspection of crude oil under a microscope will show asphaltene precipitation
- Magnification of 100x is typically sufficient to show precipitation. Severe cases do not require any magnification.
 - Photo is an example of crude oil with precipitated asphaltenes and not from this site

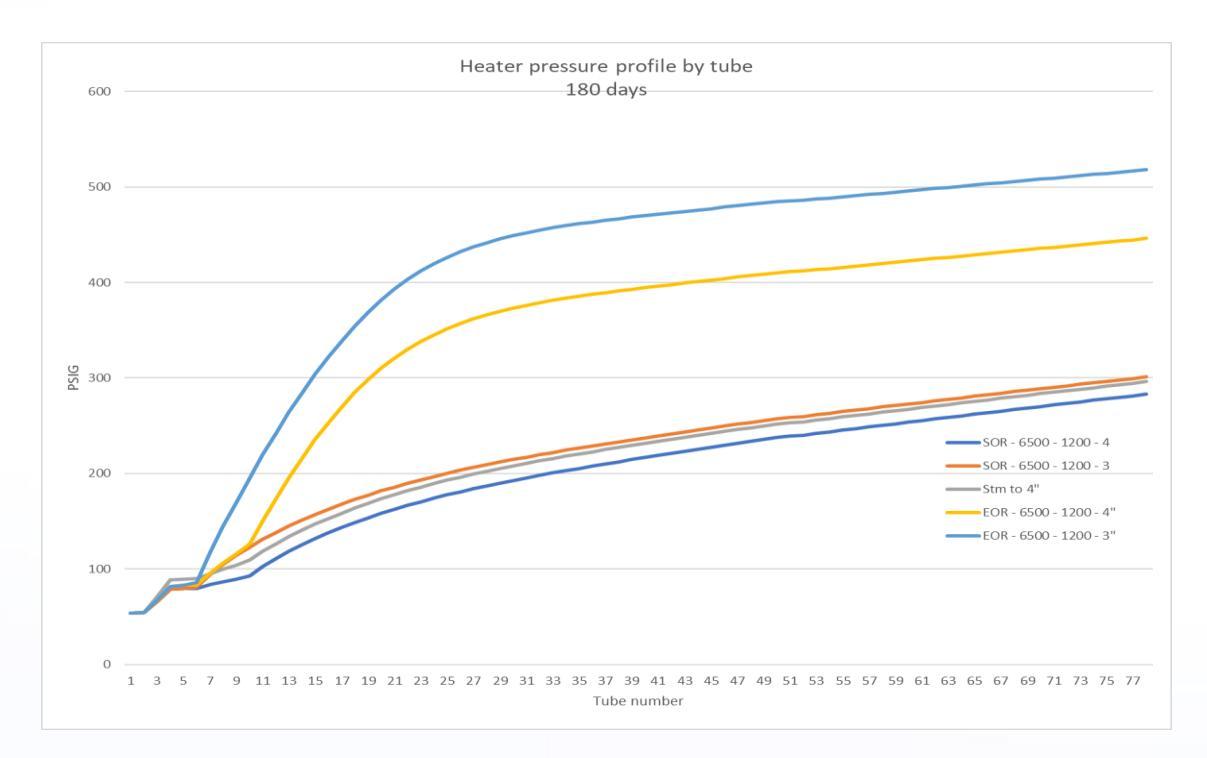
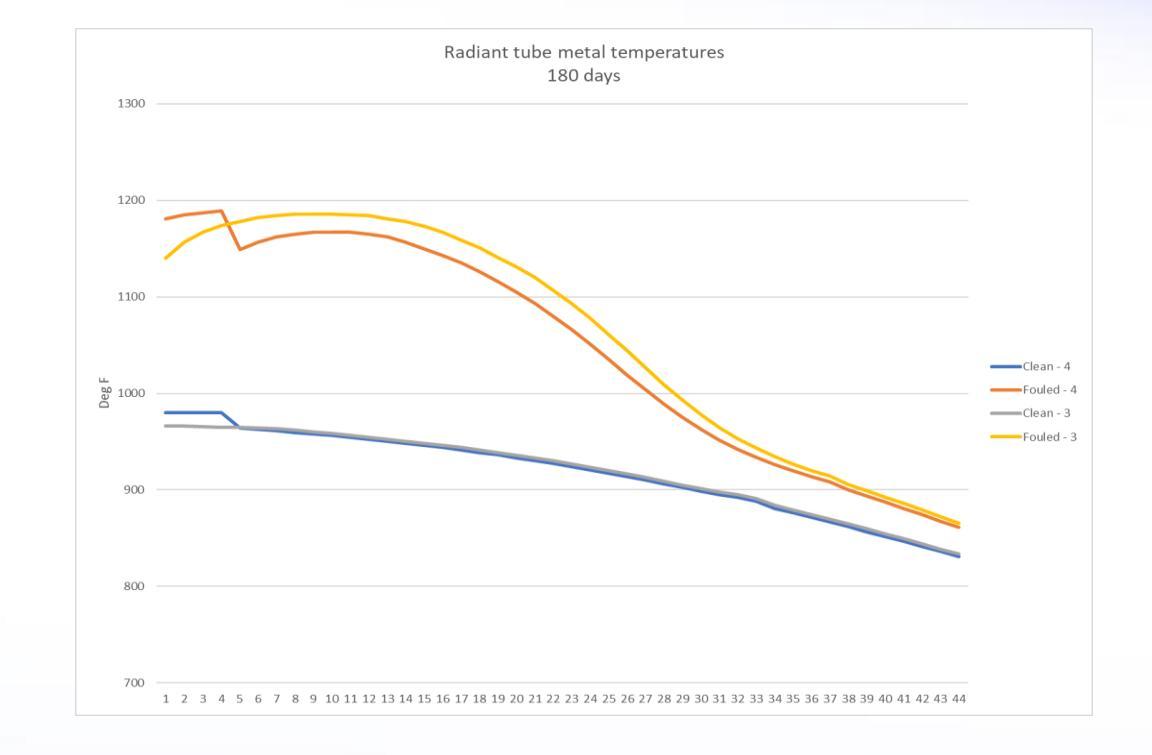
DC-SIM modeled alternate configurations

- Alternate coil configurations were evaluated to answer the following questions:
 - Could the larger tubes be replaced with same size tubes as rest of heater?
 - Could the larger tubes be removed completely?
 - Could more velocity steam prevent the fouling?

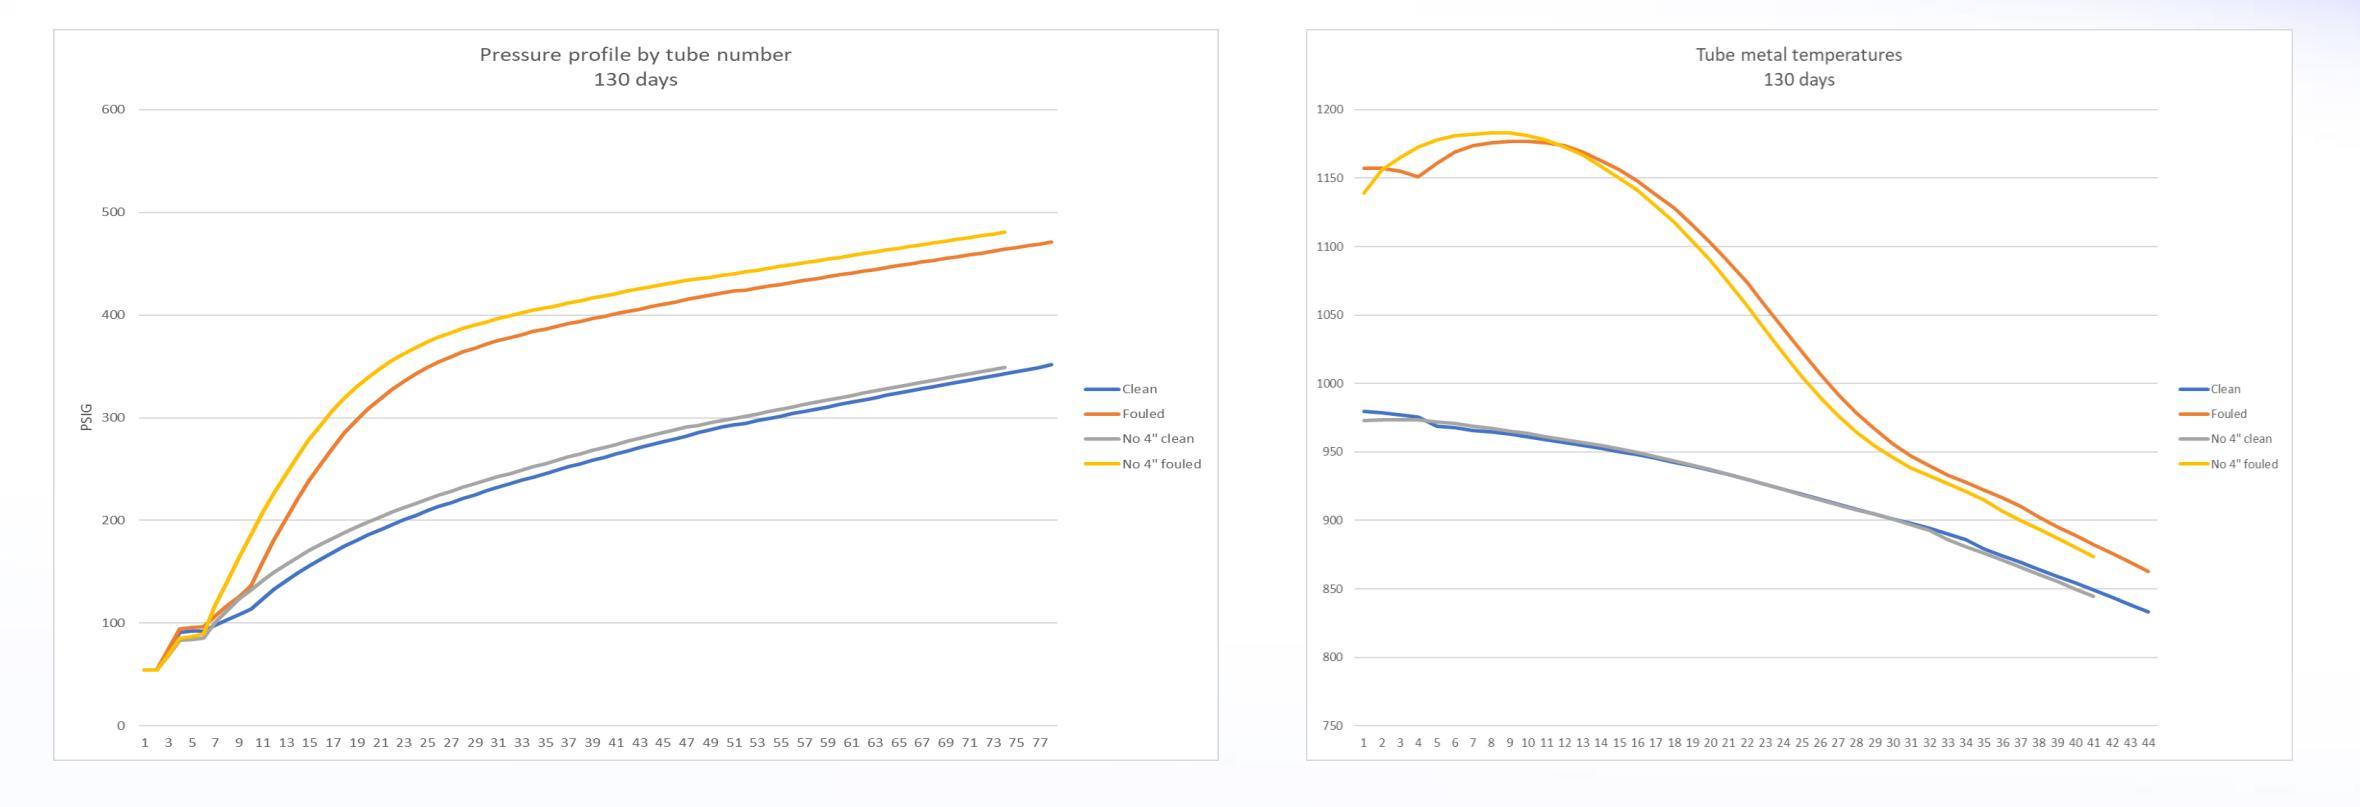
DC-SIM modeled alternate configurations

Results of modeling showed adding velocity steam to first of the larger tubes and maintaining the existing coil configuration had the fewest objections

- Larger diameter tubes were necessary to limit heater pressure drop at end of run
- Removing large diameter tubes caused average radiant heat flux to be 7900 BTU/hr-ft2 at the reduced throughput. In tube velocity was high and would limit future capacity. Additionally, that modification did not resolve low velocity in transfer line
- Velocity steam was required in the first of the larger diameter tubes to limit fouling. This also increased velocity in transfer line
 - Checked velocity in coke drum to prevent coke fines carry over
 - Preliminary check on C-factor in fractionator flash zone
 - Checked on fractionator sour water pump capability

- Site implemented crude oil testing to manage compatibility
- Velocity steam was added to first of the large diameter tubes on each pass
- These modifications have been in place since Jan 2019 with good results
