REFCOMM[®]
MUMBAI 2019

On Line Repair of DCU Vessel Skirt Cracks at Reliance SEZ Plant

Anand C Haridas –Head Corrosion & Inspection-Jamnagar Complex, RIL

Pedro E. Amador – VP Business Development & Technology, AZZ WSI

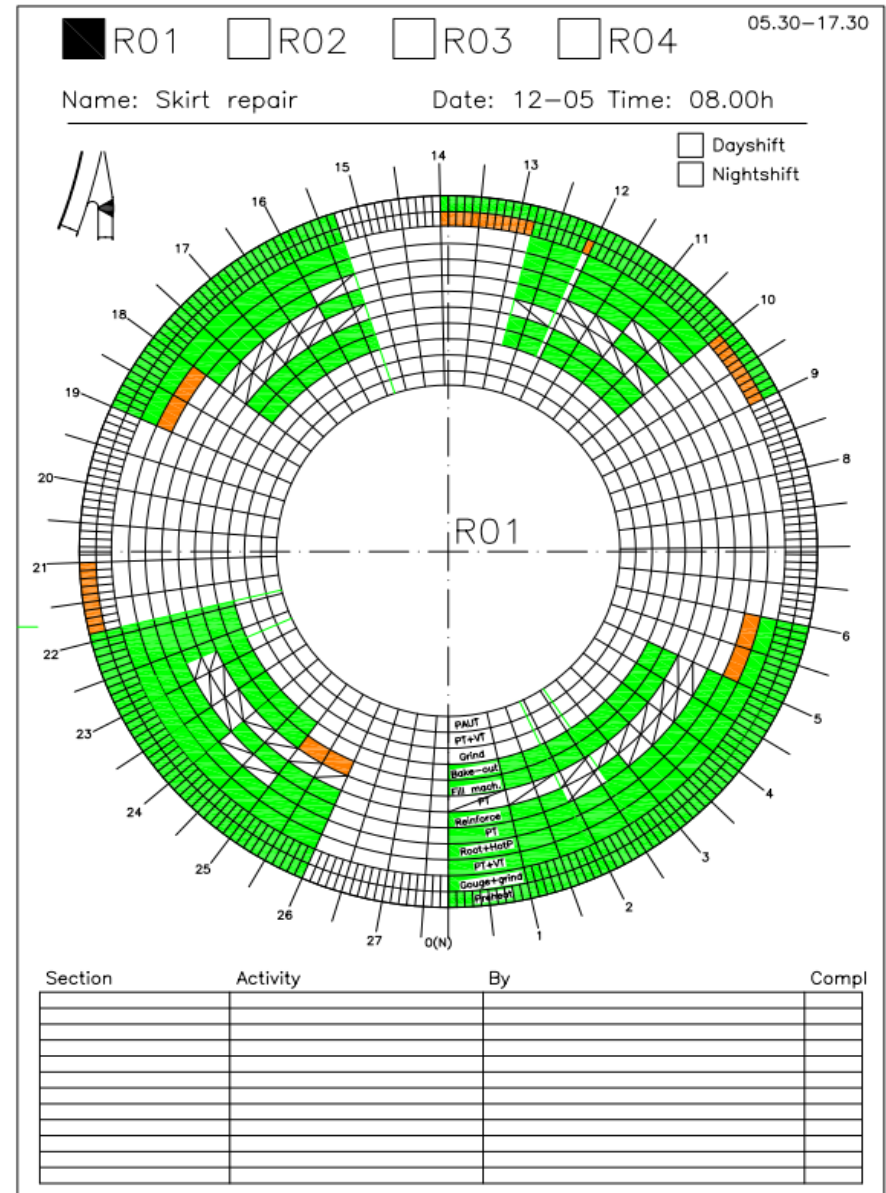
- PAUT was used to inspect all welding upon completion.
- An average of 6 repairs were identified in each circumference with a maximum of 12 repairs on one of the vessels.

- Because 8 drums were being repaired in parallel using a temperbead process, careful tracking and monitoring of the status of each drum was required.
- Since repairs were made in operation, each team had to be ready to start work efficiently at the beginning of their work window.
- Effective communication and cooperation between Reliance and AZZ crews was likely the most important contribution to success.
