Online Monitoring and Life Extension of Coke Drums

Details of coke drums

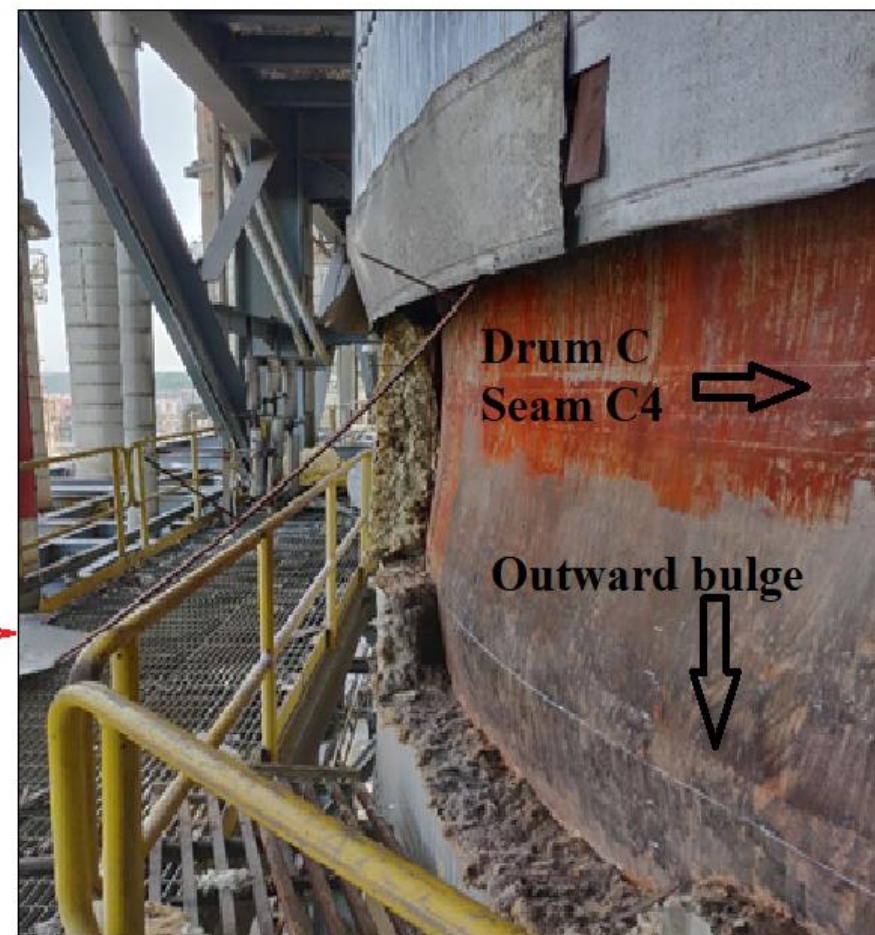
Laser Mapping data of Drum C

Drum C	Drum D
Laser data	Radial growth in mm	Radial growth in mm
2017/2018	33 to 60 mm	24 to 78 mm

Contour plot of the radius (inches) looking from the inside of the drum

Drum nominal radius is about 180 inches
(4572 mm)

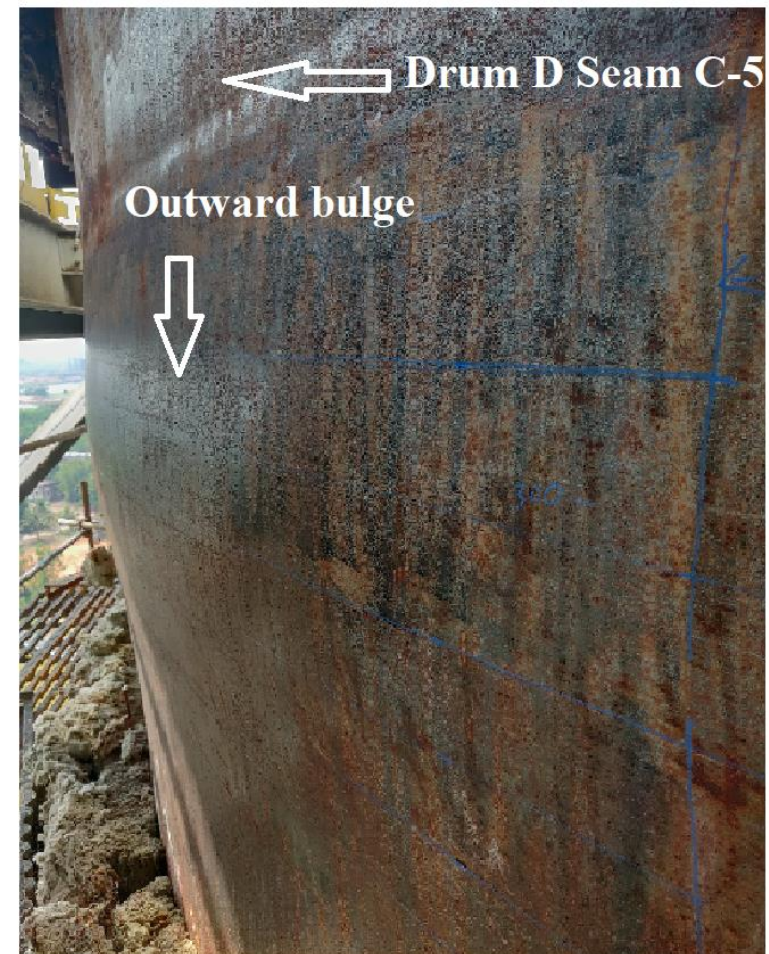
Laser Mapping data of Drum D

**Drum D-2018: Contour plot of radius (inches)
looking from inside of drum**

Drum nominal radius is about 180 inches
(4572 mm)

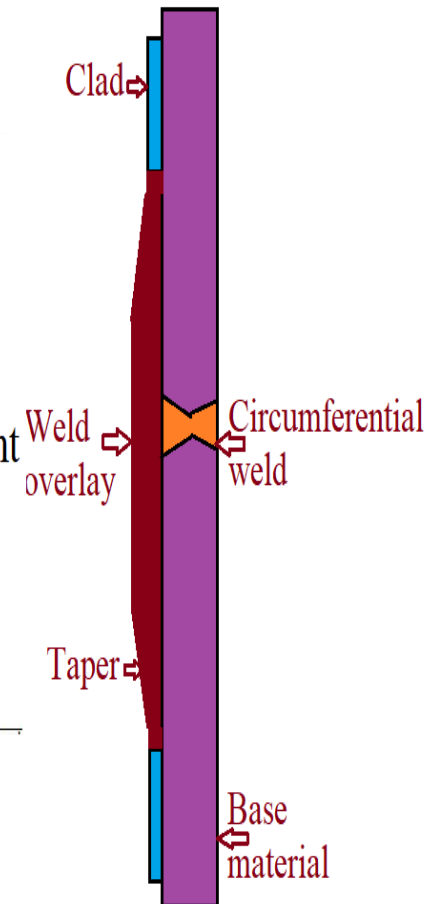
After

Total height/
axial extent
1118 mm,
44 inches
