Online Monitoring and Life Extension of Coke Drums

Details of coke drums

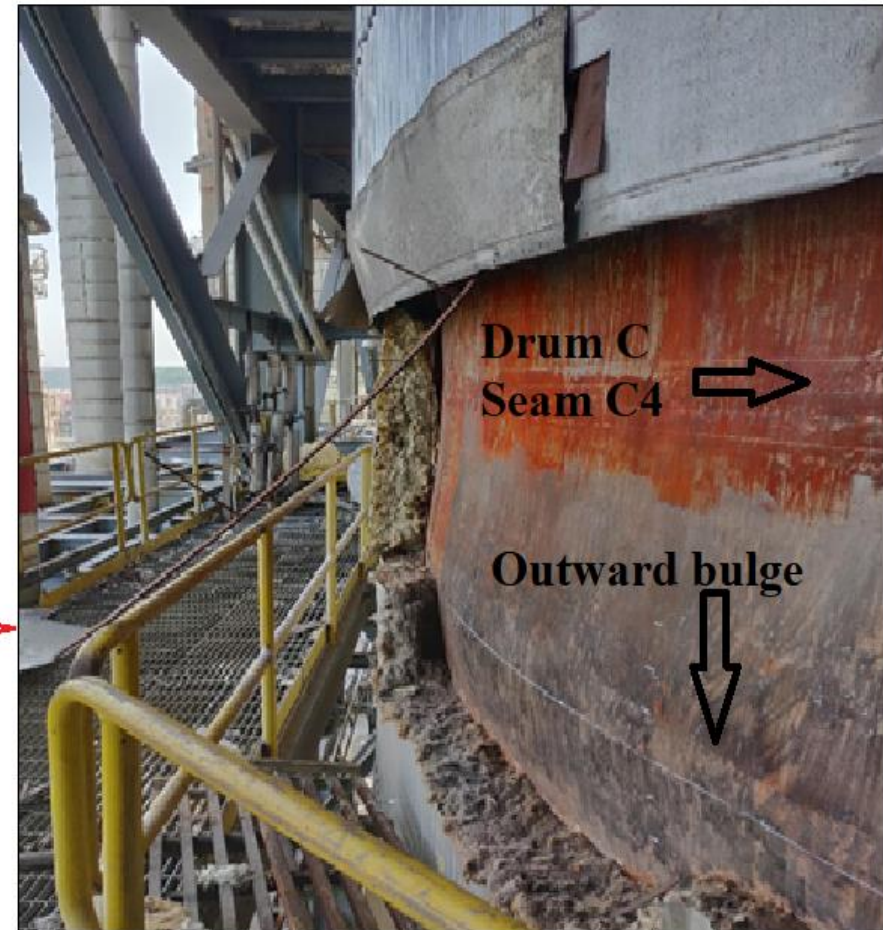
Laser Mapping data of Drum C

Drum C	Drum D
Laser data	Radial growth in mm	Radial growth in mm
2017/2018	33 to 60 mm	24 to 78 mm

Drum nominal radius is about 180 inches
(4572 mm)

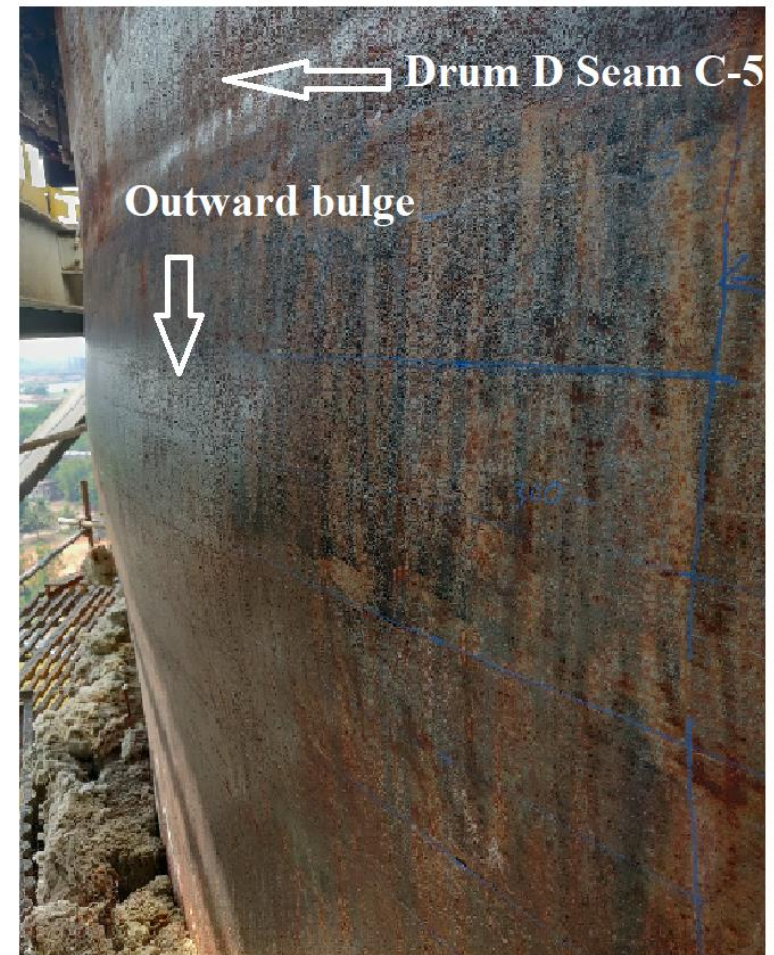
Laser Mapping data of Drum D

**Drum D-2018: Contour plot of radius (inches)
looking from inside of drum**

Drum nominal radius is about 180 inches
(4572 mm)
