Case History: Sudden Drop and Tilt of an Operating Coke Drum

Dave Dewees PE Bobby Wright PE

THE WORLD'S PREMIERE DELAYED COKING CONFERENCE REFEONING GLOBAL Virtual Conference 2020

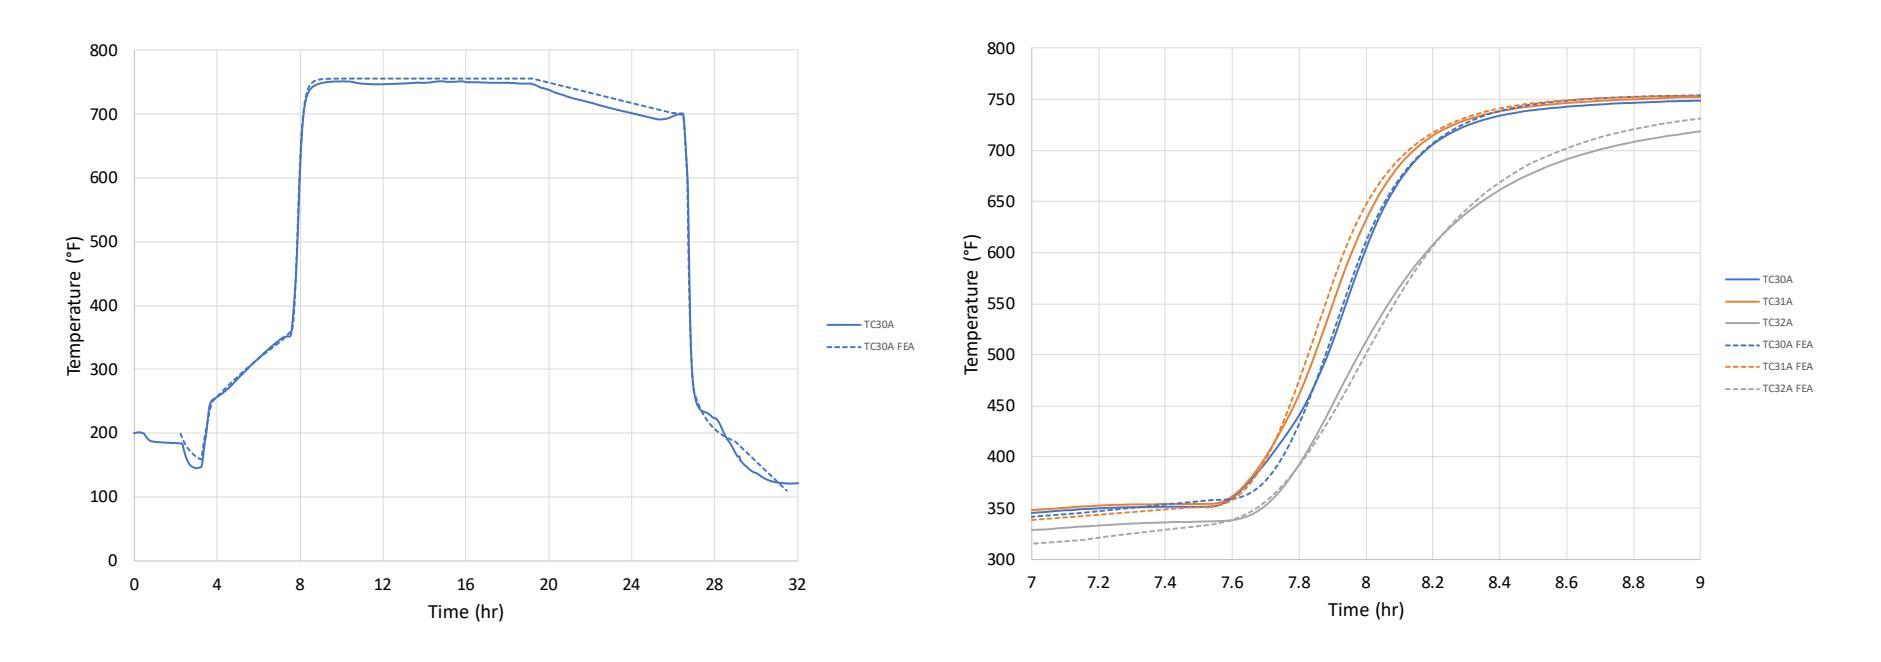
FEA – Thermal Calibration

- Moving liquid level used for fill and quench, flow rate tuned to match TC data
- Hot box radiation included, heat transfer coefficients tuned (within physically reasonable bounds) as well
