U.S. Chemical Safety and Hazard Investigation Board

Understanding And Addressing Operational Risk

**RefComm 2024
May 1, 2024
Galveston, TX**

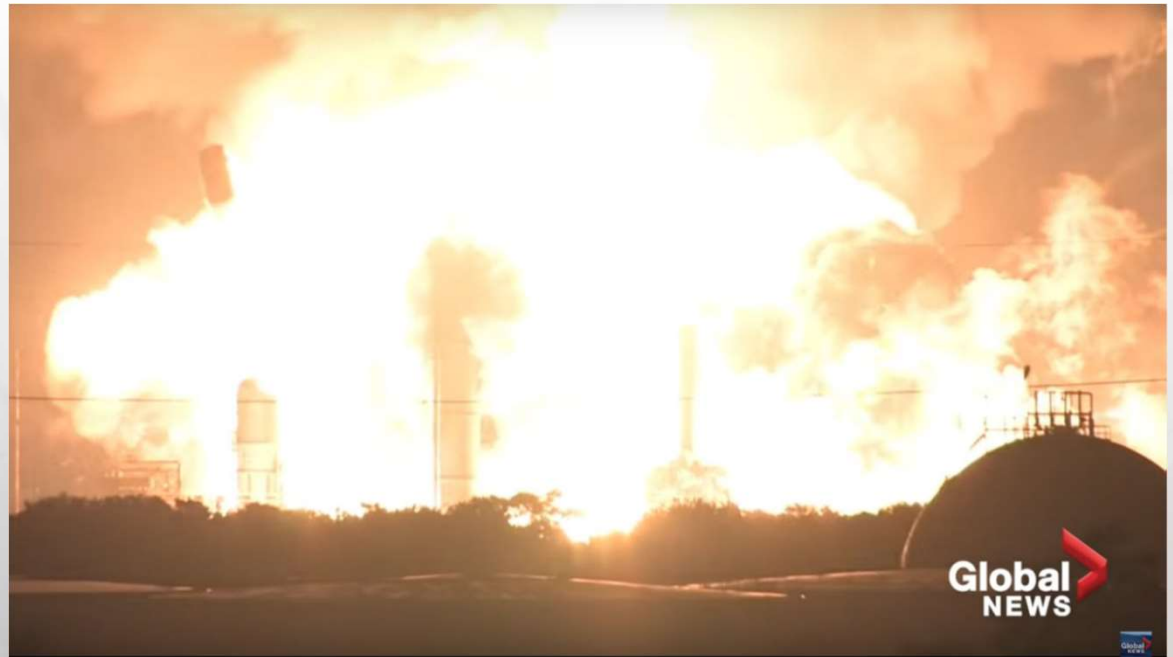
Philadelphia Energy Solutions Philadelphia, PA

- June 21, 2019
- Fire and Multiple Explosions
- 6 Injuries

- A pipe elbow in the hydrofluoric acid (HF) alkylation unit ruptured.
- A large vapor cloud (95% propane, 2.5% HF, and other hydrocarbons) engulfed the unit.
- The vapor cloud ignited about two minutes after the start of the release, causing a large fire followed by multiple explosions.

The rupture of a steel piping component with high nickel and copper content that had corroded from HF and thinned faster than adjacent piping components with lower nickel and copper content.

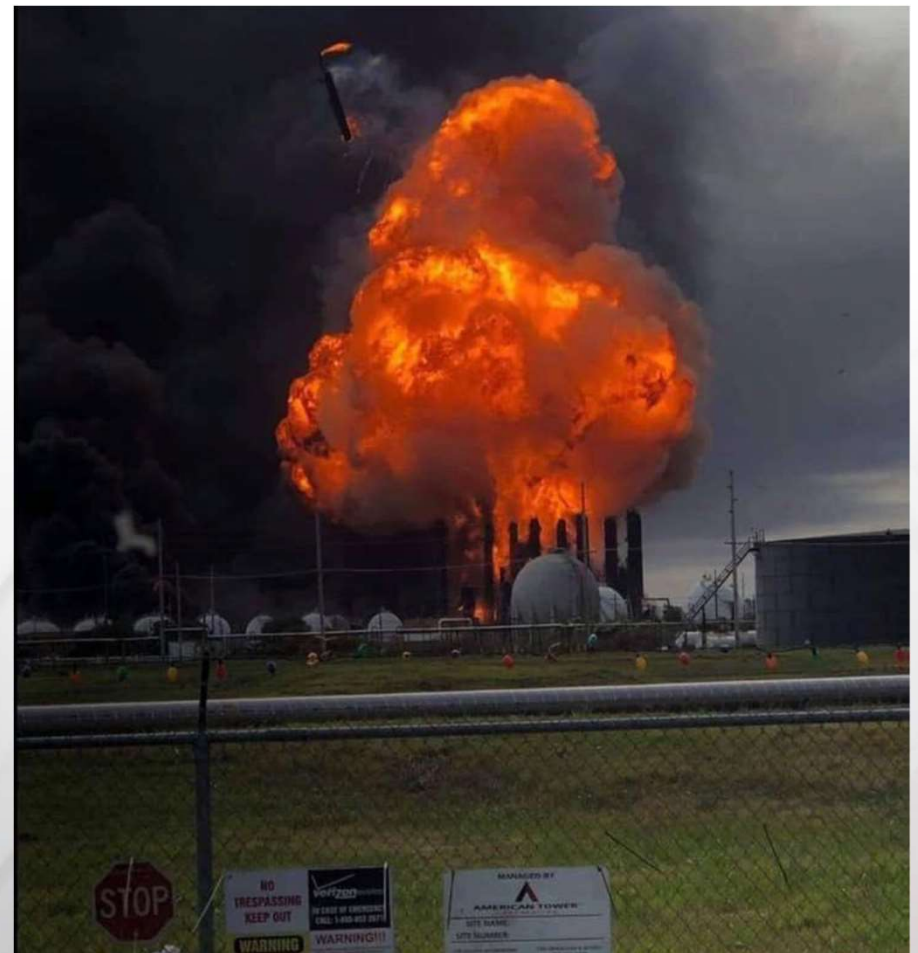
TPC Group Port Neches, TX

- November 27, 2019
- Multiple Explosions and Fires
- 3 Injuries

The popcorn polymer continued to accumulate and expand until the internal piping pressure increased to the point that the piping ruptured, releasing butadiene from the process unit.

The failure to identify that an out-of-service pump within the butadiene unit caused a temporary dead leg allowing popcorn polymer to develop and exponentially expand in the piping section until the piping ruptured.

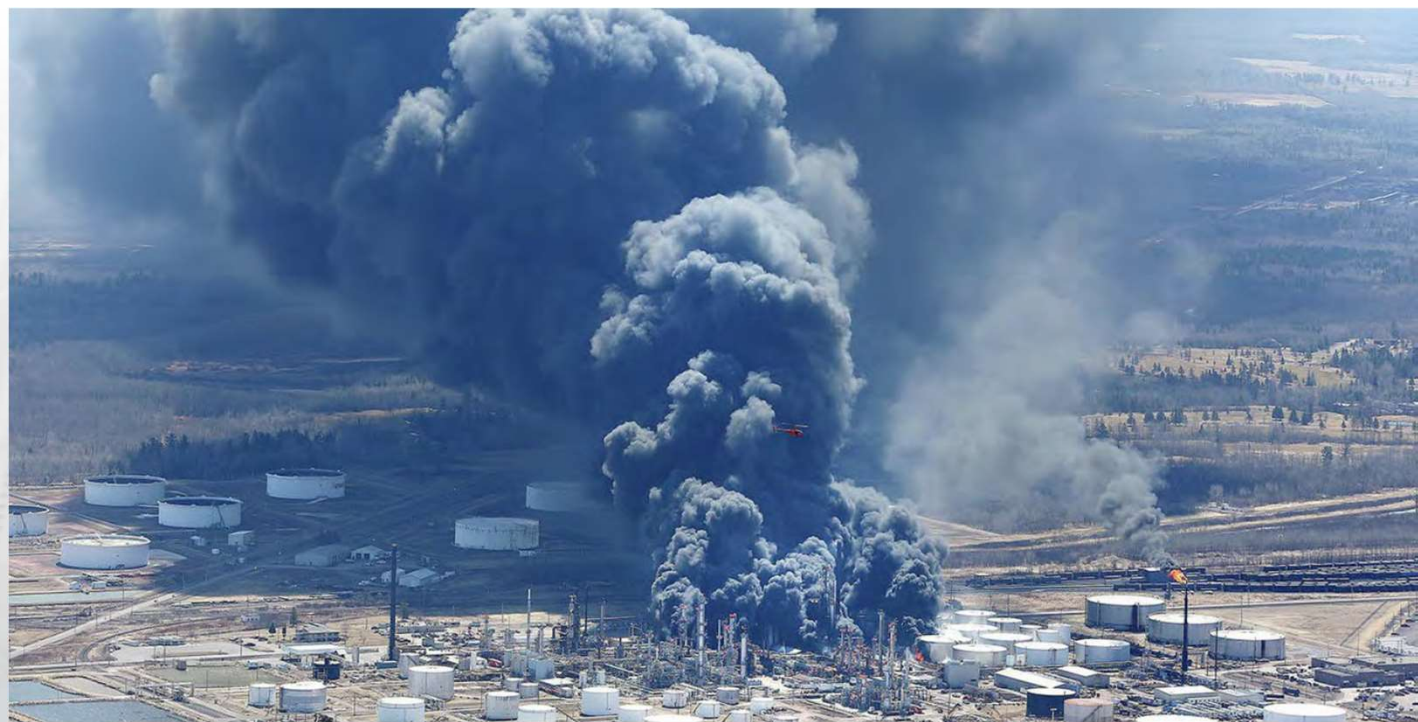
Husky Superior Refinery Superior, WI

- April 26, 2018
- Explosion and Asphalt Fire
- 36 Injuries

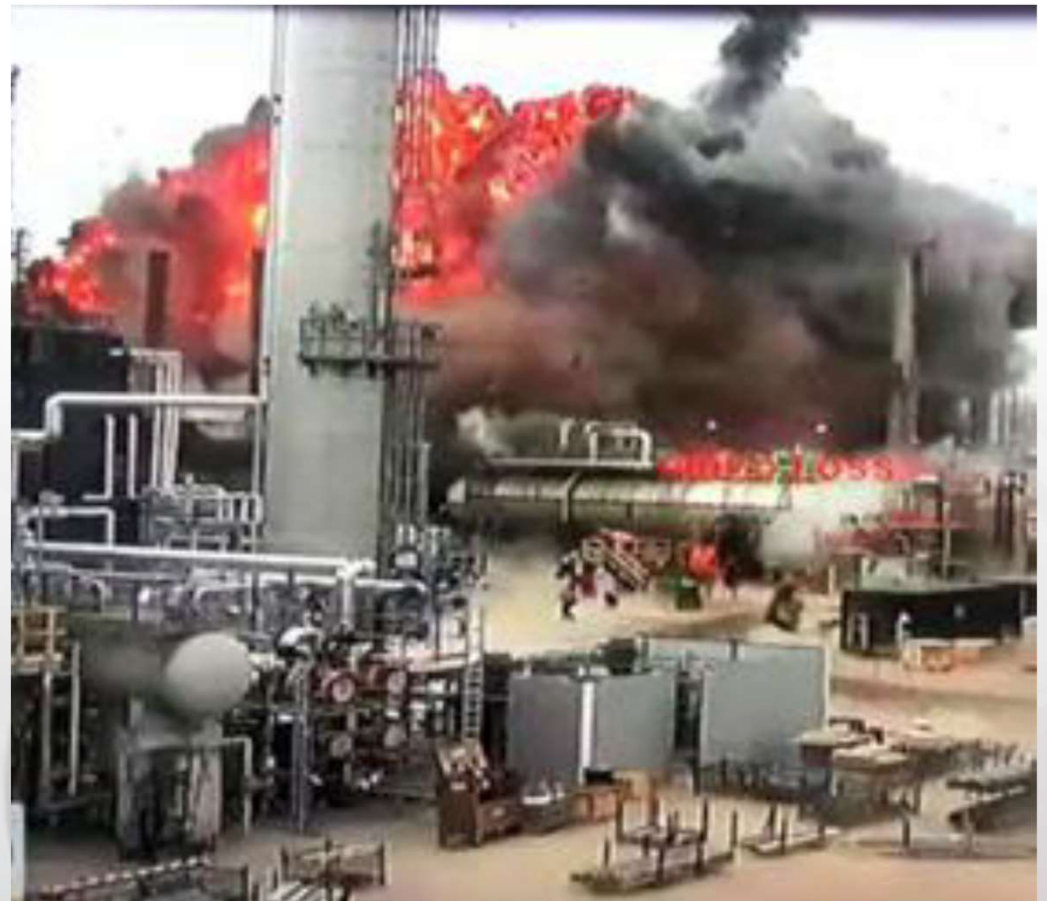
Operators were shutting down the FCC unit for a planned turnaround.

Explosion in the FCC unit occurred at about 10:00 a.m.

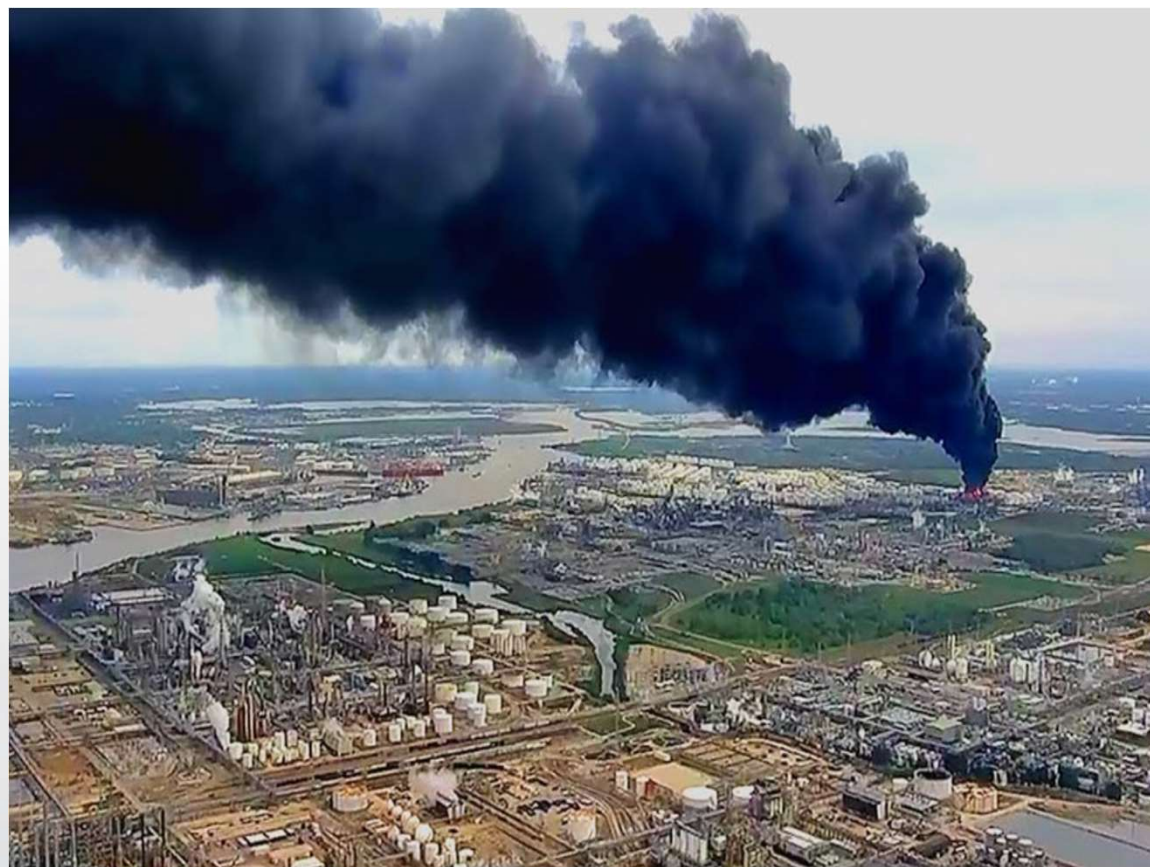
Intercontinental Terminals Company (ITC) Deer Park, TX

- March 17, 2019
- Storage Tank Fire
- Significant Environmental Damage

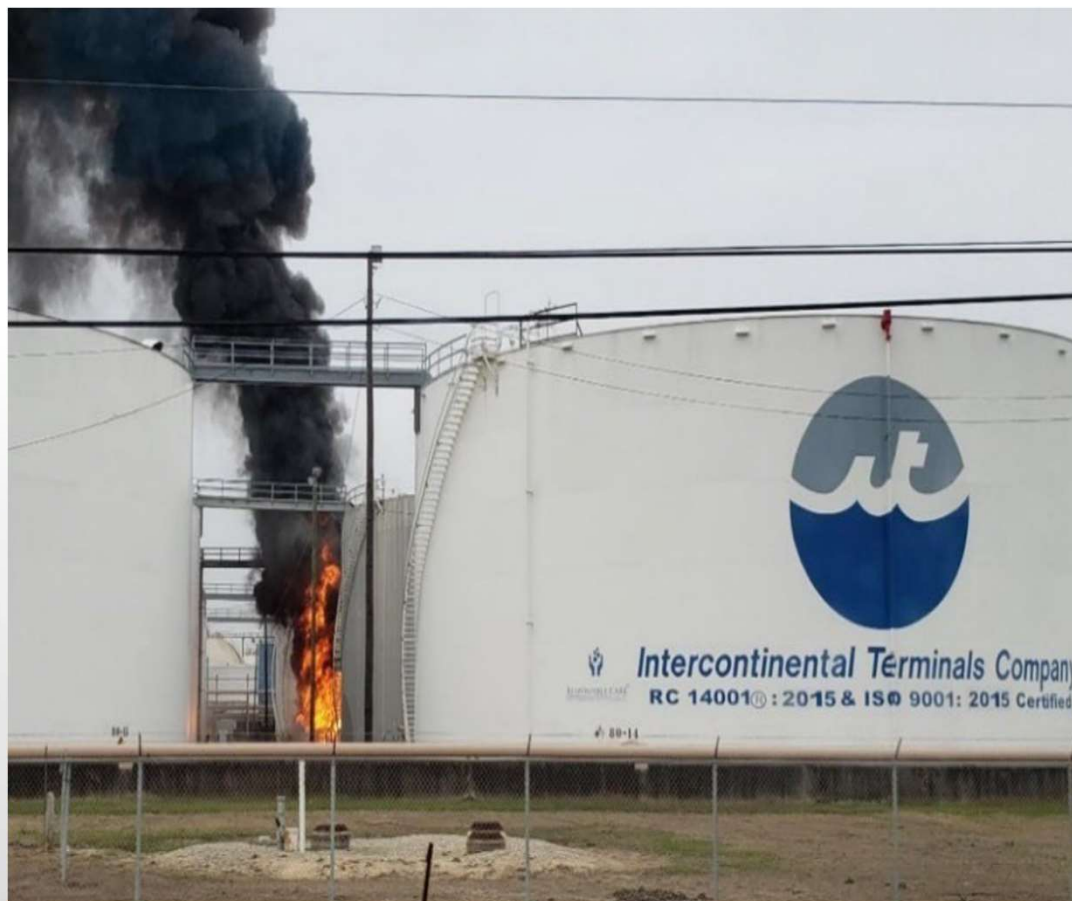
ITC was a bulk liquid storage terminal.

A fire originated in an 80,000-barrel aboveground atmospheric storage tank that held a blend of naphtha and butane product.

Once the fire erupted, ITC was unable to isolate or stop the release. The fire burned, intensified, and spread to the other 14 tanks in the same containment area.

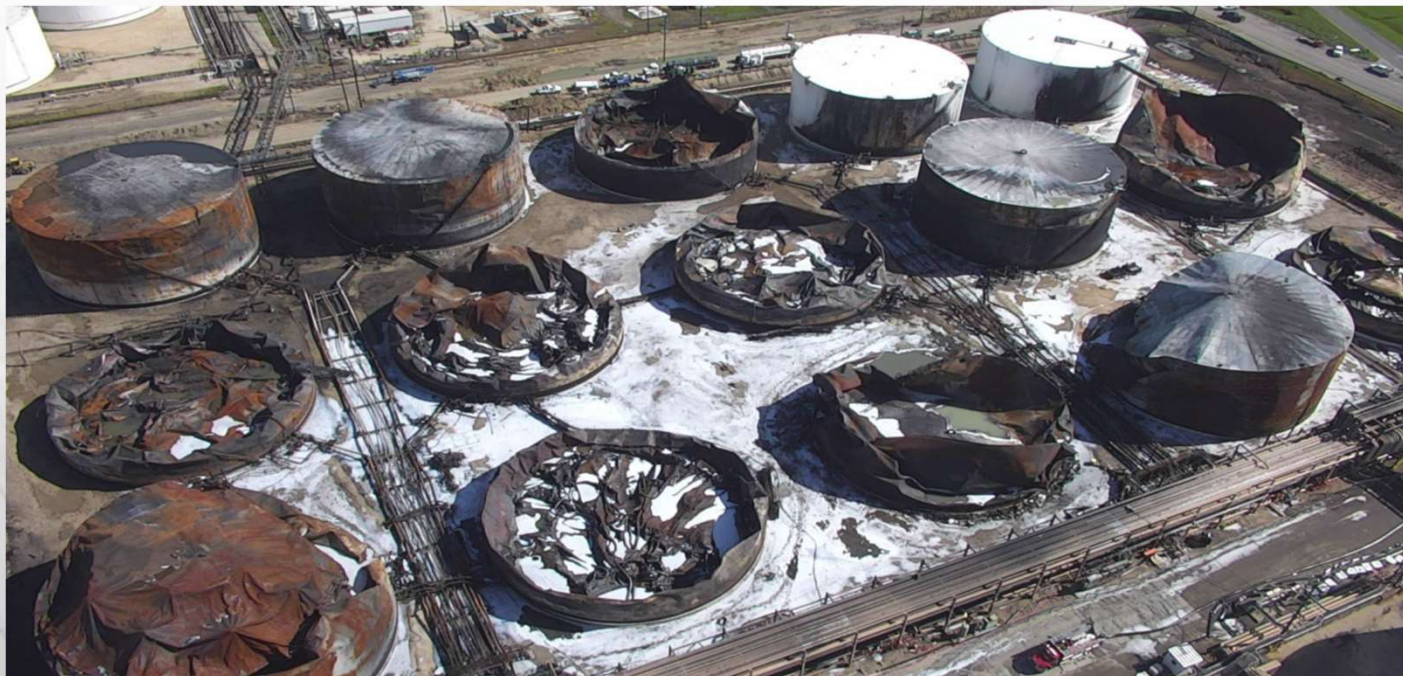
Pump Mechanical Integrity

- The pump failed allowing butane-enriched naphtha product to be released from the pump's mechanical seal while the pump continued to operate.

the release of flammable butane-enriched naphtha vapor from the failed Tank 80-8 circulation pump.
