The Critical Link between Reliability
and Safety Drives Global Acceptance
of New Inspection Technologies for
Fired Heaters

FTIS™ Design Advancements

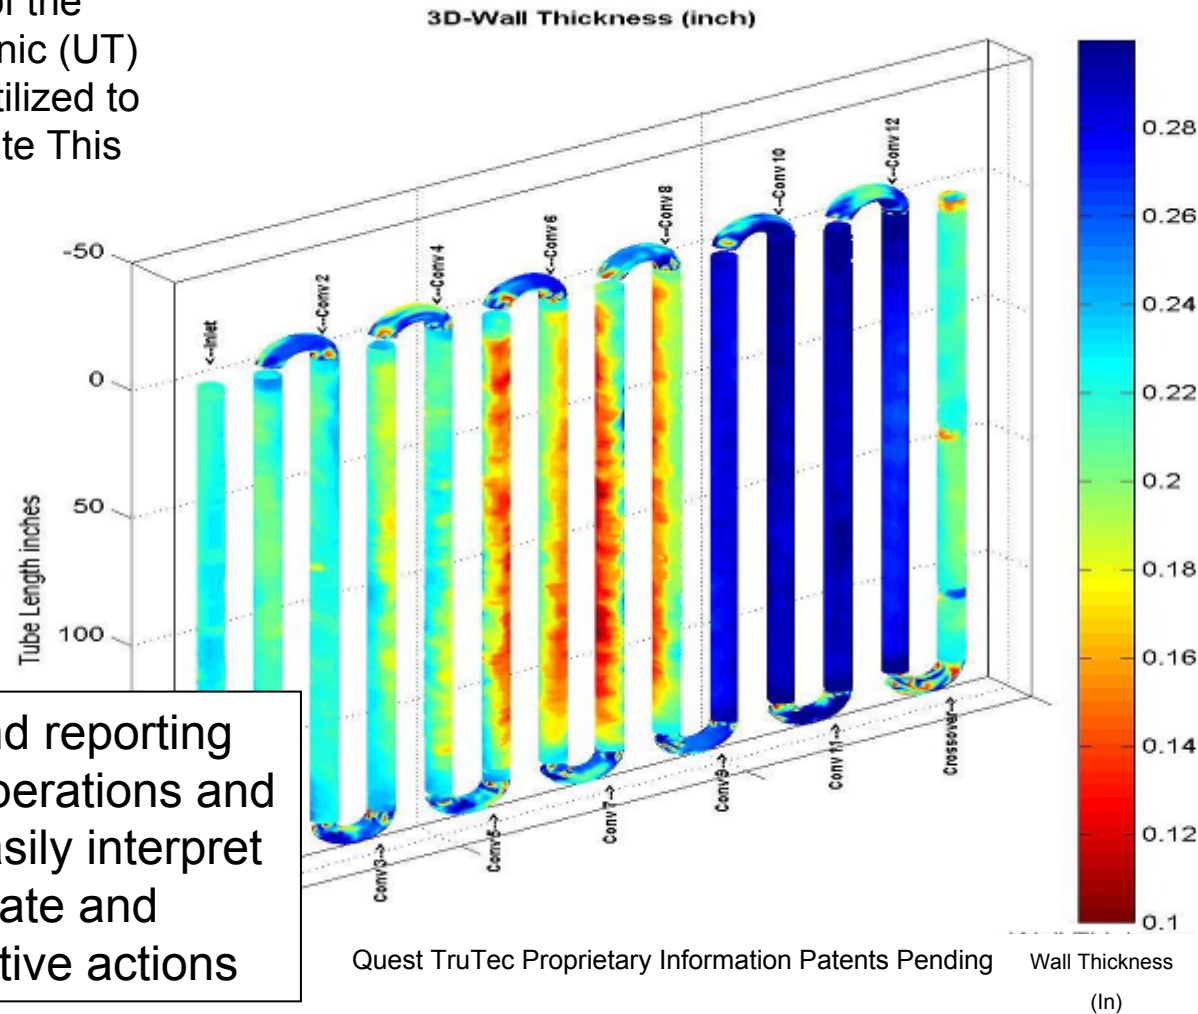
3D Modeling of FULL Serpentine Coil

100% of the
Ultrasonic (UT)
Data Utilized to
Generate This
Image

3D modeling and reporting options allow operations and inspection to easily interpret data for immediate and accurate corrective actions

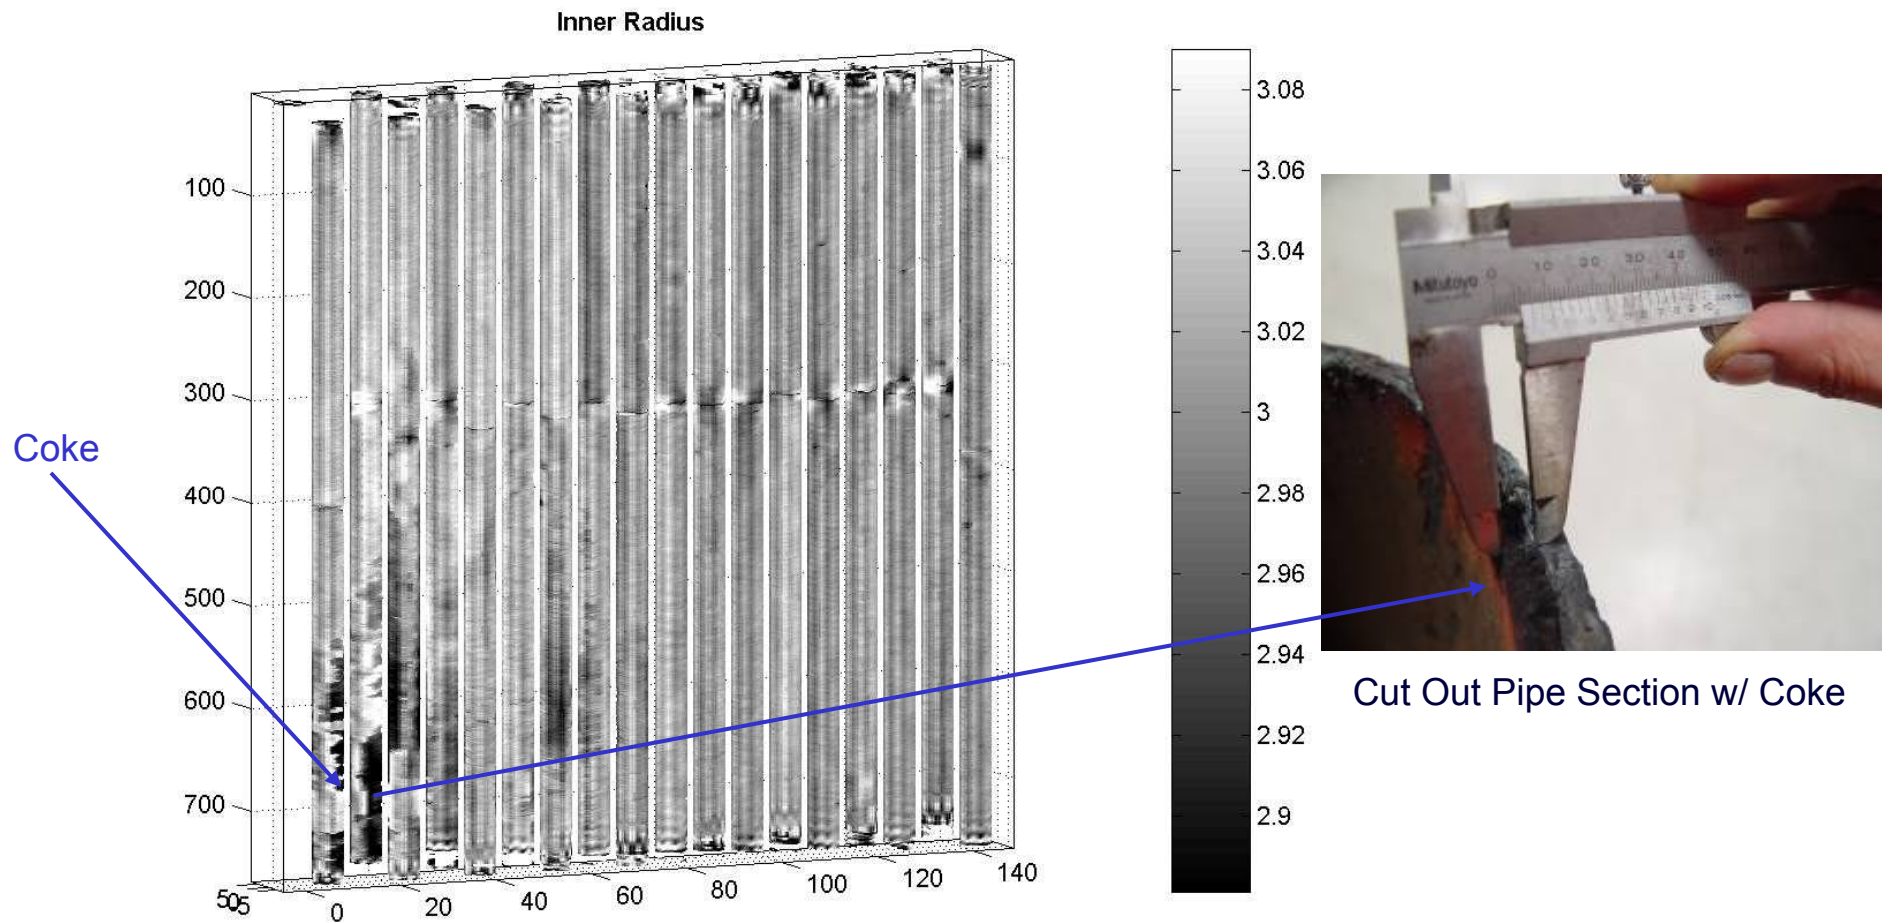
DeCoking Quality Control / Quality Assurance

Capability of flipping 3D plot to Grey Scale to assist mechanical decoking companies with understanding data.

Note coke on ID of tube in numerous locations

Photo is of a tube removed from a heater directly after FTIS inspection.

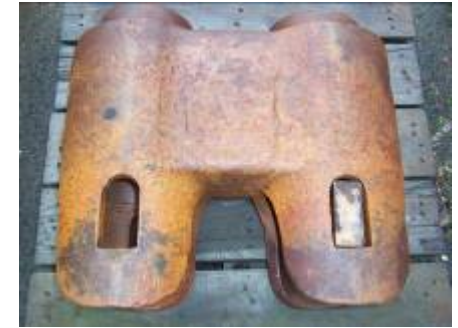
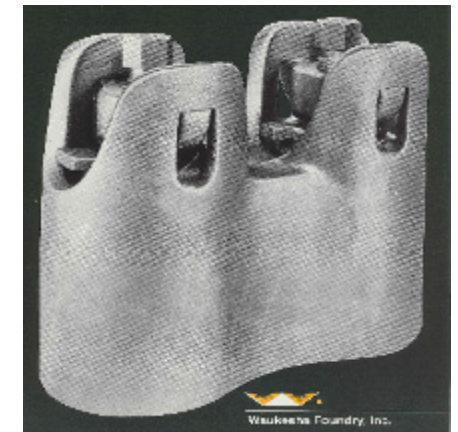
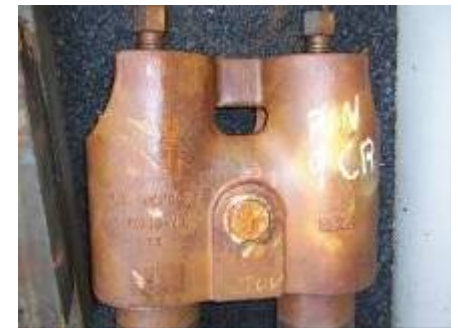
LOTIS® Inspection of Furnaces Containing Plugged Headers (Mule Ears)

❑ LOTIS® is capable of inspecting furnace coils which contain “Plugged Headers” (*a.k.a. Mule Ears*)

❑ Straight Section of Pipe is Inspected

❑ “Internal” flaws detectable and quantifiable:

- ✓ Corrosion, Erosion, Pitting
- ✓ Creep (Bulging / Swelling)

RDR13 FTIS currently cannot get through plugged headers (also commonly referred too as Mule Ears)

We can apply LOTIS to inspect plugged headers

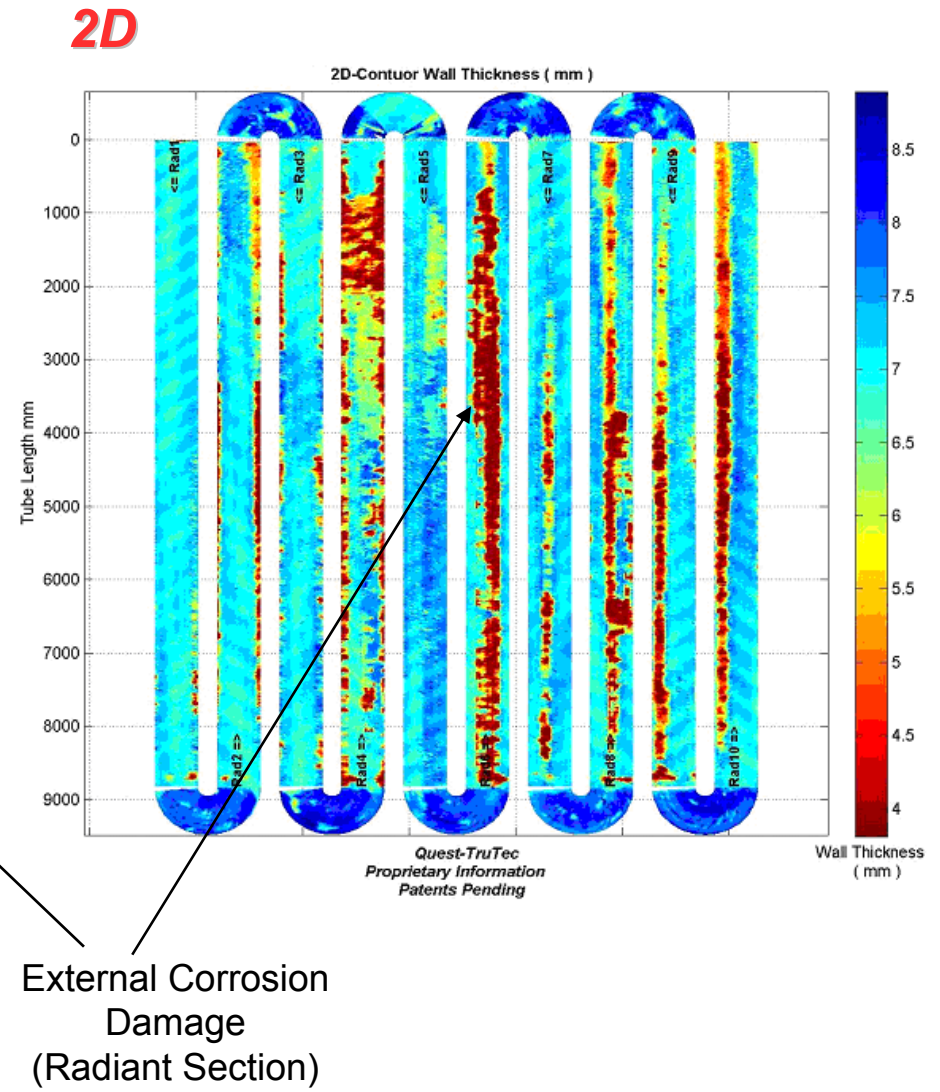
Case Study #3 Extensive External Corrosion Masked by Tightly -Adhered Scaling

RDR35 Damage was in "radiant" section.

FTIS data was confirmed by both "visual" and "destructive" testing.

- Number of Coils / Passes = 2
- Pipe Material = ASTM A335 – P5 (6-inch x Sch40)
- Heater Vintage = 1976
- FTIS™ was applied to inspect both process coils.
- FTIS™ inspection results detected extensive external corrosion damage in the radiant section.
- Visual inspection found tightly adhered scale on piping exterior surface.
- FTIS™ results were not impacted by tightly adhered scale.
- Large broad areas with 56% external wall loss were noted.
- Plant engineers utilized FTIS™ inspection results to make decision for replacement of several pipe sections.

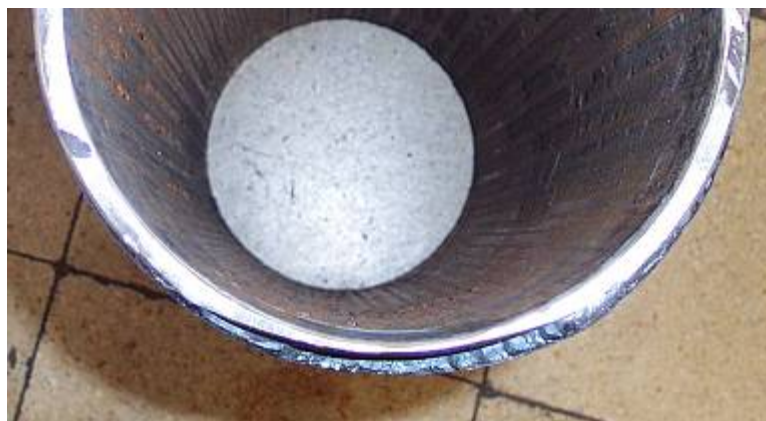
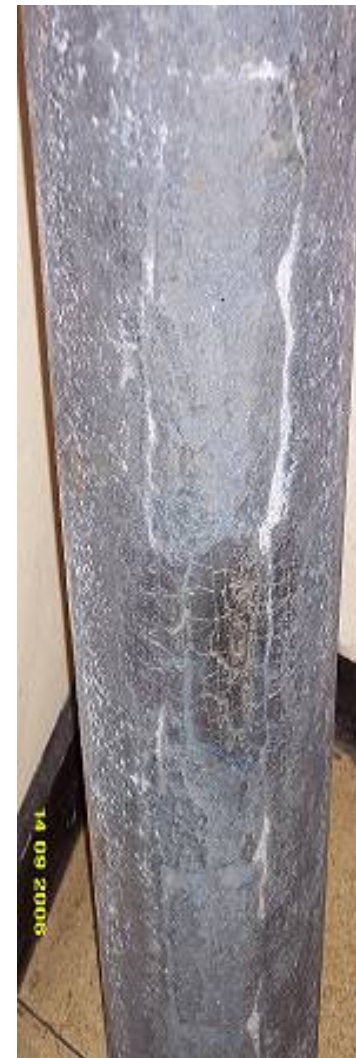
Case Study #3 Extensive External Corrosion Masked by Tightly -Adhered Scaling

56% Wall Loss

Tightly Adhered Scale

Side View of Pipe
