## Increased Reliability and Reduced Risk

*Applying FTIS™ Intelligent Pigging Technology to Inspect Certain Process Heaters Containing Plugged Headers*

## Process Heater Risk Management Solutions

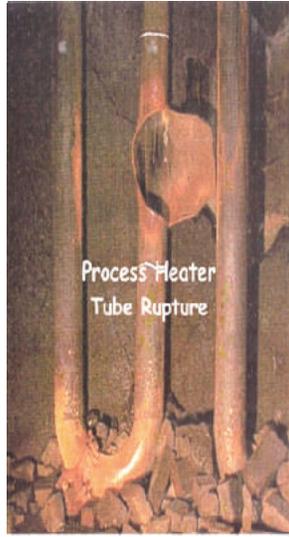
## FTIS™ / LOTIS® Detectable Failure Mechanisms

- Pipe/Tube Wall Loss
  - ✓ Corrosion (Int. or Ext.)
  - ✓ Erosion (Int. or Ext.)
  - ✓ Pitting (Int. or Ext.)
  - ✓ Mechanical Damage (Int. or Ext.)
- Deformation
  - ✓ Bulging (i.e. Flame Impingement)
  - ✓ Swelling (i.e. Creep Strain)
  - ✓ Denting
  - ✓ Ovality

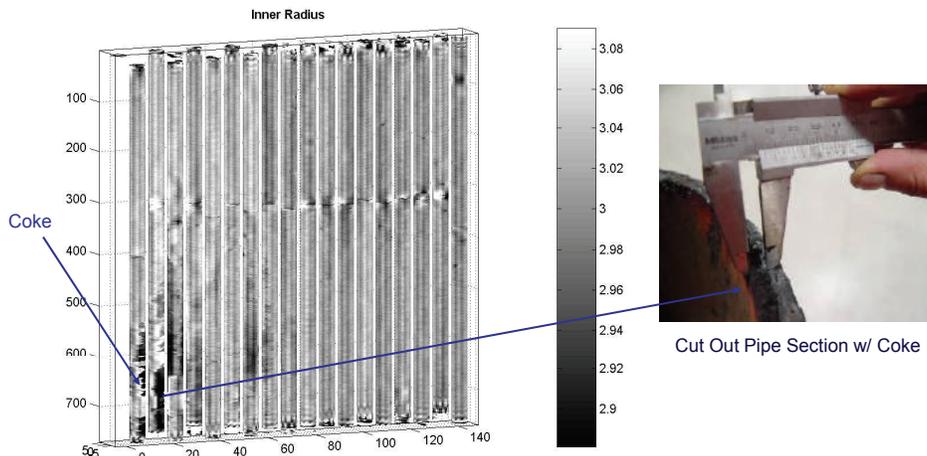
## Decoking Quality Control / Quality Assurance

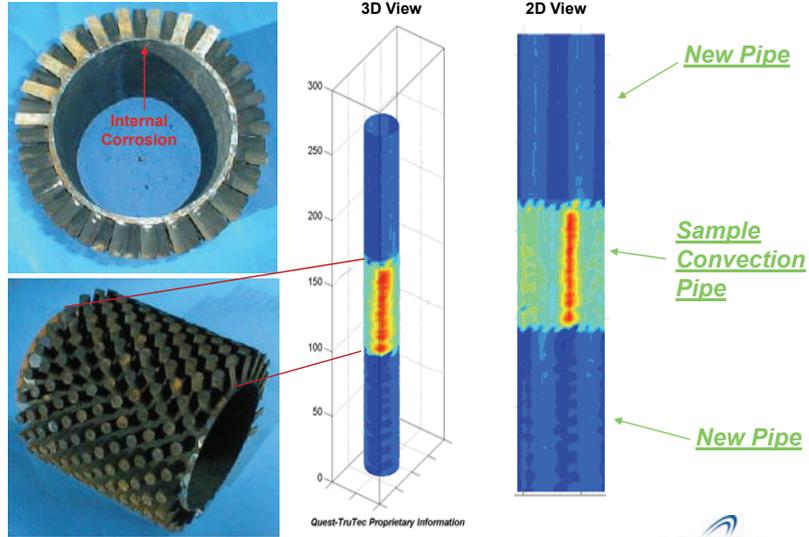
## Convection Pipe Studded / Finned Pipe

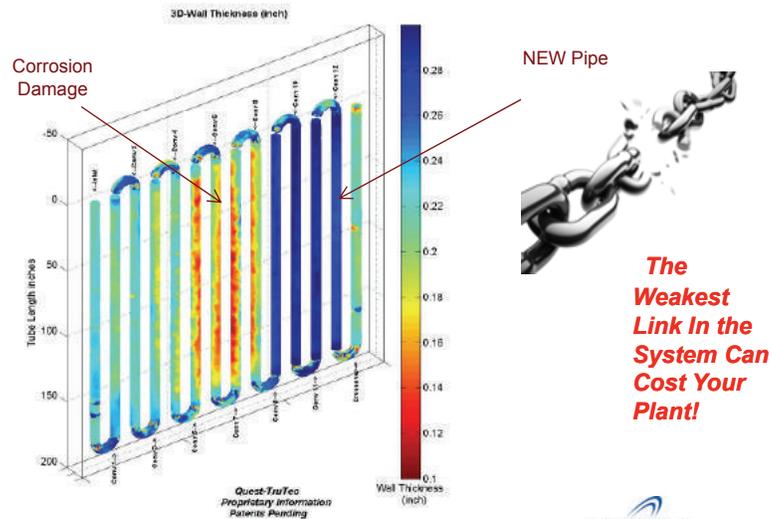
## Corrosion (Convection Section)

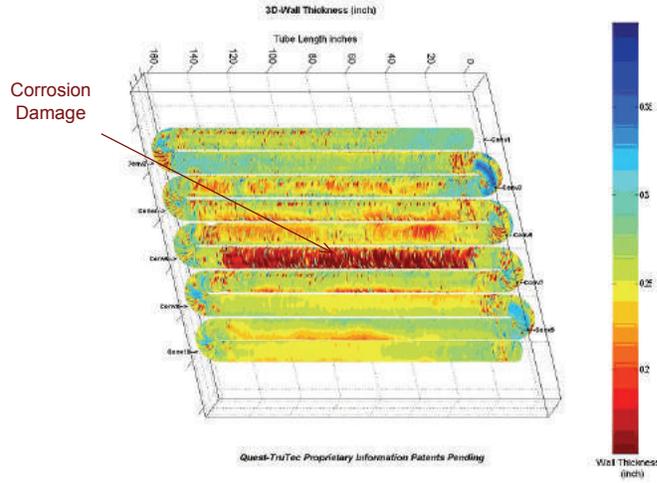
# Corrosion (Convection Section)

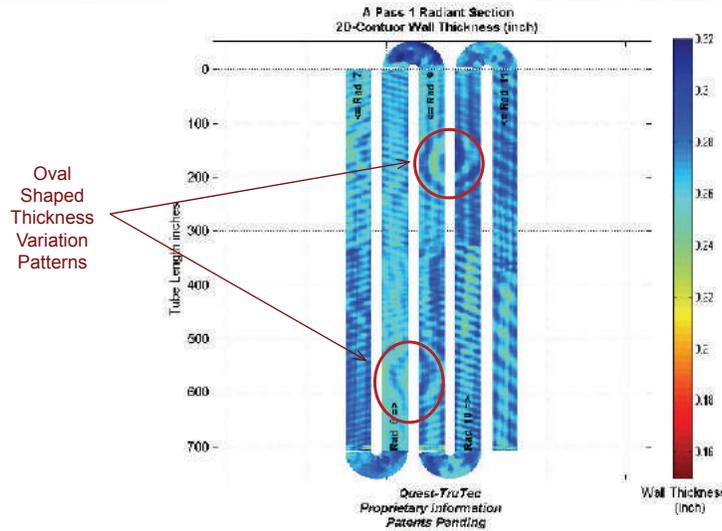
# Various Tube Wall Thickness (Radiant Section)

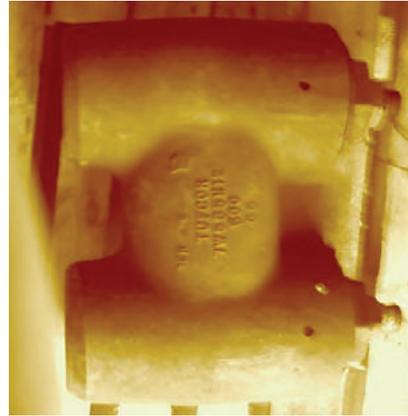
## Plugged Headers

- Also known as mule ear returns
- Cast fittings mounted at the ends of serpentine piping coils
- Original intent was to allow access to the interior of the heater in the event of a coke blockage

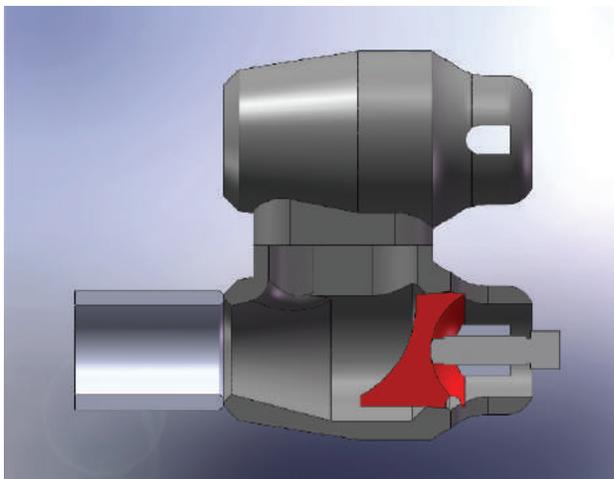
## Plugged Header Inserts

Shoe-horn style inserts round-off the hard internal angles

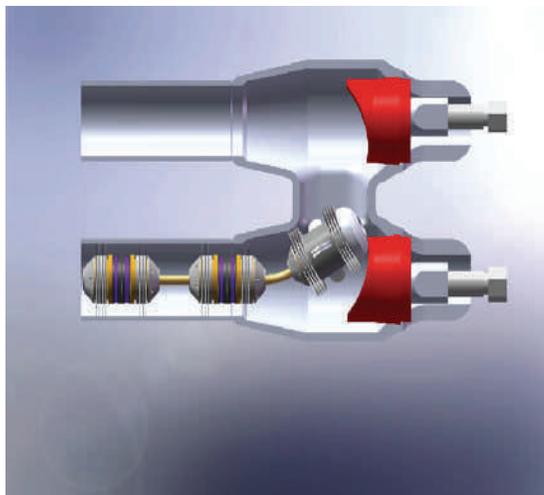
## FTIS™ - New Generation

The new generation 4" FTIS™ has successfully navigated plugged headers with inserts of this type in 6" diameter heater coils.

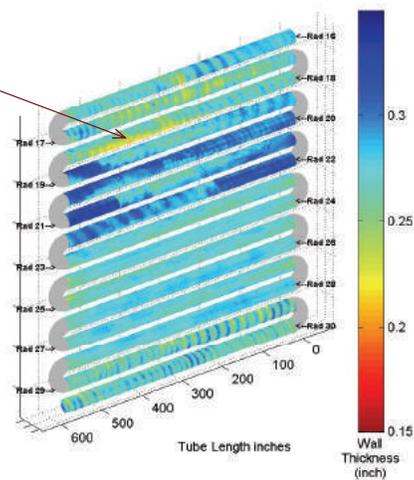
## Case Study #1 – Corrosion Damage in Radiant Section

Wall Thinning  
Damage Caused  
by  
Erosion/Corrosion  
Damage

- Number of Coils / Passes = 5
- Radiant Pipe Material = A335-P9 (6" x Sch-40)
- General wall thinning caused by internal erosion/corrosion was detected throughout.
- Piping has been in service since 1994.
- Several return bends in the radiant section contained plugged headers with show-horn style inserts.
- Most significant wall thinning in radiant section (31% loss) was approximately 2x that in convection section
- Refinery personnel indicated radiant section coils were not previously navigable by intelligent pig technology.
- Refinery personnel indicated that without the FTIS™ inspection data, the wall thinning in the radiant section would have remained undetected.

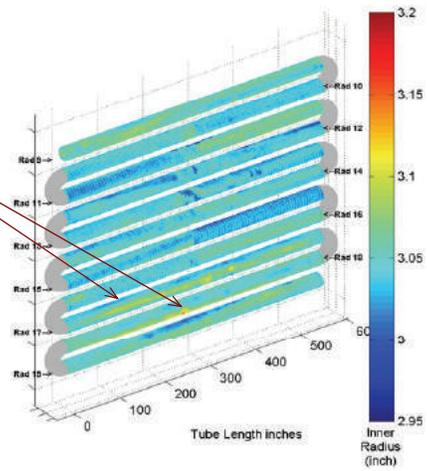
## Case Study #1 – Corrosion Damage in Radiant Section

Wall Thinning  
Damage Caused  
by  
Erosion/Corrosion  
Damage

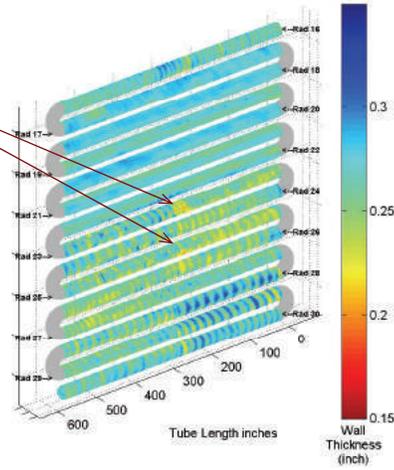
## Case Study #1 - Corrosion Damage in Radiant Section

Wall Thinning  
Damage Caused  
by  
Erosion/Corrosion  
Damage
