REFCOMM[®]
BUDAPEST
2-5 Oct 2017

FCCU REFRACTORY SELECTION

Gareth Maclagan
Sales Representative, Europe & GCC
HarbisonWalker International

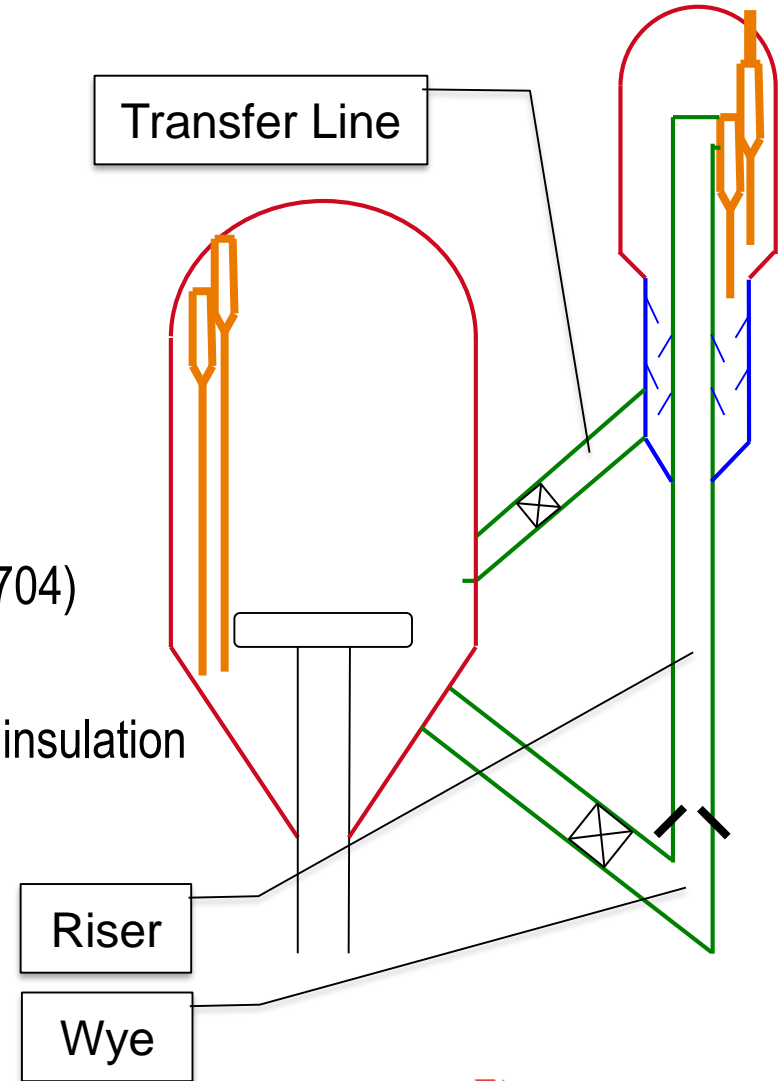
Riser and Transfer Lines

- High speeds in riser
- Very abrasive in all lines
- Need to retain heat balance

- Typically 75-150mm thick
- Abrasion resistance 5-12cc loss (ASTM C704)
- Density 2000-2600 kg/m³
- Must find a balance between strength and insulation
- Calcium Aluminate Cement bonded

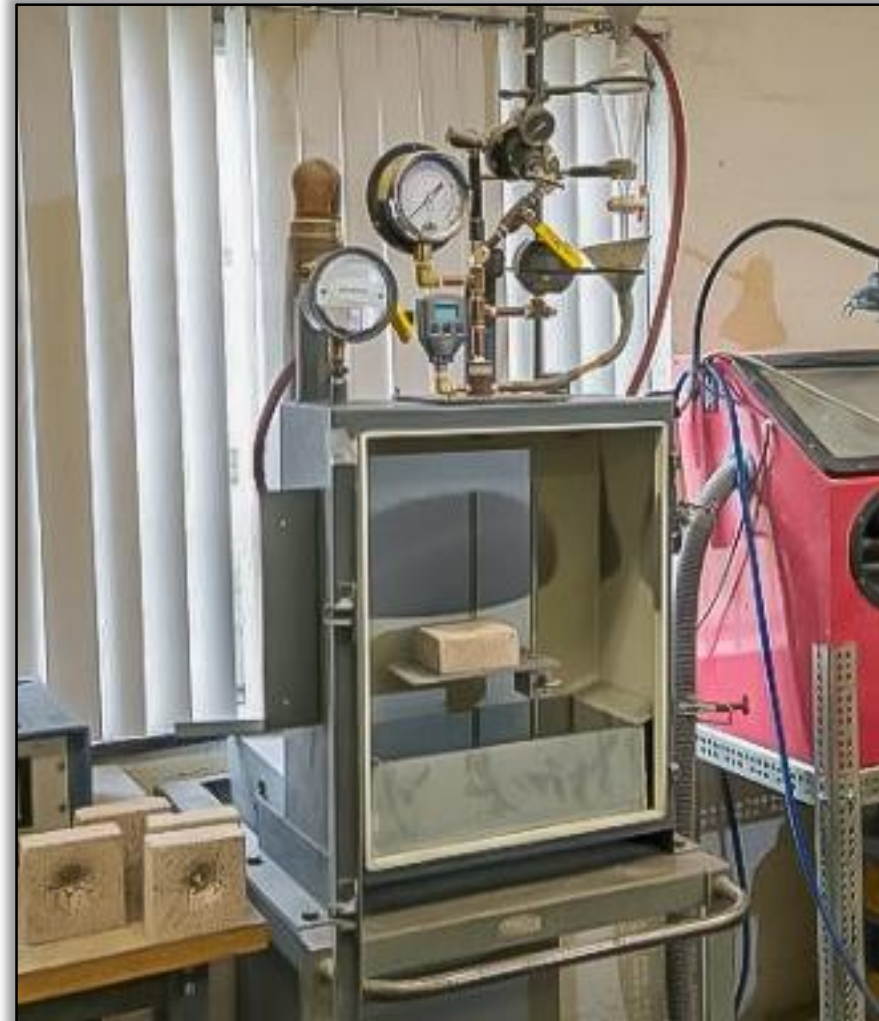
C704 Abrasion Testing

115 x 115 x 50mm sample

Weight and density are determined
before test and after being fired to
815°C

SiC grit is sprayed onto sample

Pressure through gun and inside
chamber is regulated

Sample is weighed after test and results
are recorded as “cc loss”

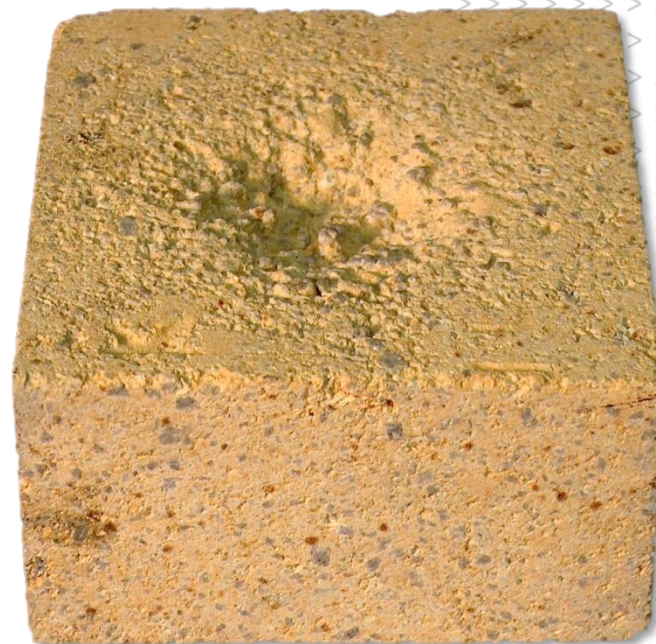
After

11.5 cc Loss of Refractory

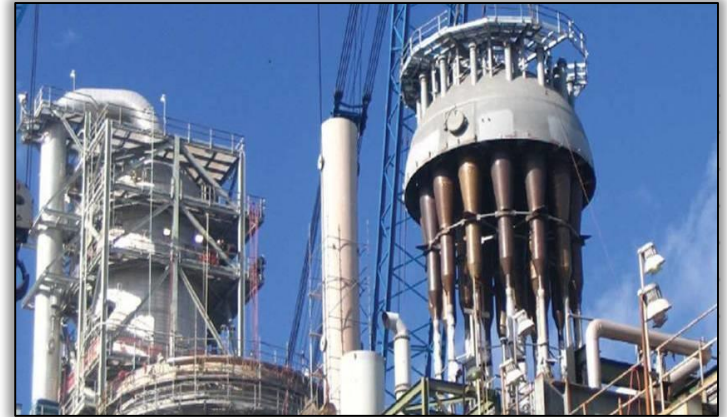
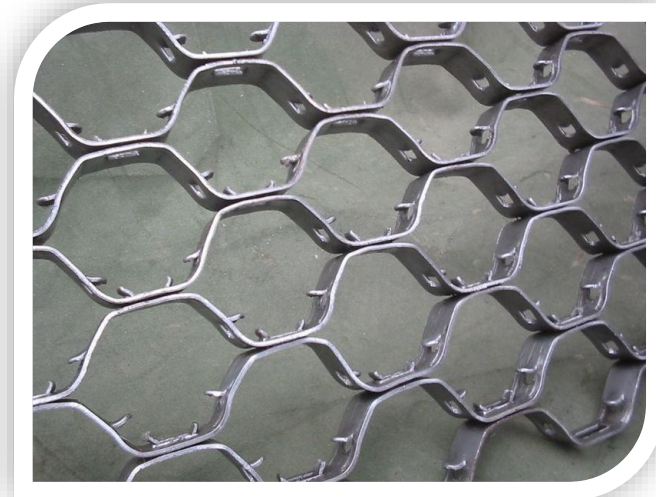
Cyclones

- Typically 25-50mm thick
- Rammed installation into hexmesh or S-bar anchoring
- Inlet and cyclone area
 - Abrasion Resistance of 2-5cc loss
 - Exotherm Reaction Bonded
- Cone and Dipleg
 - Abrasion resistance of 2-7cc loss
 - Can be CAC bonded

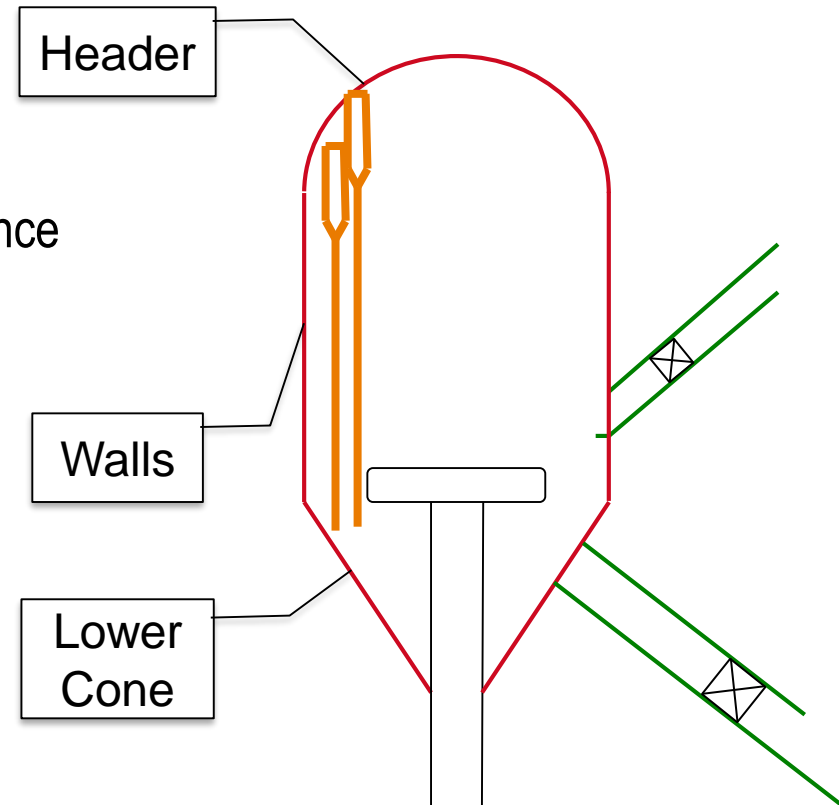
Reactor and Regenerator

- Typically 75-150mm thick
- Walls and Header
 - CCS 11-20 MPa
 - Density 1150-1250 kg/m³
- Lower Cone Areas
 - Abrasion Resistance 10-15cc loss
 - Density ~1750 kg/m³

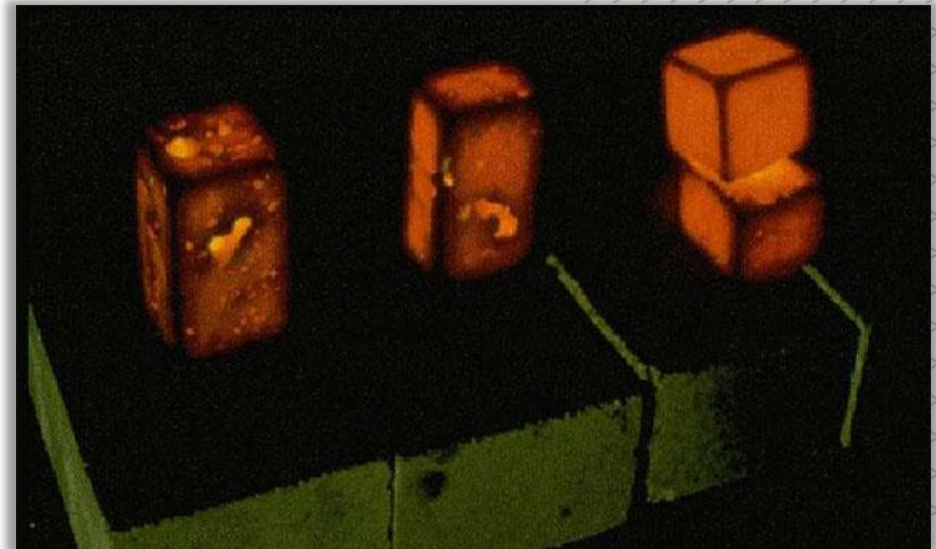
Flue Gas Line

- Low Iron, <1.5%
- Abrasion resistance 10-15cc loss
- Thermal shock resistant
- Density of 1750 to 2100kg/m³

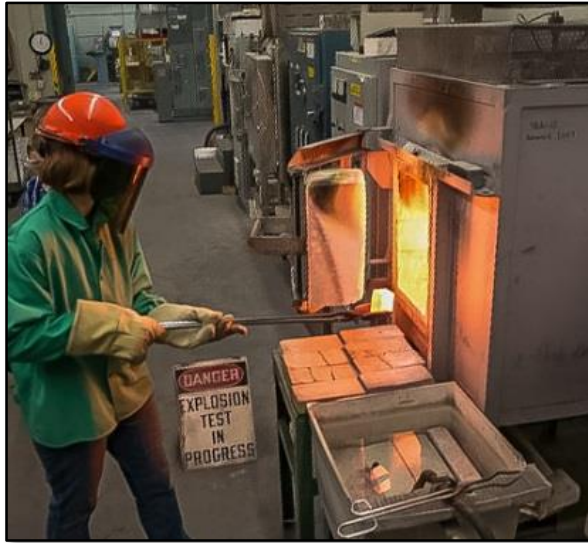
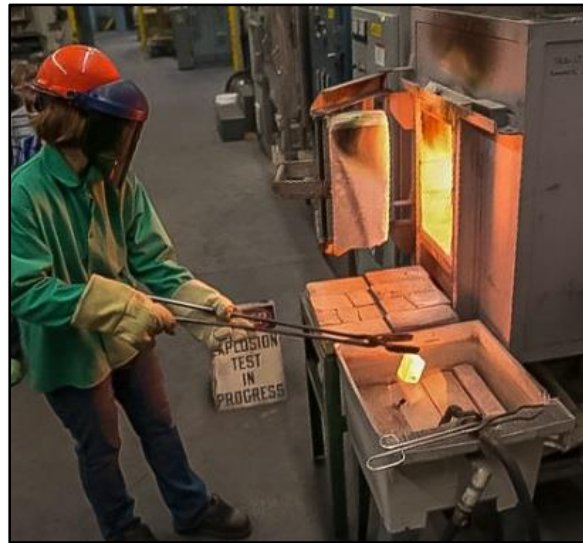
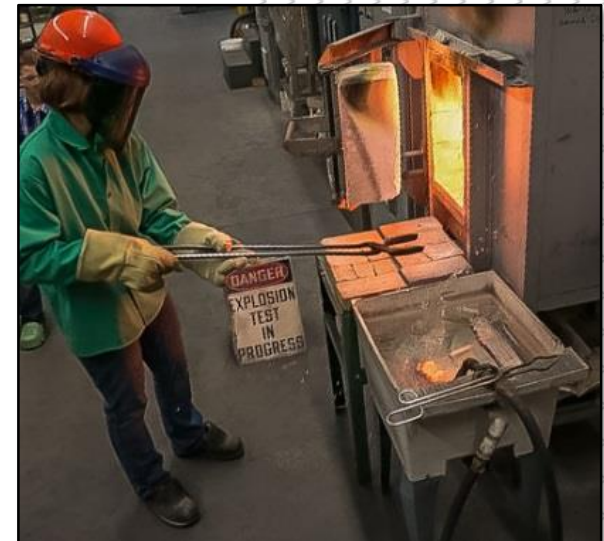
Thermal Shock Testing

Cycles to failure

- Low: 1-10
- Average: 10-20
- Good: 20-30
- Excellent: 30-40+
